A Survey of Crane Operating Experience at U.S. Nuclear Power Plants from 1968 through 2002

**U.S. Nuclear Regulatory Commission
Office of Nuclear Regulatory Research
Washington, DC 20555-0001**

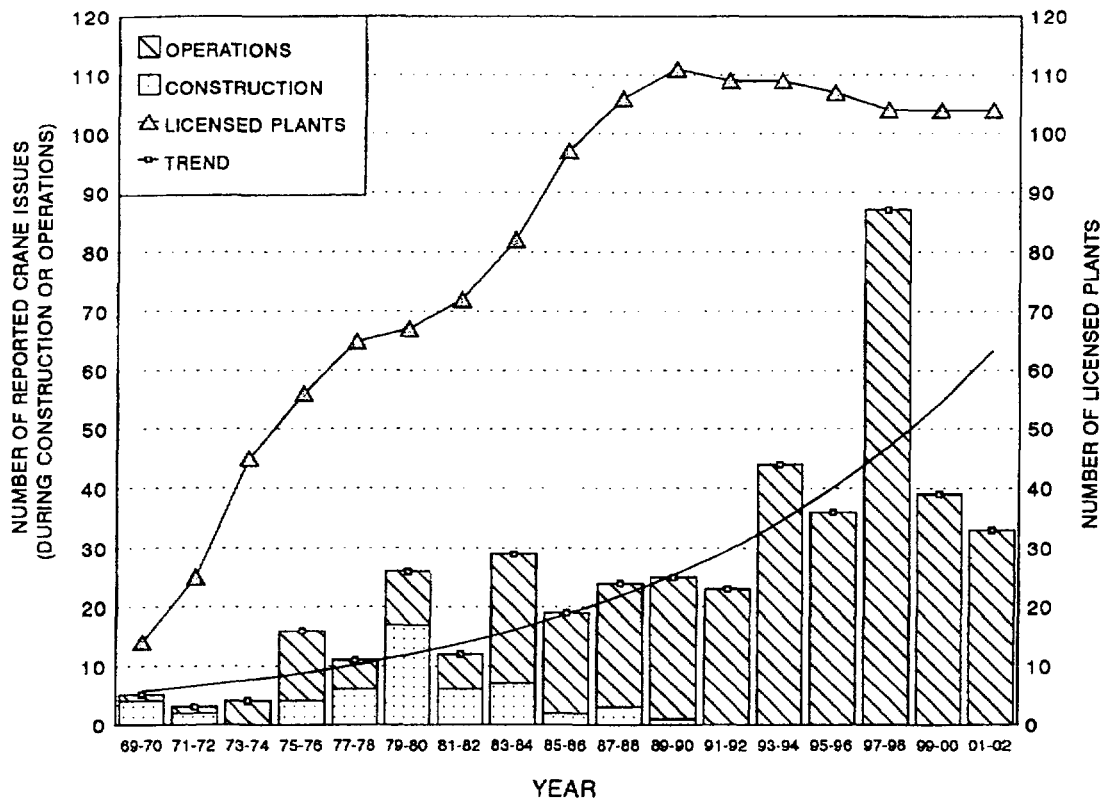
Figure 1, “Reported crane issues at U.S. nuclear power plants,” shows the total number of reported crane issues in two-year increments. Although there has been a steady increase in the number of crane issue reports since the late 1960s, when compared to the number of operating units as shown in the figure, an improving trend (based on issues reported per number of operating units) is noticed. The two-year period 1997 through 1998 appears to be an outlier compared to operating experience data documented prior to and after that time period. The 1997 through 1998 period also experienced a high percentage of human errors (83 percent), including a high number of load drops (8).

Figure 1: Reported Crane issues at U.S. nuclear power plants

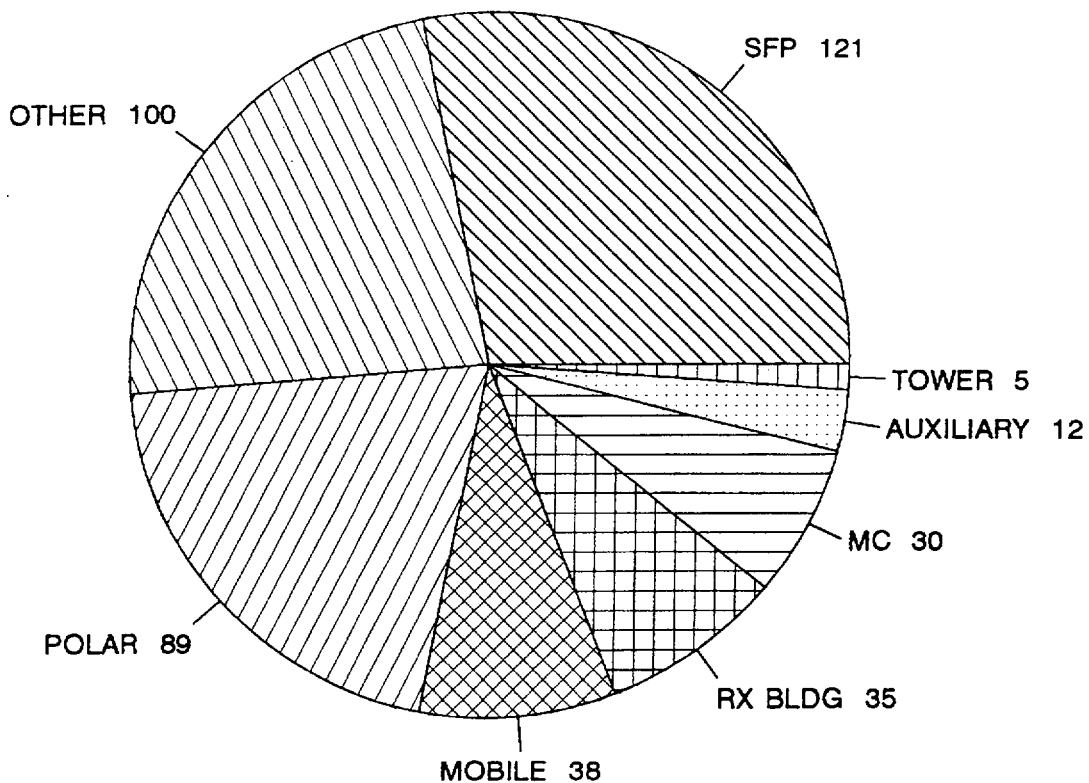
For the 430 reported crane issues during the period 1968 through 2002, Figure 3, "Crane issue distribution by crane type," shows the total number of crane issues documented for each crane type. The number of crane issues for each crane type was not broken down by reactor type, operational phase, or weight of load at the time of the event. Crane types include polar, spent fuel pool (SFP), tower, auxiliary building, refueling/manipulator (MC), reactor building (RB), mobile, and other. The category "other" refers to cranes which do not specifically fit into one of the remaining categories, and could include turbine building cranes, special cask handling cranes, unspecified cranes, or miscellaneous cranes used inside or outside of areas containing safety-related components. If the event report did not specify the crane type, it was categorized as other. The crane reporting the most number of issues (approximately 28 percent of the total) was the SFP crane (121). The reason for the high number of issues is due in part to the number of times that the crane is used in moving fuel assemblies. The SFP cranes were responsible for many procedural violations involving building ventilation requirements, and fuel assembly drop events. The "other" category is high (100) because it represents several miscellaneous crane types. Small cranes and hoists were not included as part of this survey.

Figure 3: Crane issue distribution by crane type

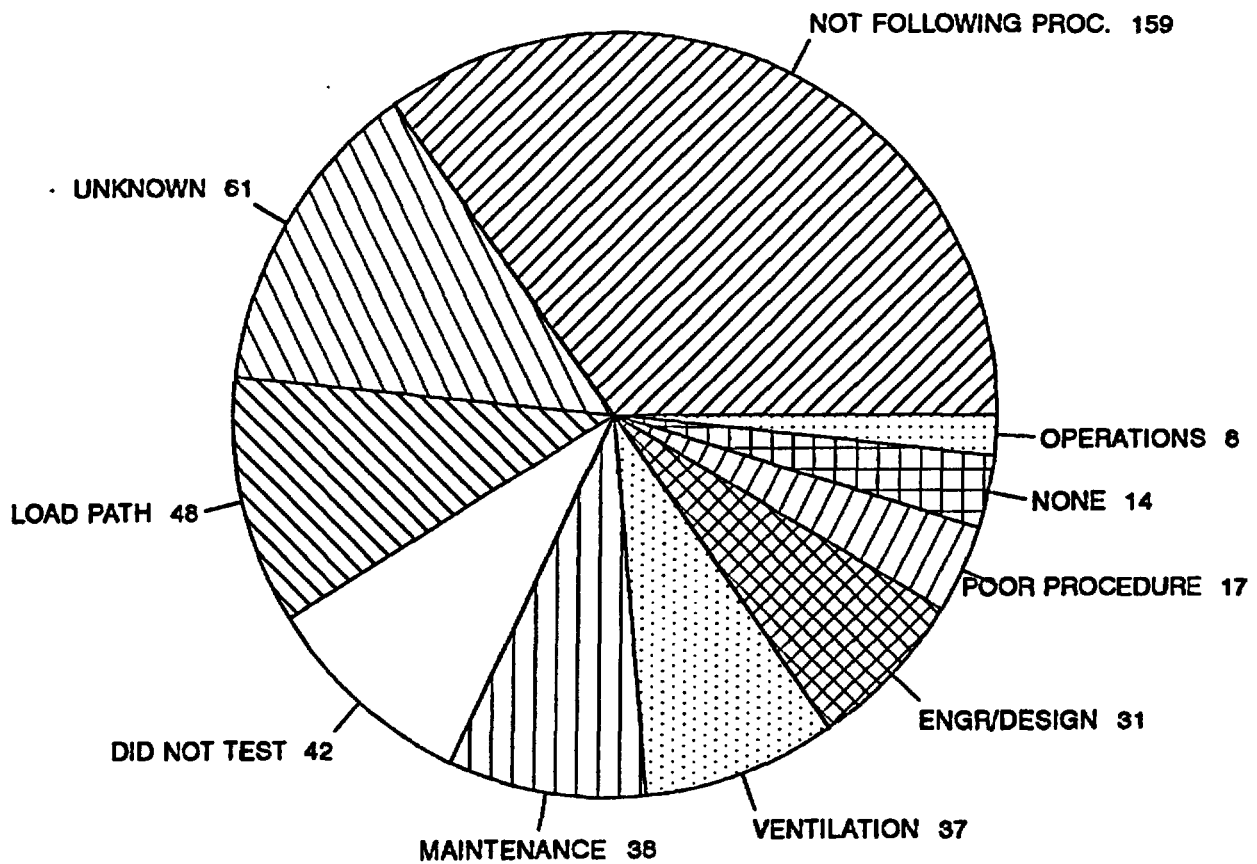
Upon review of the 430 crane issues, a cause of the issue was either listed in the crane issue report, was determined by the available facts presented in the document, was indeterminate (category "Unknown"), or there was insufficient information given in the report to conclude that any deficiency existed (category "None"). Figure 6, "Principal reasons for crane events," shows the distribution of causes for the crane issue being reported. "Not Following Procedures" was the largest category with 159. Other categories that are similar to "Not Following Procedures" would be "Ventilation" (i.e., failure to establish the required ventilation prior to load movements in certain areas), "Did Not Test" (i.e., failure to perform crane surveillance tests prior to use) and "Load Path" (i.e., failure to move loads over established safe load path areas). There were 61 crane events where the cause of the event was categorized as "Unknown." In most of these instances, the event report lacked sufficient detail to determine the cause with certainty.

Figure 6: Principal reasons for crane events

The probability of a drop over SSE would be related to the probability of the failure to follow procedures. As shown in Figures 2 and 6, a large percentage of crane issues are either related to not following procedures, or to not properly implementing procedures. For the purposes of this assessment, it was conservatively assumed that all failures to follow procedures (159) event could have caused a drop over SSE. This would result in a probability of $159/54000$ or approximately $3E-03$ failures per lift. A lower estimate of $1.5E-03$ was used which assumes that 50 percent of the crane events caused by not following procedures, resulted in a load drop over SSE.

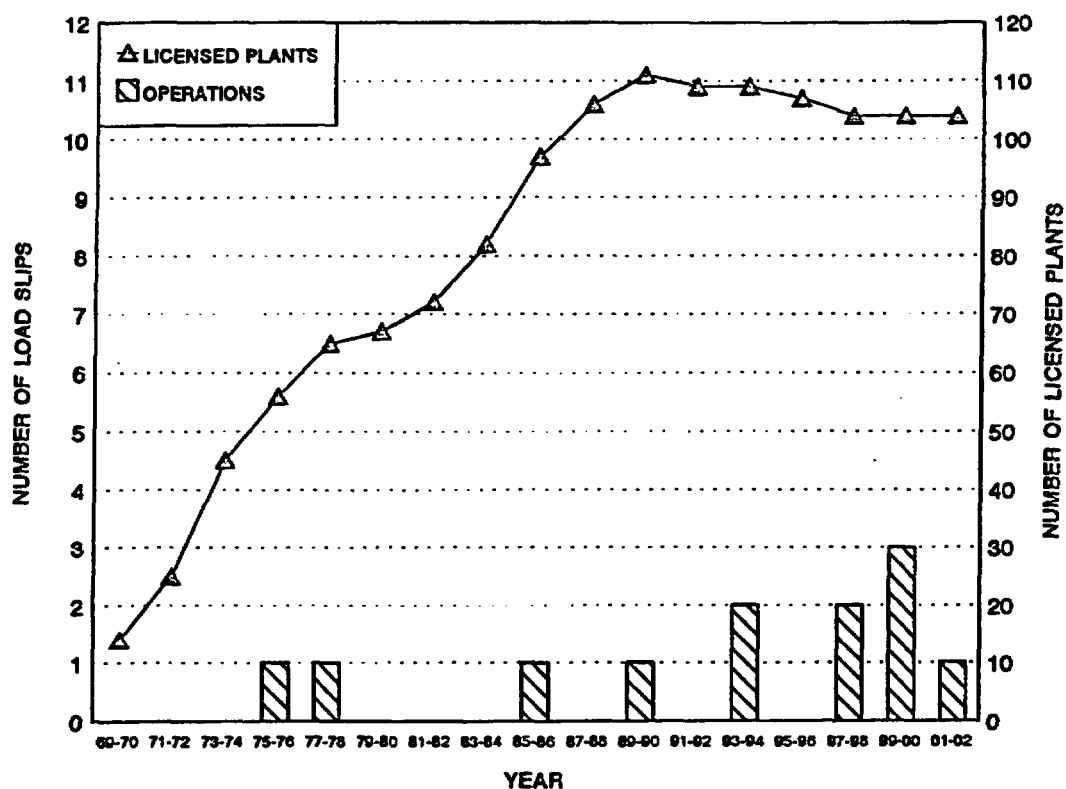
During the period 1968-2002, there were 12 reported events involving load slips. Figure 8, "Load slip distribution," shows that there has been an increase in the number of load slips within the last decade (1993-2002) during a period where the number of operating nuclear power plants has remained fairly constant. No load slip events were recorded which involved plants that were still in their construction phase, probably because of the lack of reporting during that time period. No one cause dominated the events. Load slips were caused by below-the-hook issues, control systems, operations and engineering. Six of the 12 load slip events occurred while operating a polar crane, however, most of these events were beyond the control of the crane or the crane operator.

Figure 8: Load slip distribution

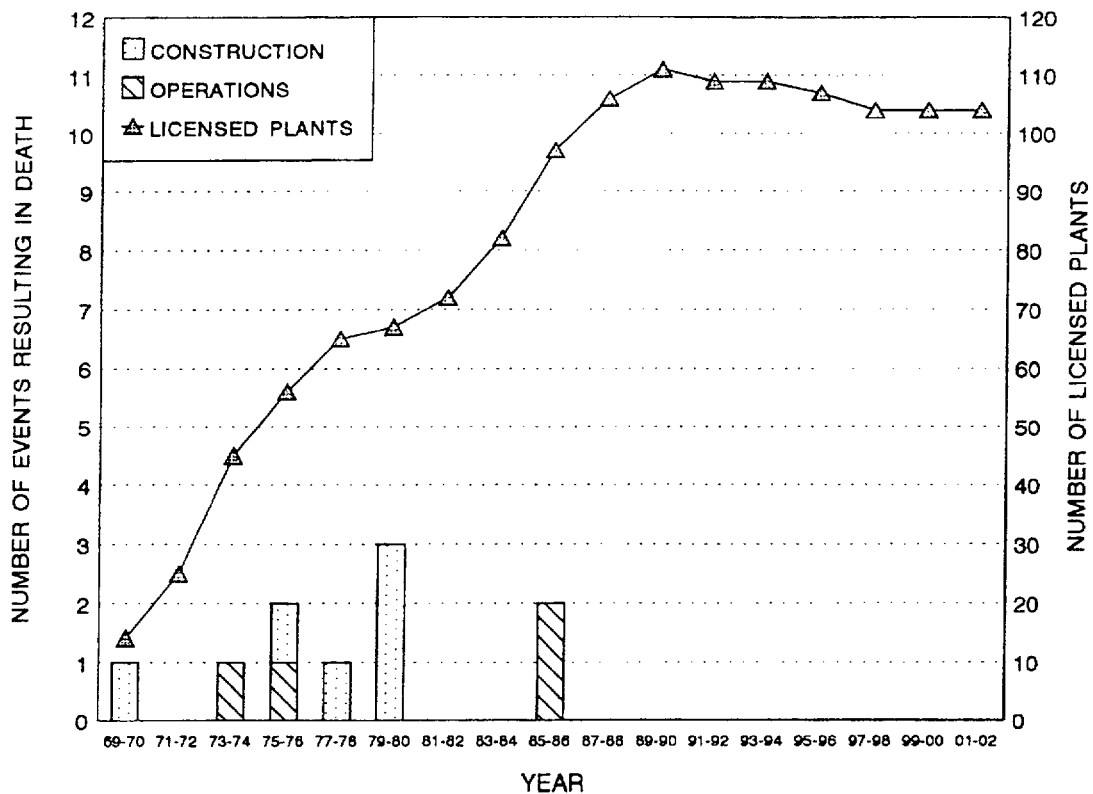
Figure 12, "Distribution of crane related deaths," shows the number of crane related events leading to at least one death. In some instances, one crane event resulted in multiple deaths. There have been 10 reported crane events that have led to deaths in the nuclear industry for the period 1968 through 2002. The highest concentration of crane related deaths at nuclear power plants occurred during the first decade (1969 to 1980). For Decade 1, six of eight events that led to a death occurred at facilities still under construction. The last death in a crane related accident in the U.S. nuclear industry was Decade 2 (1985). Table 3, "Reported crane events resulting in deaths" provides information for each of the reported crane events that involved a death. Figure 12 also shows the cumulative number of nuclear power plants that had an operating license during the period from 1968 through 2002.

Figure 12: Distribution of crane related deaths

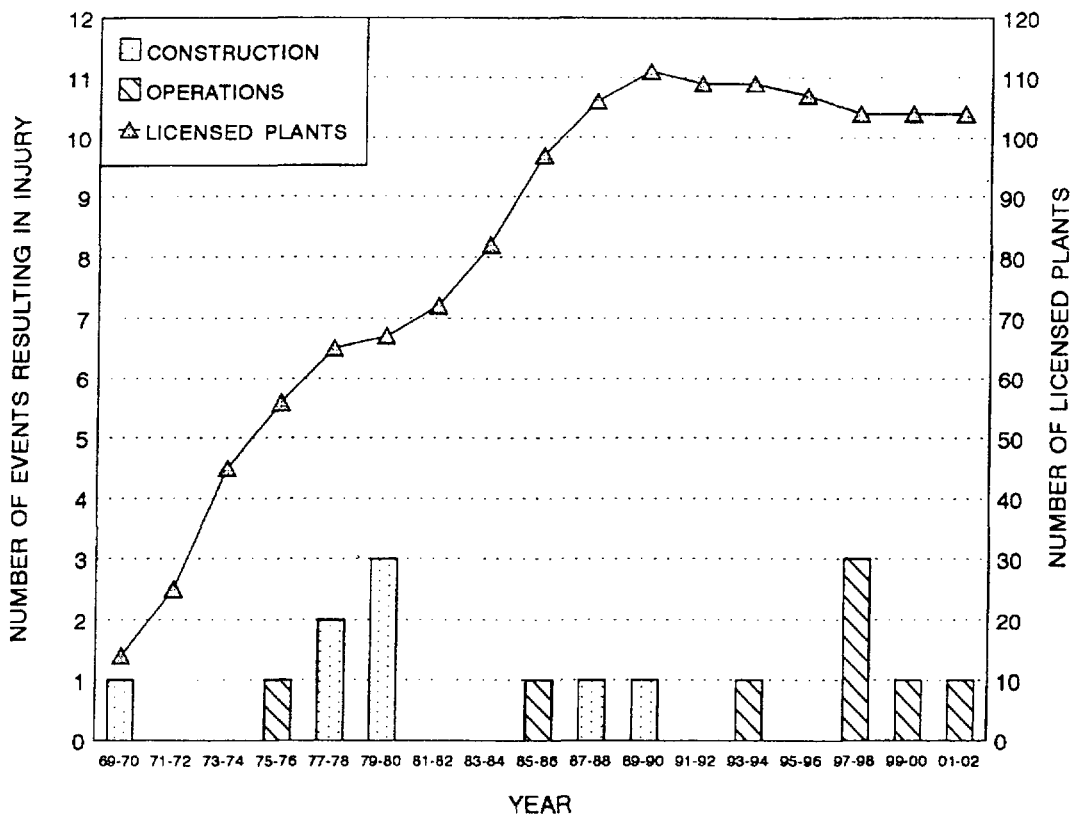
Figure 13, "Distribution of crane related injuries," shows the number of crane related events leading to at least one injury. In some instances, one crane event resulted in multiple injuries. There have been 16 reported crane events that have led to injuries in the nuclear industry for the period 1968 through 2002.

Decade 3. Six injuries, all occurring at operating plants. When comparing Decade 2 crane injuries with Decade 3 injuries, a 100 percent increase in the number of injuries occurred with a 9 percent increase in the number of operating power plants.

Figure 13 also shows the cumulative number of nuclear power plants that had an operating license during the period from 1968 through 2002. When considering the number of operating facilities during each of the three decades, the injury rate has significantly decreased.

Figure 13: Distribution of crane related injuries

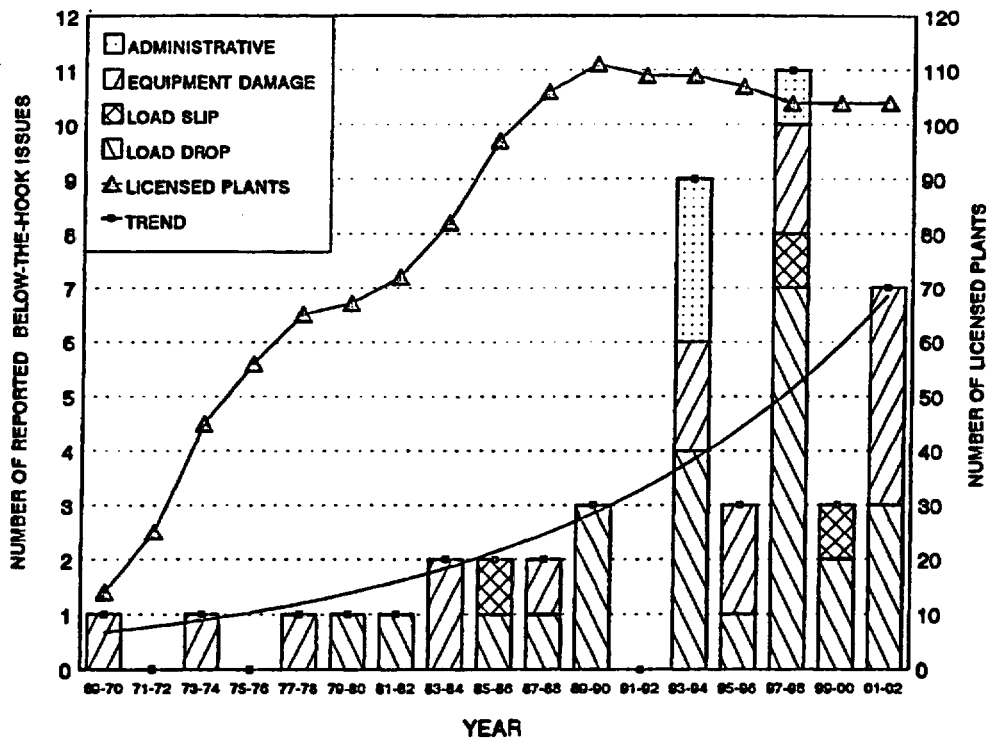
For the period 1968 through 2002, there have been 47 below-the-hook events that have been reported. A below-the-hook event is classified as an event where rigging or handling errors resulted in an event. Figure 17, "Below-the-hook crane events," shows a significant overall increase in the number of events. Figure 17 also categorizes below-the-hook events into "administrative," "equipment damage," "load slip," and "load drop." Many of these events have resulted in load drops and damaged equipment. A comparison of the three decades presents the following observations:

Decade 2. There were 10 below-the-hook events. Six involved a load drop, three involved equipment damage, and one involved a load slip. During Decade 2, the number of events increased by 150 percent, concurrent with an increase in the number of operating units by 113 percent when compared to Decade 1.

Decade 3. There were 33 below-the-hook events, of which 17 involved load drops, 10 involved equipment damage, four involved administrative issues, and two involved load slips. During Decade 3, the number of events increased by 230 percent, concurrent with an increase in the number of operating units by 9 percent when compare to Decade 2.

Figure 17: Below-the-hook crane events

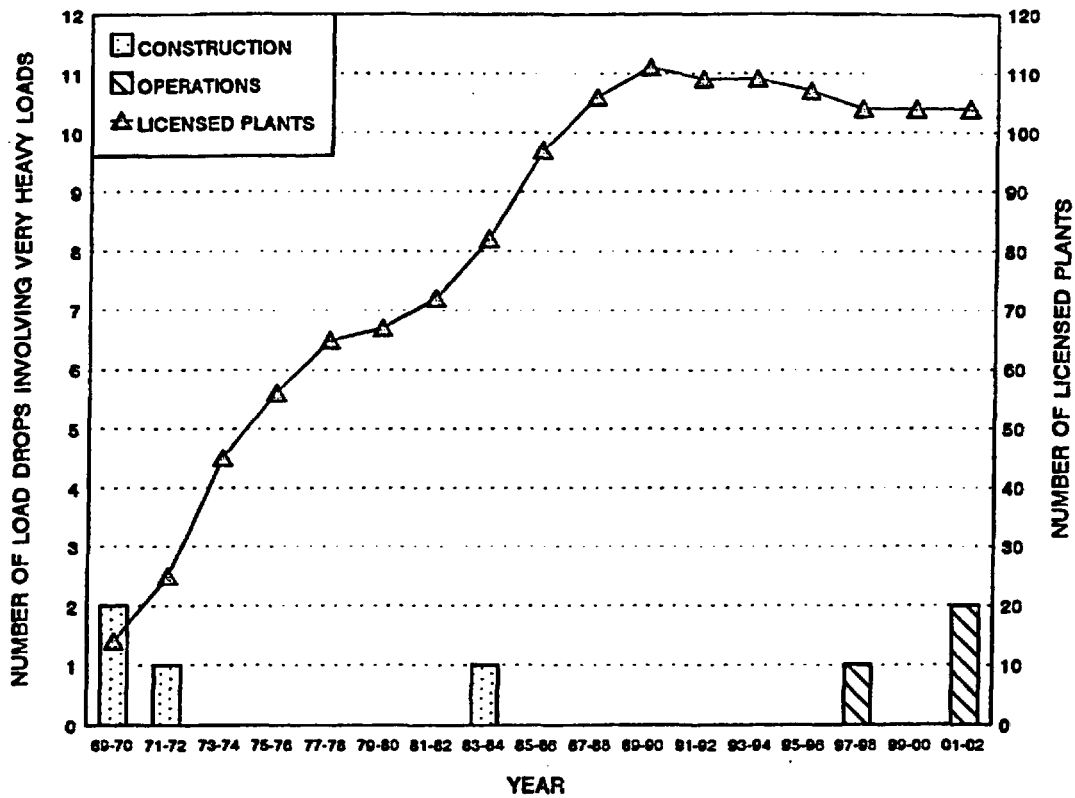
Of the estimated 54000 very heavy load lifts, there were three load drops. Figure 20, "Very heavy load drop distribution," shows the distribution of very heavy load drops from 1969 through 2002. A load drop is defined as an uncontrolled lowering of a load to the point where contact with the floor or some object stops any further decent. The figure shows seven very heavy load drops, four of which occurred during plant construction. The three very heavy load drop events that occurred after NUREG-0612 was issued and when the plant had an operating license, occurred because of human error, and ultimately because of rigging deficiencies and not because of crane deficiencies. The three events also did not occur near any safety related areas, and none resulted in radiation releases, risks to licensee personnel, or the public. Table 10, "Load drops involving very heavy loads at operating nuclear plants (1980-2002)," provides a brief summary of the three events. The Byron very heavy load drop event occurred while operating a mobile crane, while the San Onofre 3 and Turkey Point 4 very heavy load drop events occurred while operating turbine building overhead cranes.

Figure 20: Very heavy load drop distribution

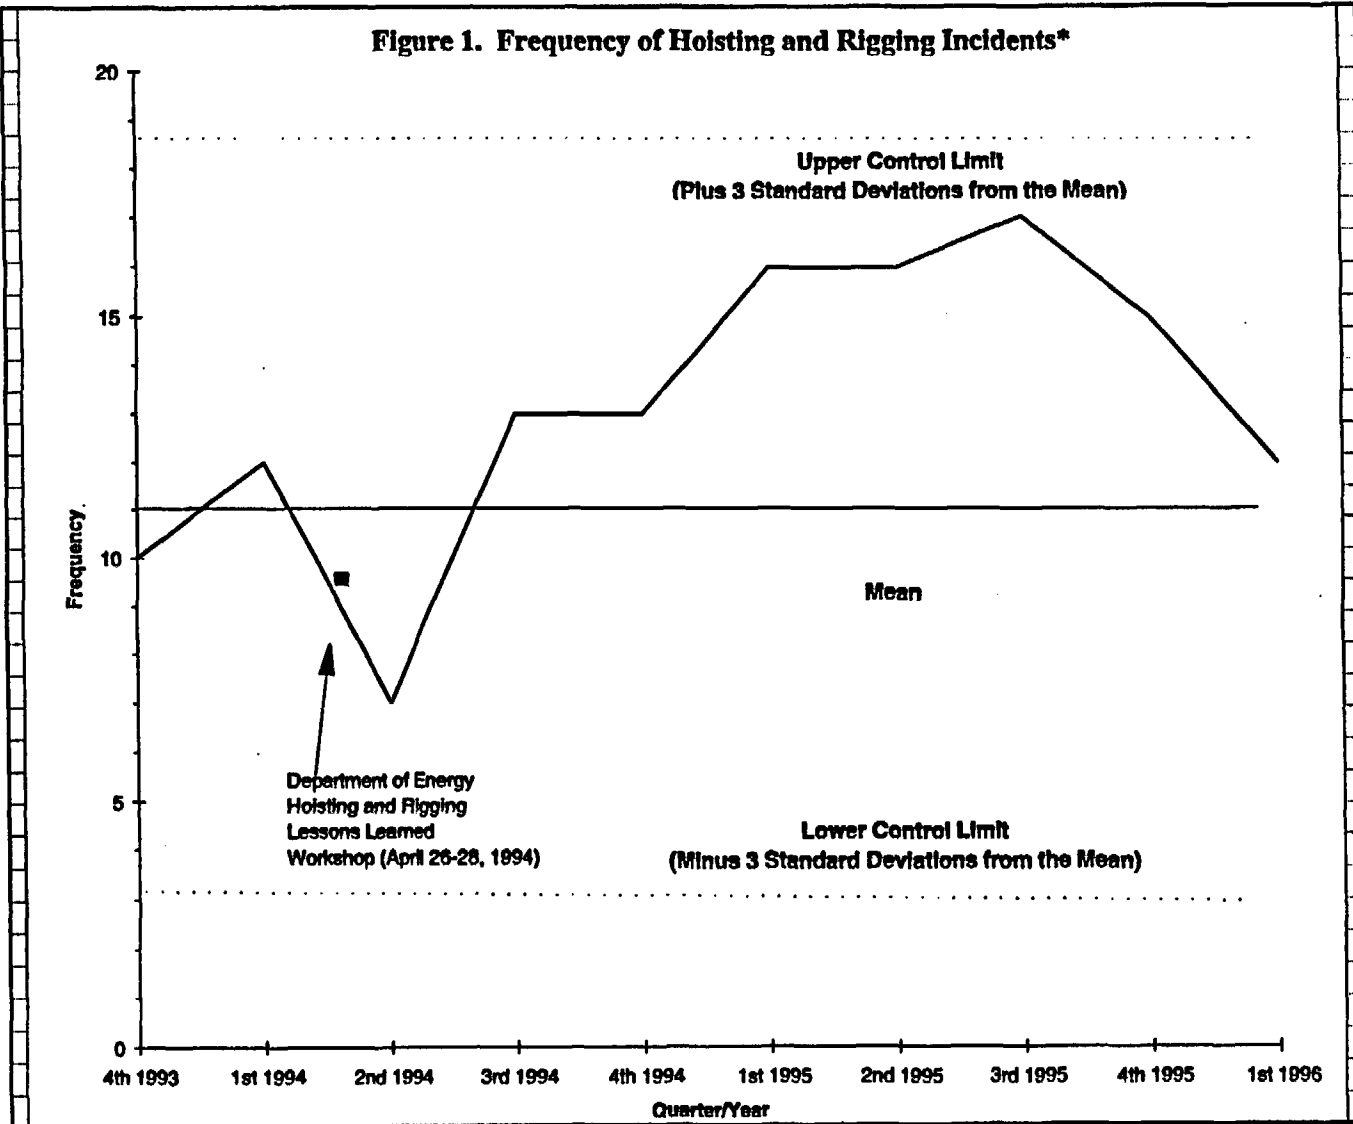
Figure 1. Frequency of Hoisting and Rigging Incidents*

The trend since 1993 is depicted in Figure 1. While random variations in safety performance are expected, there may be other factors that influence the time interval between incidents, including work stoppages and additional caution for a period following an event; these are discussed in Appendix A. Despite fatalities, suspended operations, and the workshop, there has been no statistically significant change in the frequency of reported H&R occurrences or in the H&R process within the Department.

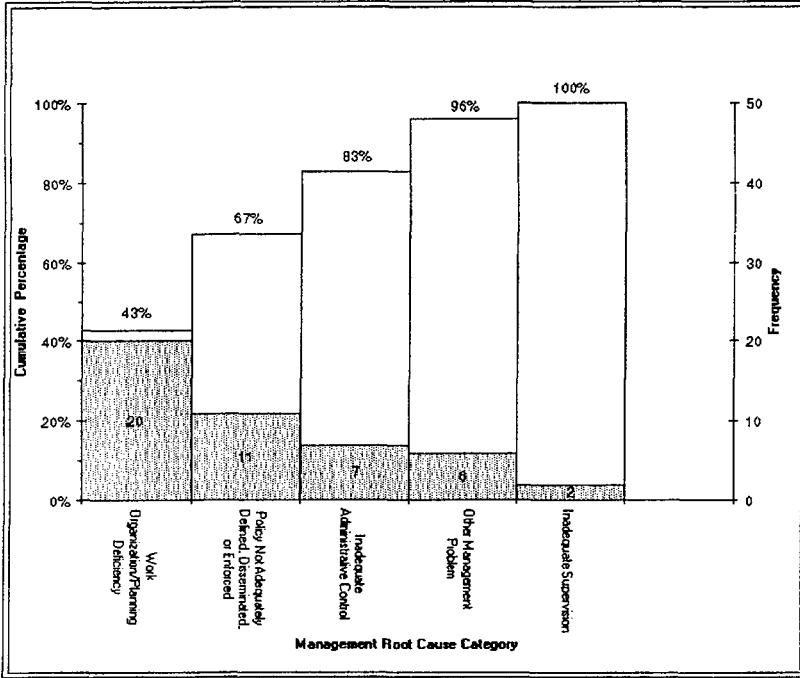
Figure 3. Management Root Cause Categories

Further analysis shows that deficient work planning (43 percent) and inadequate definition, dissemination, and enforcement of policy (24 percent) are responsible for two thirds of the incidents attributable to management deficiencies. Inattention to detail (56 percent) and not following procedures (28 percent) account for 84 percent of H&R incidents caused by personnel error. (See Figures 3 and 4, respectively.) Furthermore, inattention to detail is the most prevalent cause of all 131 H&R incidents, accounting for about one in every five incidents. Additionally, there are no indications that certain root causes are becoming less frequent over time, are being remedied, or are being replaced with other causal factors.
