Safety Evaluation Report

with Open Items Related to the License Renewal of
the Millstone Power Station, Units 2 and 3

Docket Nos. 50-336 and 50-423

Dominion Nuclear Connecticut, Inc.

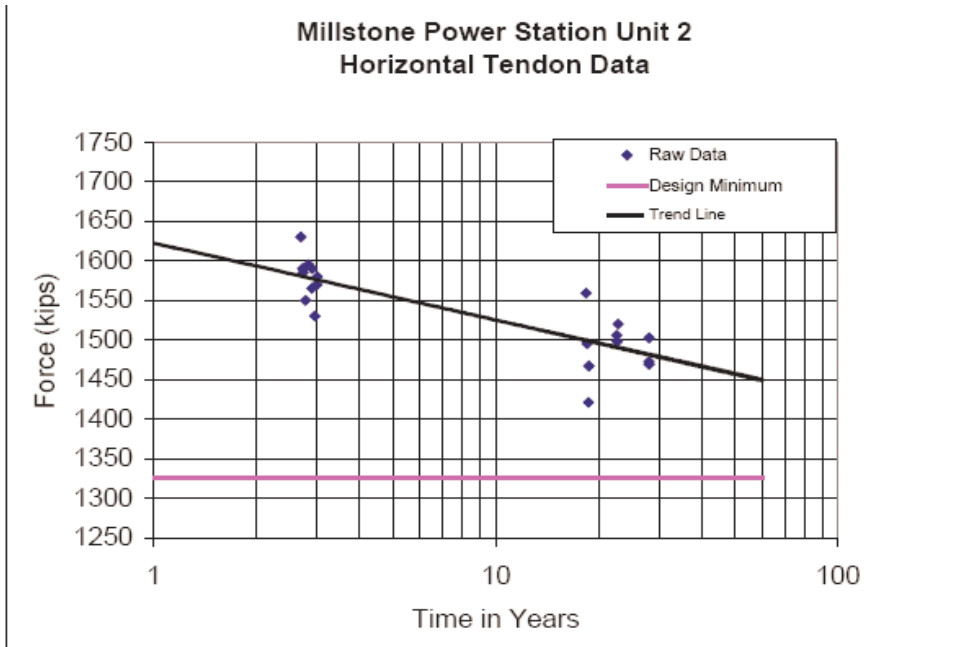
Figure A: Trend Line Relationship with Horizontal Tendons

In its January 11, 2005 response, the applicant removed the tables provided in the LRA, and substituted new tables showing measured prestressing forces during tendon inspections for each group of tendons. In response to the staff's follow-up question as to why 3-, 5-, and 10-year data are missing from the tables, the applicant stated that as these tendons went through repeated tensioning and detensioning, the data were not reliable. The measurements taken during the 1-, 15-, 20-, and 25-year inspections were used for developing the trend lines. In Figures 1, 2, and 3 of the revised response (dated January, 11 2005), the applicant provided the trend lines and the measured tendon force data. Figure A, showing the trend line related to horizontal tendons, is reproduced below:

In its response, in a letter dated January 11, 2005, the applicant confirmed that it is using procedures for monitoring and trending prestressing force consistent with the recommendations in RG 1.35.1 and NRC Information Notice 99-10. Therefore, the staff finds the process acceptable, as the use of RG 1.35.1 for estimating the target prestressing forces, and Information Notice 99-10 for projecting the actual measured prestressing forces (as illustrated in the figure above), provides the elements needed for an adequate TLAA.
