Seismic Walkdown Checklist (SWC)

Equipment ID No DC-2-67-E-BTC-BTC21

Equipment Description: 125V DC Battery Chargers

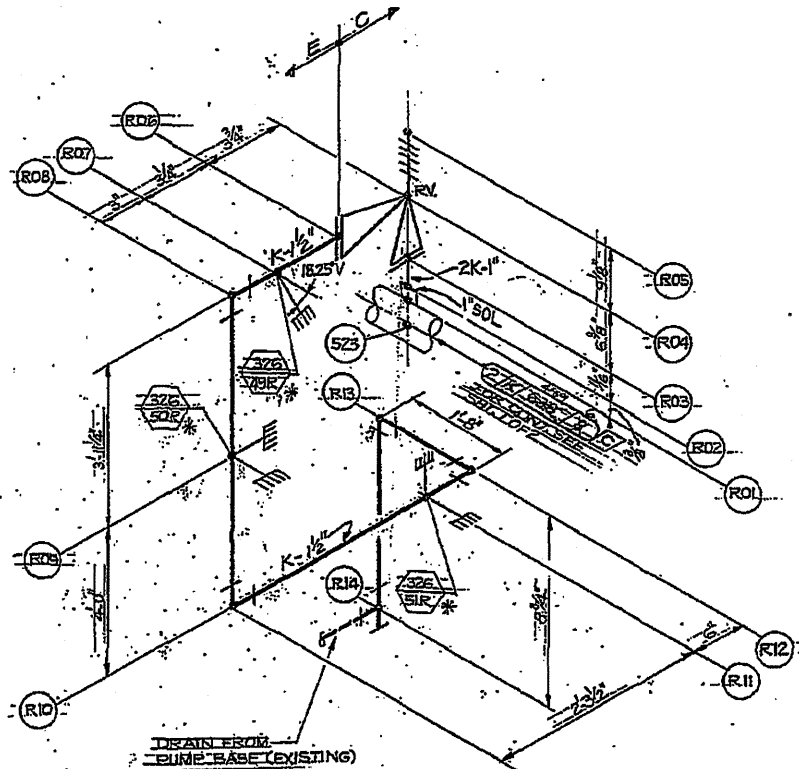
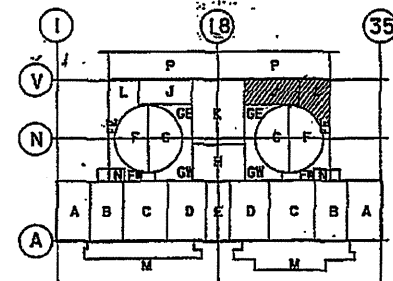
LEGEND:

- NODAL POINT
- ⊥ RESTRAINT
- |—|—| SNUBBER
- SPRING HANGER
- ▲ ANCHOR
- ≡ GUIDE

NOTE: * THESE SUPPORTS SHOULD BE DESIGNED FOR 250# ADDITIONAL LOAD IN EACH DIRECTION IN THE EMERGENCY CONDITION.

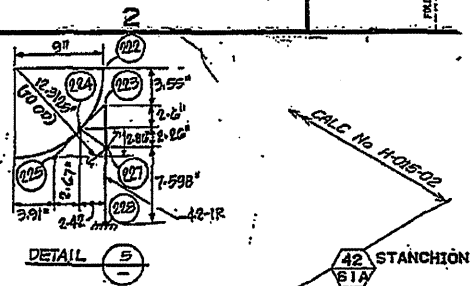
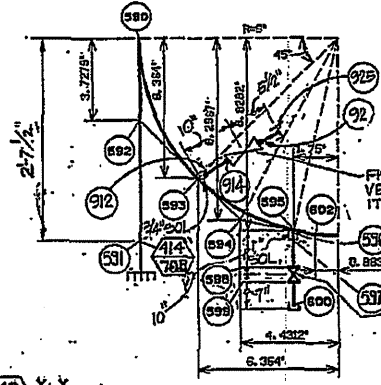
APPX. 1
SH. 2 of 4

AWC 2-AFWP2

LEGEND:

- NODAL POINT
- ⊥ RESTRAINT
- ⊥ SNUBBER
- ⊙ SPRING HANGER
- ▲ ANCHOR
- ≡ GUIDE

- REF. DWGS:
1. P&ID 108003 SH4/1
 2. PG&E ISO. 449298/2
 3. WALKDOWN 07/02/82

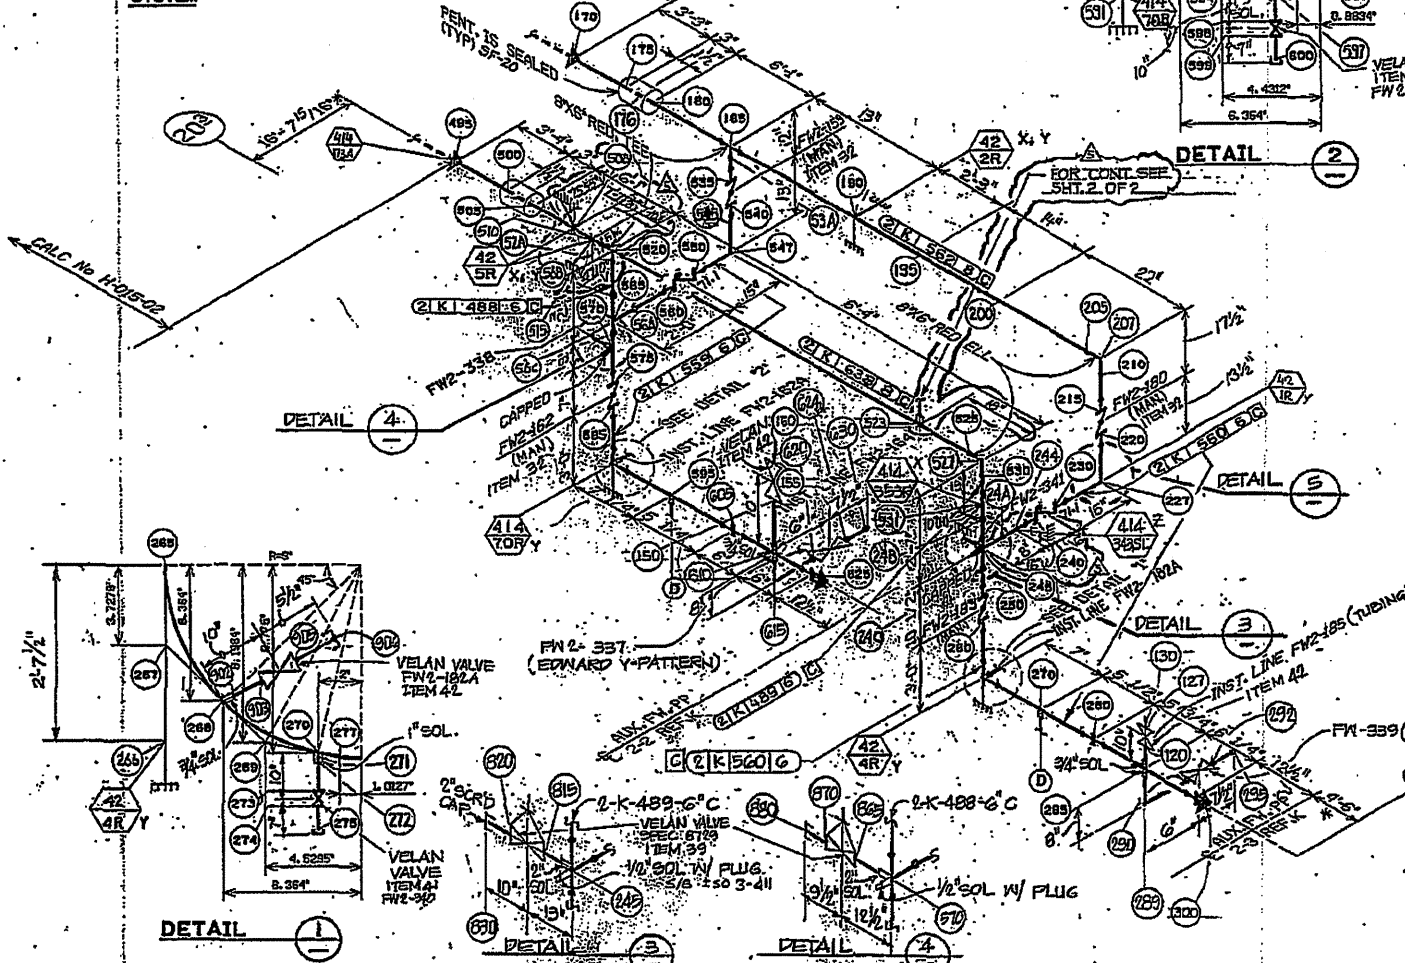
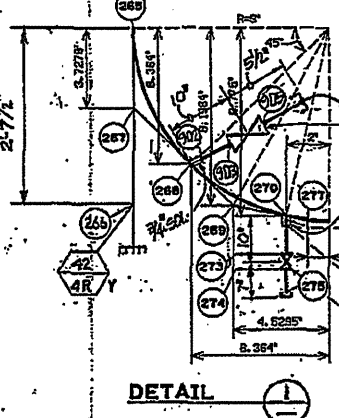
DETAIL 4

DETAIL 3

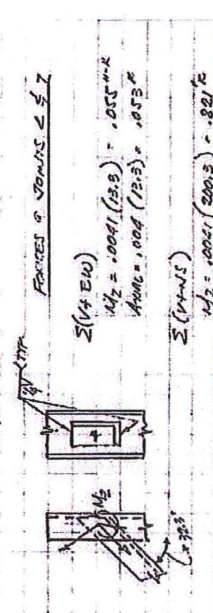
59253-2, 3, 4, 30, 32A, 32B
 1804
 12/16/12
 VRL
 FORCES IN VTS @ 1

$\Sigma (V_{FEW})$
 $1/2 = .0041 (12.5) = .055 \text{ k}$
 $Area = .004 (12.5) = .053 \text{ k}$
 $\Sigma (V_{TMS})$
 $1/2 = .0041 (200.3) = .821 \text{ k}$
 $Area = .004 (200.3) = .801 \text{ k}$

CHECK REACTION FORCES AND GIVEN IN LOCAL COORDINATES
 AND WE WANT TO CHECK WELD ON GLOBAL YZ PLANE,
 DIVIDE FORCES BY 202.577*
 $1/2 = .821 / 202.577 = 1.536 \text{ k-k}$ CHECK
 $Area = .801 / 202.577 = 1.489 \text{ k}$ (TENSILE)
