Area Walk-By Checklist (AWC)

Location (Bldg, Elev, Room/Area): Area Walk-by 3-20

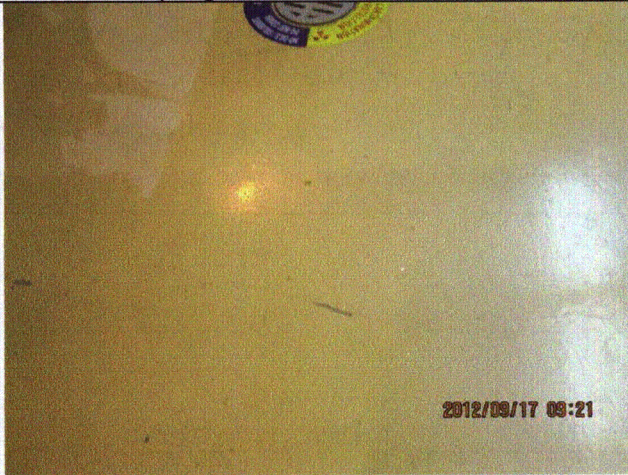
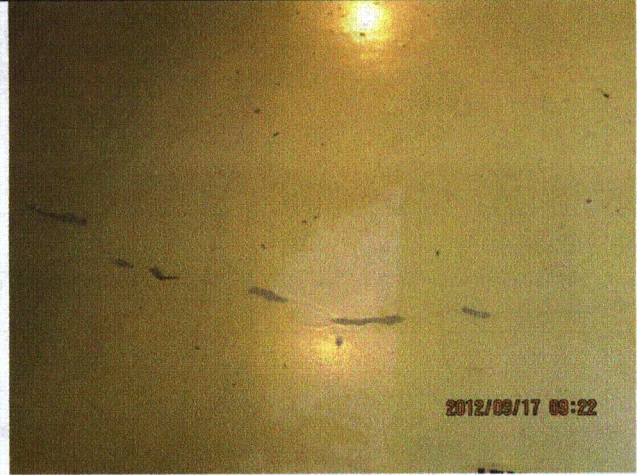
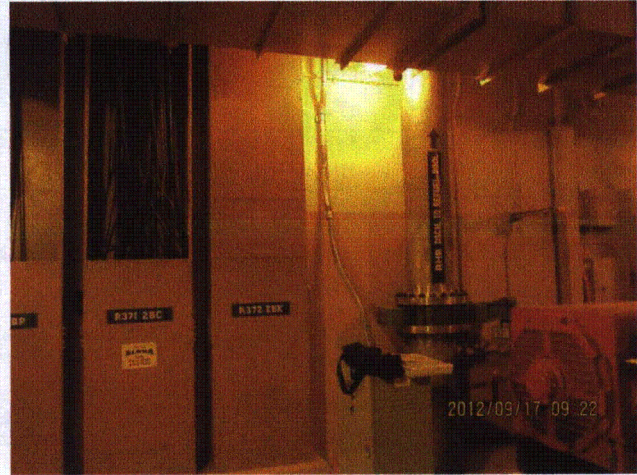
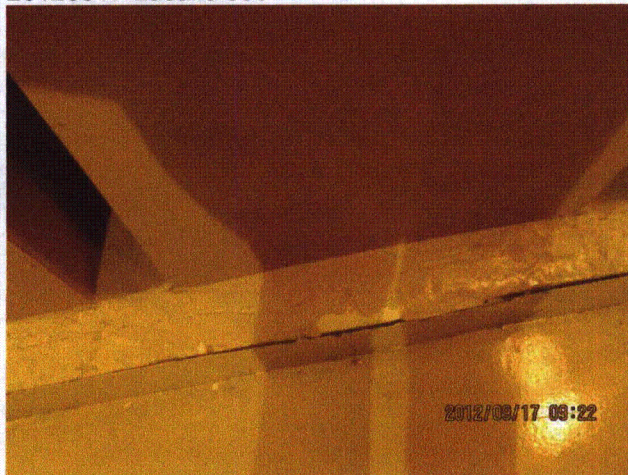
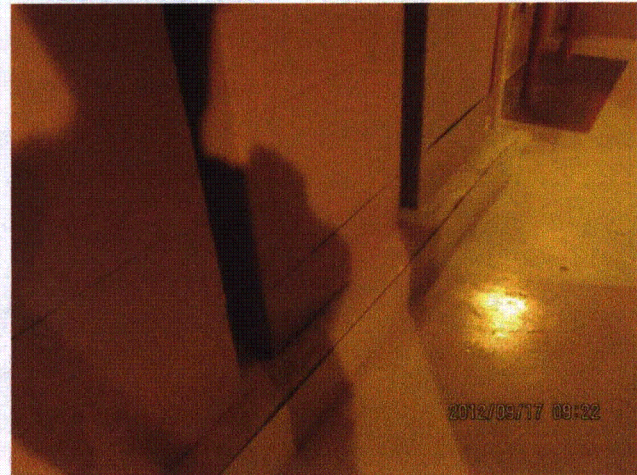
Location (Bldg, Elev, Room/Area): Area Walk-by 4-02

2. Does anchorage of equipment in the area appear to be free of significant degraded conditions? Yes
Minor cracks at interface between drywell wall and floor judged to be acceptable.

Minor cracks in drywell wall judged to be acceptable.

Crack in drywell post-tensioning tendon buttress at 4th tendon from floor. Per discussion with Engineering, crack is small (0.009 inches) and at a cold-form joint; therefore, it is not of structural concern.

3. Based on a visual inspection from the floor, do the cable/conduit raceways and HVAC ducting appear to be free of potentially adverse seismic conditions (e.g., condition of supports is adequate and fill conditions of cable trays appear to be inside acceptable limits)? Yes
Minor shrinkage cracks in grout pad at panel 2PL78J judged to be acceptable.

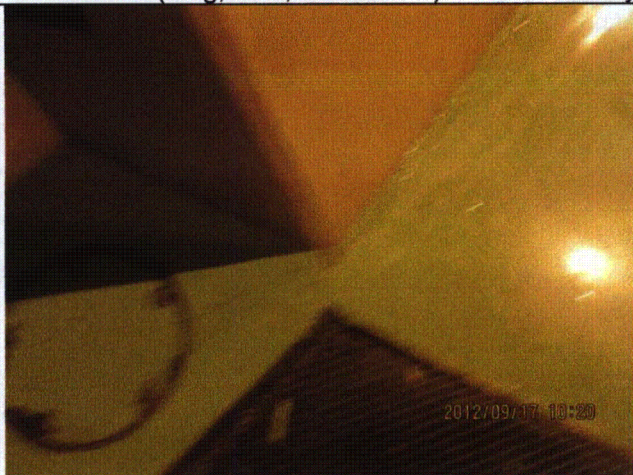
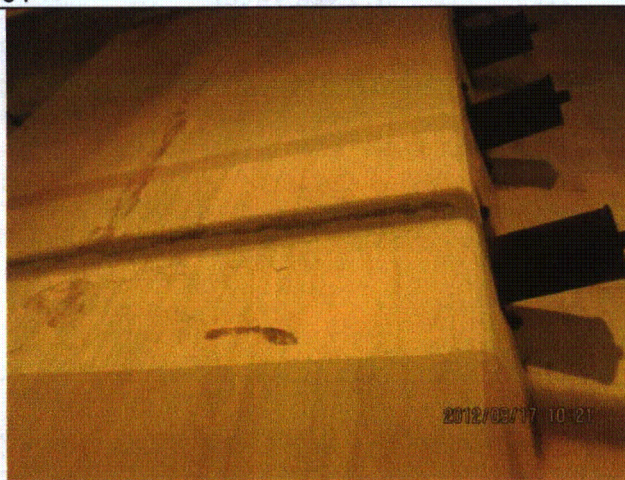
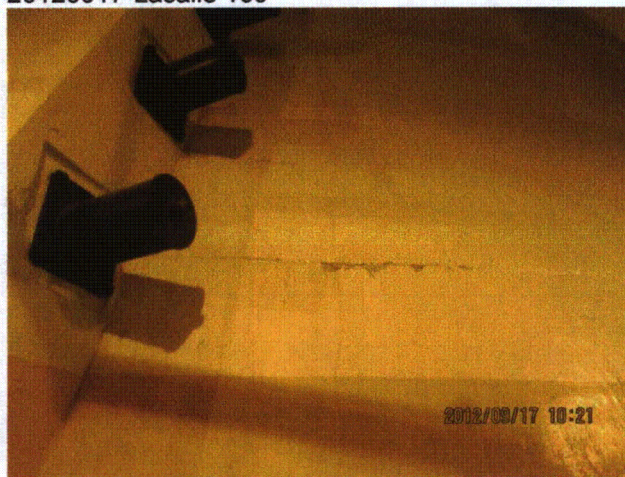
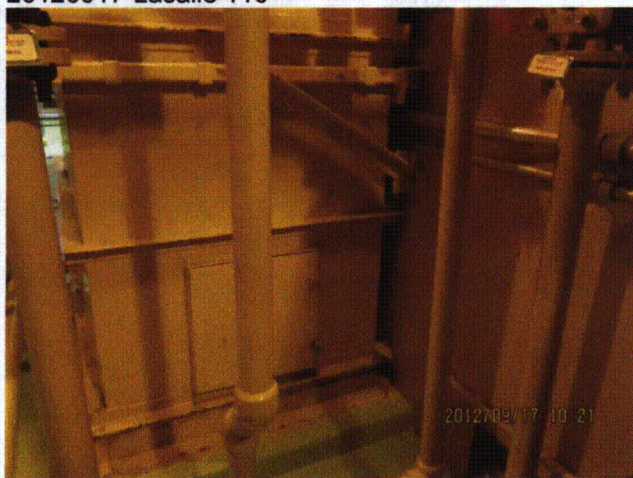
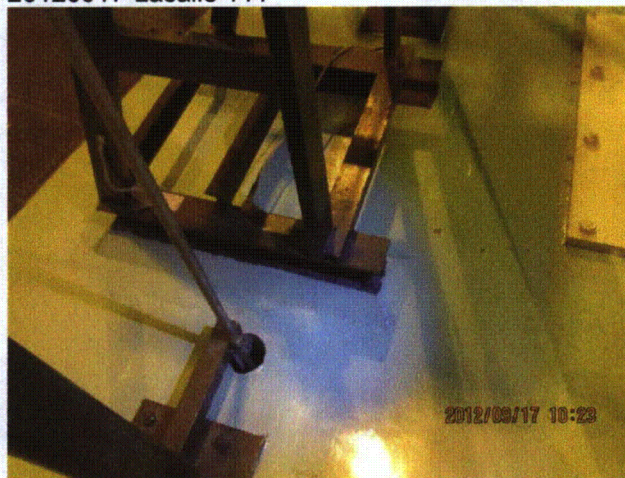
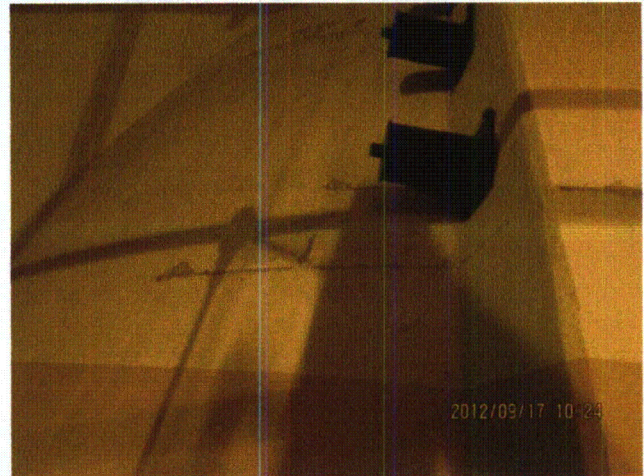
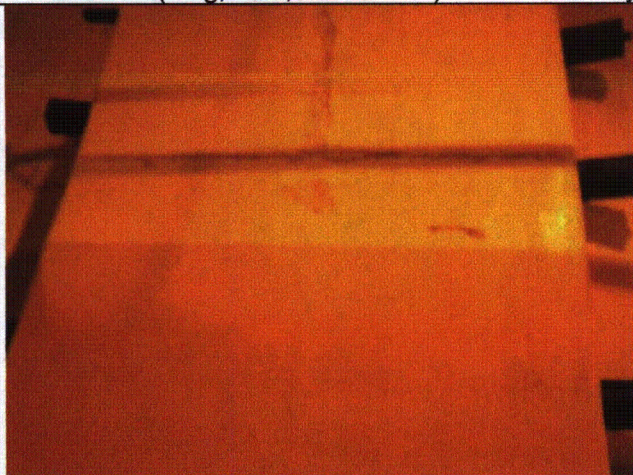
Location (Bldg, Elev, Room/Area): Area Walk-by 4-04

3. Based on a visual inspection from the floor, do the cable/conduit raceways and HVAC ducting appear to be free of potentially adverse seismic conditions (e.g., condition of supports is adequate and fill conditions of cable trays appear to be inside acceptable limits)? Yes
Cable raceway in contact with large, robust pipe. Pipe is rigid, function of raceway will not be lost during a seismic event. Judged to be acceptable.

8. Have you looked for and found no other seismic conditions that could adversely affect the safety functions of the equipment in the area? Yes
Top of back door on panel 2B33-F001A is sprung. Door is properly latched and judged to be acceptable.

Loose bolts on top of 2B33-S001A MG set are not a seismic concern.

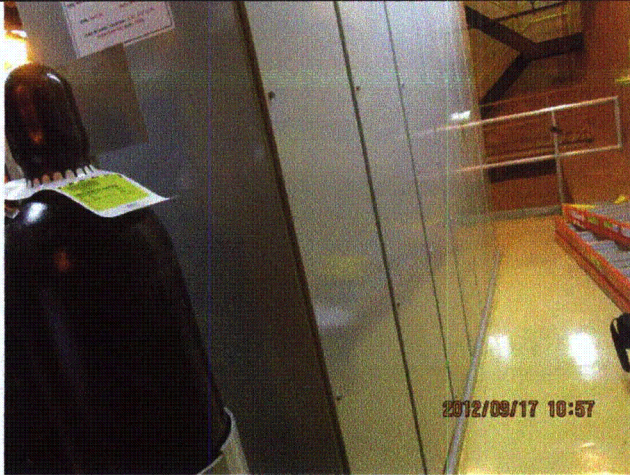
20120917-Lasalle 139

Location (Bldg, Elev, Room/Area): Area Walk-by 4-06

5. Does it appear that the area is free of potentially adverse seismic interactions that could cause flooding or spray in the area? Yes
All piping is welded and judged to be acceptable.
