# Screen Penetration Test Report

**NRC Job Code Y6041**

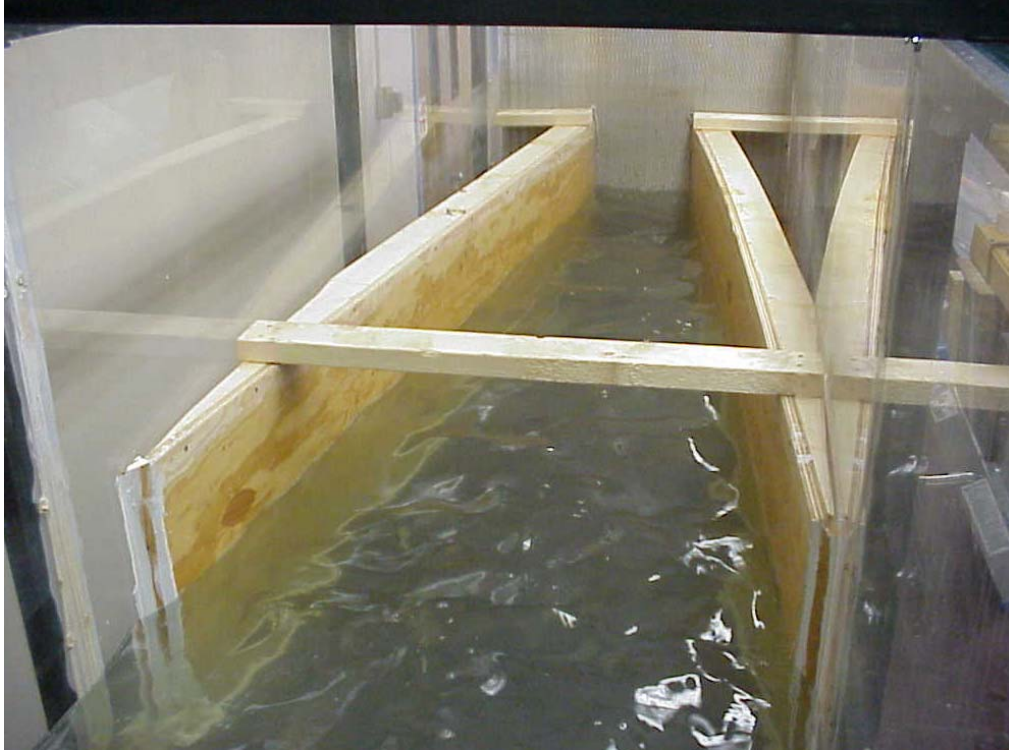
To obtain maximum flow velocities at the sump screen, the flow cross section is reduced to force the flow to accelerate by converging the sidewalls. The channel width is decreased linearly from 0.91 m (3 ft) to 0.3 m (1 ft) at the downstream screen over a length of 2.4 m (8 ft). The plywood walls used for flow convergence are shown in Figure 2-3. Downstream from this device, 1.2-m (4-ft)-high Plexiglas® walls confine the flow of water to the central 0.305-m (1-ft) width of the flume (Figure 2-4). Each Plexiglas® wall is held in place by a 5-cm × 10-cm (2-in. × 4-in.) piece of wood at the bottom and by unistrut metal supports at the top. Wooden supports [2.5 cm × 2.5 cm (1 in. × 1 in.)] are placed between the outer walls of the flume and these inner Plexiglas® walls to prevent movement of the walls during the test caused by water pressure and handling of the test equipment. The bottom and side edges of the Plexiglas® are caulked adequately to prevent water leakage during the tests.

Figure 2-3. Converging flow.

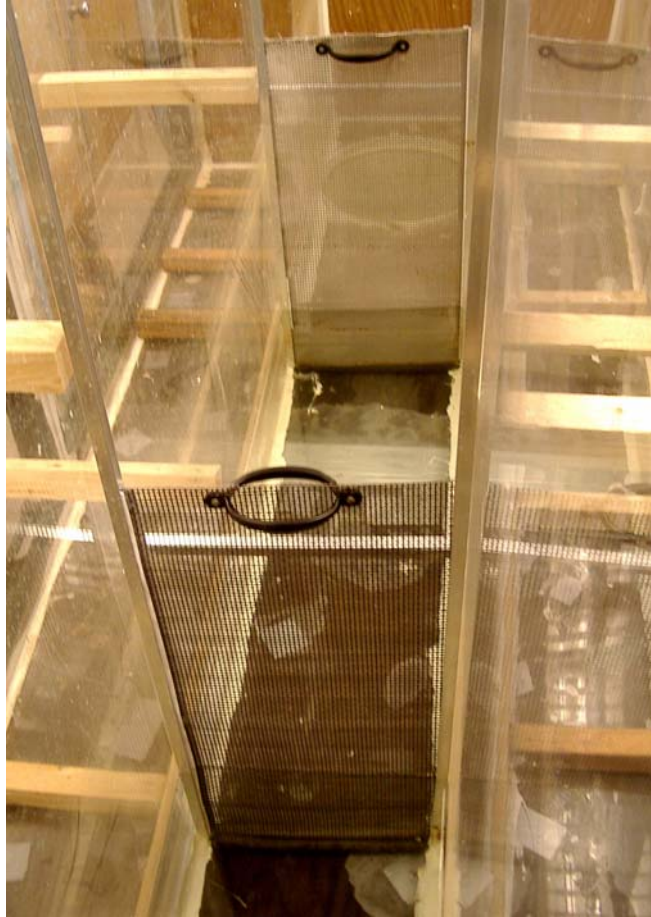
Figure 2-5a shows both the test screen and the fine screen located downstream of the test screen, which are used to retain the debris. A close-up of the 0.25-in. test screen is shown in Figure 2-5b. Note that the actual openings on the screen were approximately square in shape and not triangular, as may be incorrectly inferred from this photograph because of the three-dimensional (3D) weave of the wires and the angle at which this photo was taken. Figure 2-5b also shows the horizontal tray on the floor of the flume, which was used to remove and subsequently weigh the debris retained on the floor. A tray was placed on the floor of the test section immediately before each of the two screens. Each tray is 0.305 m (12 in.) wide and 0.41 m (16 in.) long, with a 1.3-cm (~1/2-in.)-high metal edge. Each tray consists of a fine (#200-sieve) screen attached adhesively to a stiffer screen. The size of the openings in the #200 screen is 0.075 mm, with approximately 200 openings per inch (79 openings per centimeter). These screens were removed vertically using attached nylon strings to collect the debris on the floor.

Figure 2-5a. Test screen and fine screen in the test section.

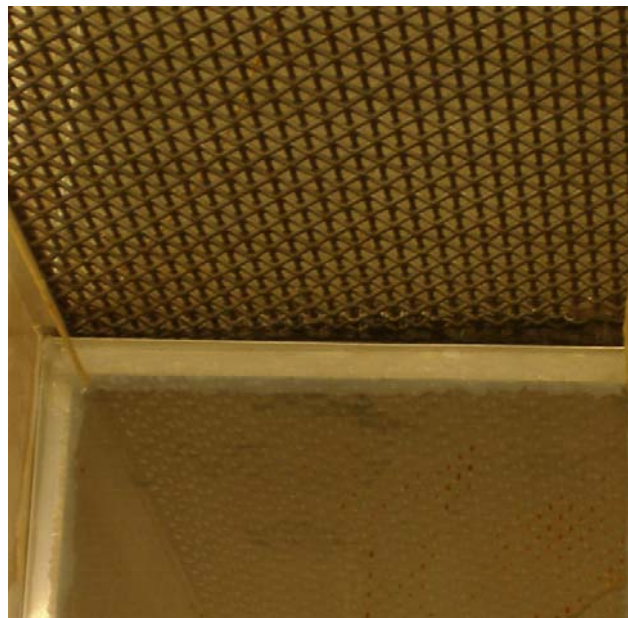
Figure 2-5b. Close-up of the 0.64-cm (0.25-in.)-opening screen and tray on the floor.

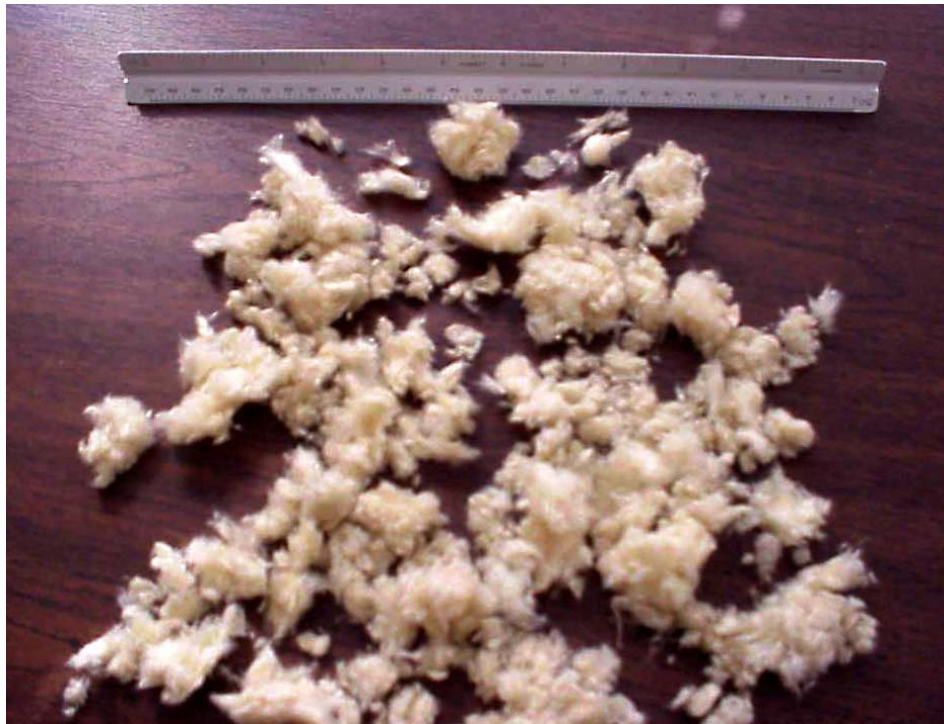
The preparation procedure for the NUKON™ and CalSil debris test specimens was identical to previous studies [1, 8]. NUKON™ insulation debris was generated by using a leaf shredder to shred blanket insulation, followed by heating it to  $>90^{\circ}\text{C}$  to remove the coating on the surface of the glass fibers, which more accurately simulated post-LOCA fiber conditions. The NUKON™ then was stirred for 5 min using a kitchen blender to separate the fibers and prevent clumping. Figure 3-1 shows the NUKON™ after processing by a leaf shredder (LS NUKON™).

Figure 3-1. LS NUKON™.

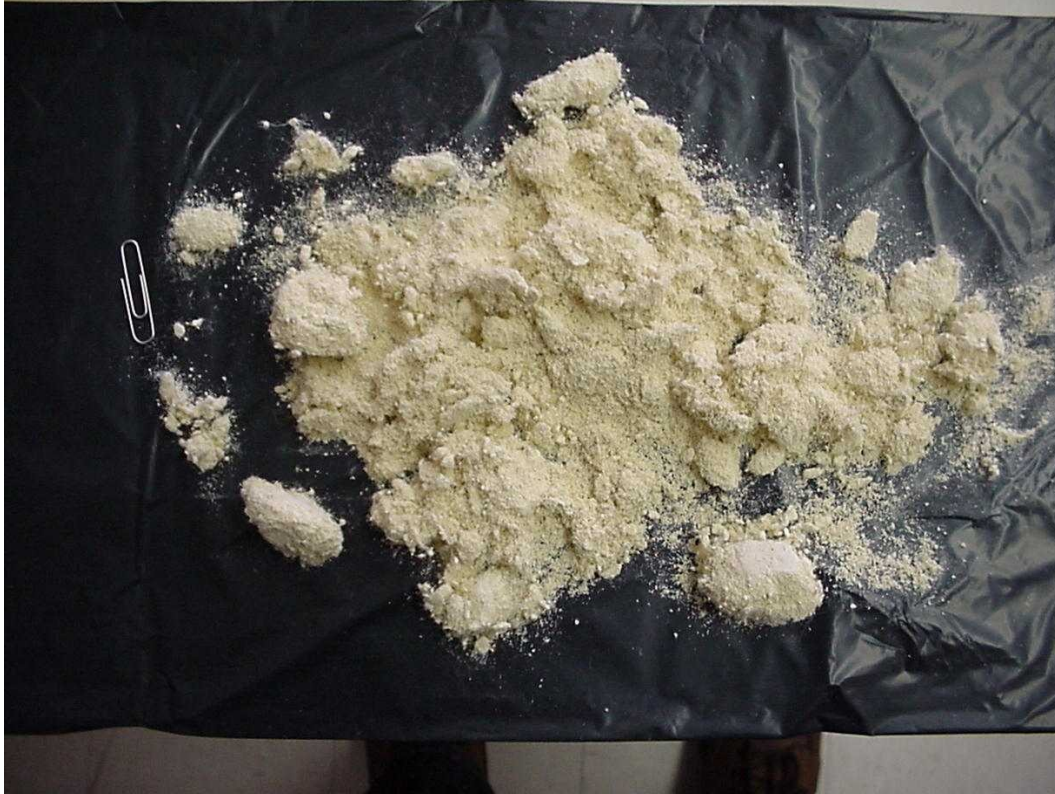
Figure 3-3. Prototypical crushed CalSil debris.

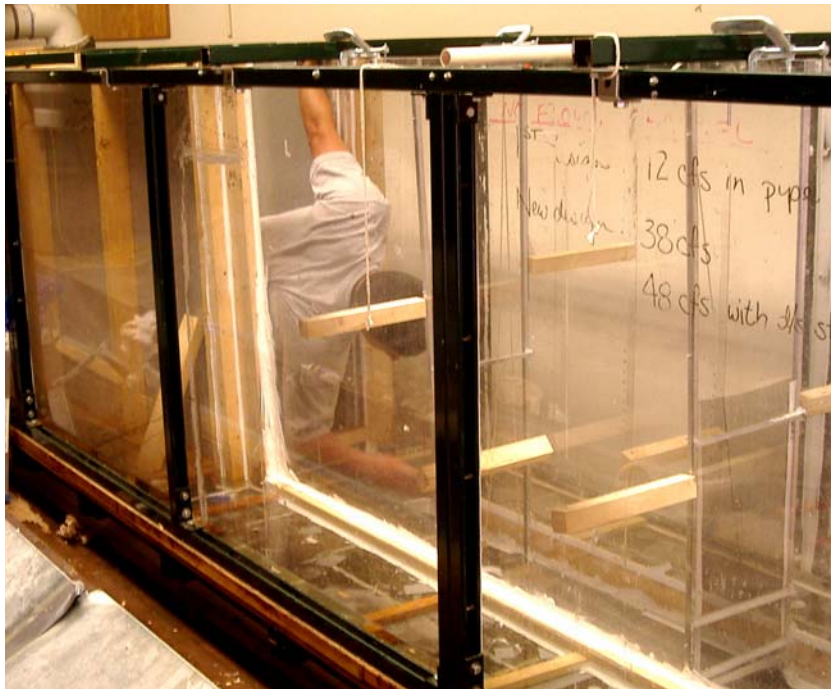
Figure 4-2. Removal of RMI by hand inside the flume.

The fraction of debris that does not pass through the screens is determined by weighing the amount of debris caught on the test screen and before the test screen on the flat tray. The amount that passes through the screen is measured by carefully removing the material on the fine (#100-sieve) screen downstream and the material between the two screens. To weigh the amount of NUKON<sup>™</sup>, the fibers must be separated from the water through a slow filtration process (Figure 4-1) before being dried in the oven. Small pieces of RMI that did not move to the trays must be removed by hand (Figure 4-2).

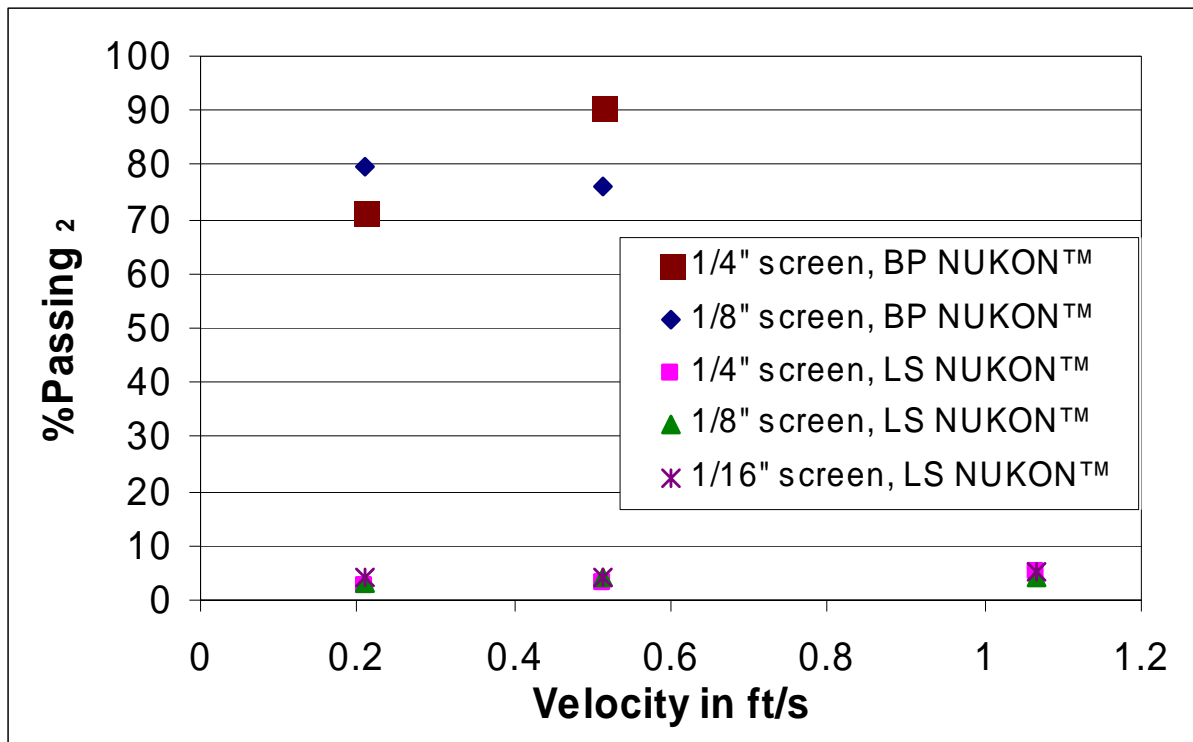
The results for the NUKON™ debris tests are plotted in Figure 5-1, comparing the maximum penetration (%passing<sub>2</sub>) for BP NUKON™ and LS NUKON™. The plot in Figure 5-1 illustrates that the lack of blending for the LS NUKON™ had a major impact on the fraction of NUKON™ insulation that passed through any of the screens. Only a very small fraction of the LS NUKON™ went through the screens. The results for NUKON™ indicate that the particle-size distribution of the debris is a larger determining factor of screen penetration than either the screen size or flow velocity for the conditions tested.

Figure 5-1. NUKON™—%Passing<sub>2</sub> (1 ft/s = 0.305 m/s).

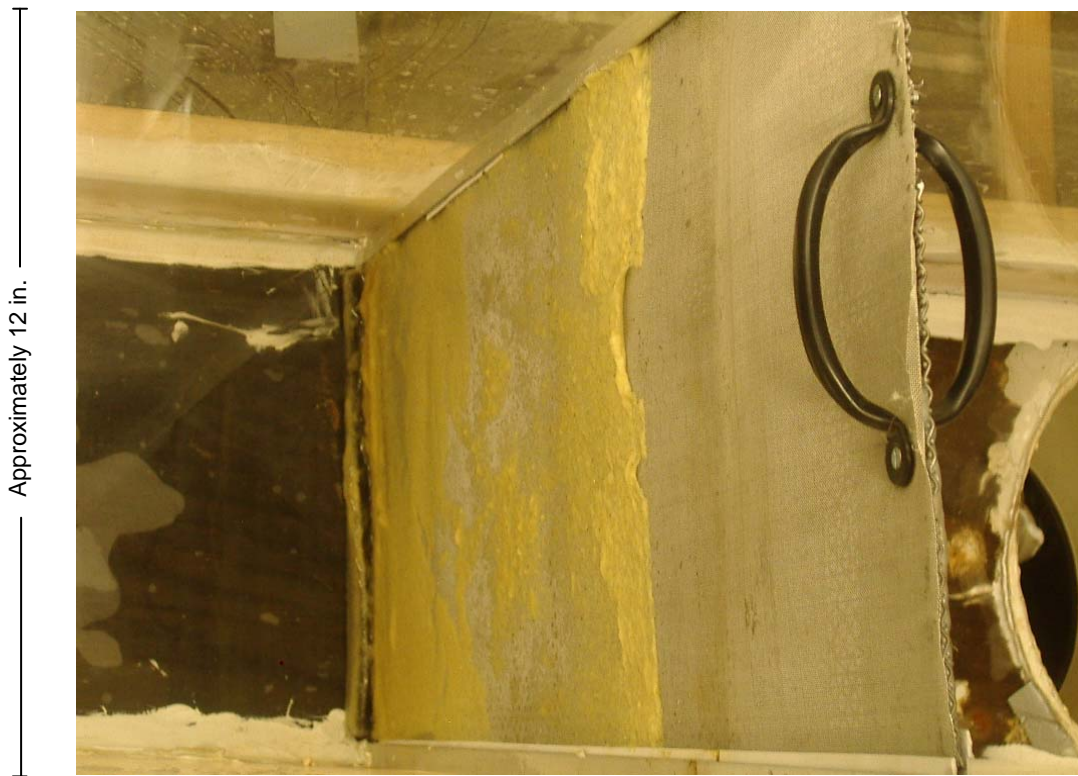
Figures 5-2 through 5-4 present photographs of the NUKON™ debris tests. The height indicated in Figures 5-2 and 5-3 represents ~30.48 cm (12 in.) in width, which is equal to the width of the test section. Figure 5-2 shows a small amount of BP NUKON™ remaining on the floor in front of the test screen following the test. Figure 5-3 shows a comparatively larger fraction of the finer-sized BP NUKON™ trapped on the fine screen downstream after passing through the test screen. In Figure 5-4 it can be seen that the individual pieces of LS NUKON™ simply aggregated at the test screen and did not pass through. No difference was noted in the transport of the NUKON debris on the floor between the Plexiglas® section and the test section with the screen on the floor. Any NUKON™ debris that transported went all the way to the test screen.

Figure 5-3. Finer-sized BP NUKON™ collected on the fine screen located downstream.

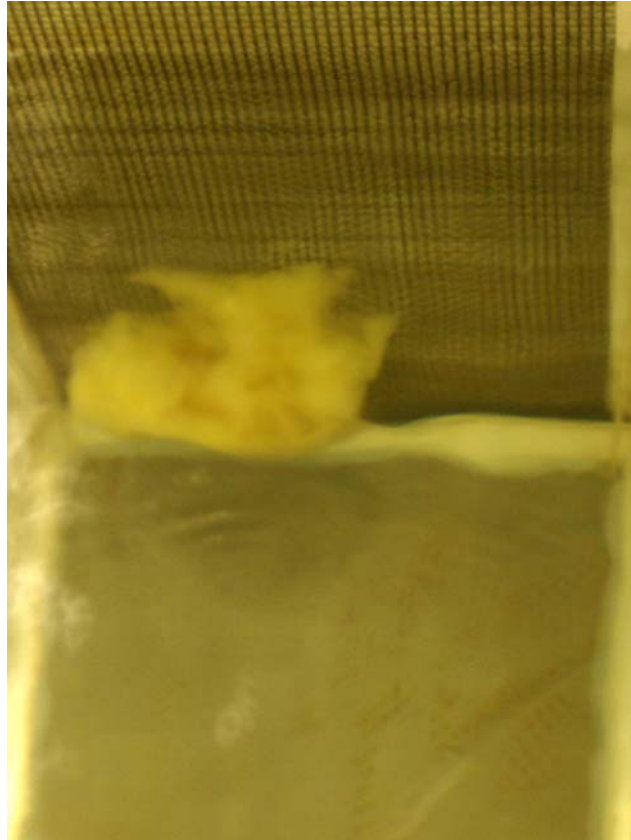
Figure 5-4. LS NUKON™ forms clusters at the test screen.

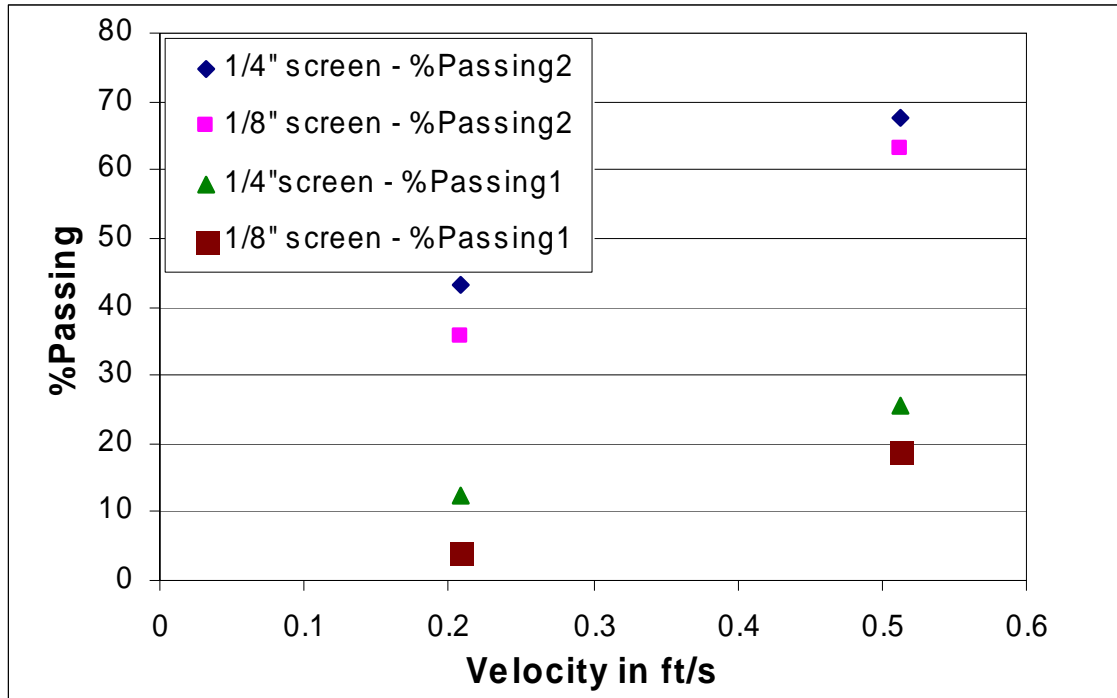
The results for the CalSil debris tests are plotted in Figure 5-5, comparing the minimum and maximum passing percentages. This comparison is made for CalSil because, of all the debris types, the discrepancy between these two measurements is greatest for CalSil. This difference stems from the inability to recover a significant portion of CalSil following the test. Most of the unrecovered CalSil remains suspended in the water and continues to circulate in the loop. A larger fraction of CalSil goes through the test screen than any other debris type. Also, the results show that with a larger screen opening and increasing flow velocity, more of the CalSil passes through, with flow velocity being more important than screen size under the range of conditions tested. The effect of flow velocity largely is due to the increased ability of the flow to break up larger CalSil clumps. The larger clumps of CalSil remain on the floor (Figure 5-6) and do not transport to or are captured by the test screen. Finer clumps and particles disperse in the water (making it murky) and partially collect on the fine screen downstream or on the tray on the floor (Figure 5-7). Some of the larger clumps of CalSil also were caught on the screen of the flat tray immediately before the test screen. Thus, the tray screen's roughness could have affected the CalSil test results.

Figure 5-5. CalSil—%Passing (1 ft/s = 0.305 m/s).

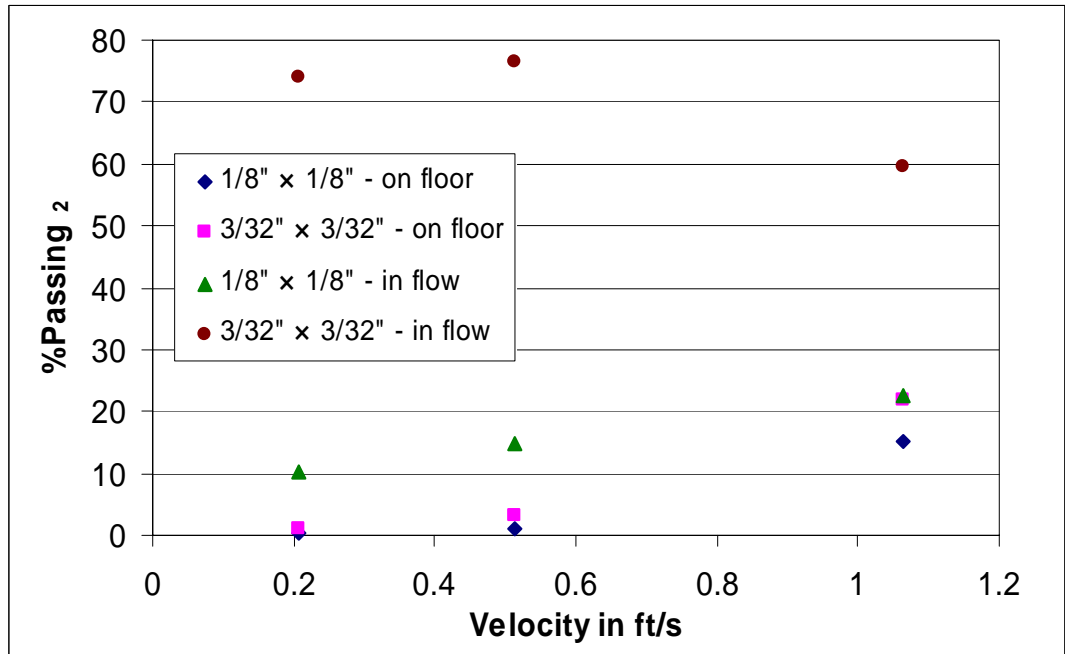
The results for the RMI debris tests are plotted according to screen size in Figures 5-8 and 5-9. For a given screen size, each plot compares the results for RMI based on the method of debris introduction and debris size. For cases where the RMI debris was introduced on the Plexiglas<sup>®</sup> floor, most of the RMI remained stationary and never reached the screen. No difference was noted in the transport of the debris on the floor between the Plexiglas<sup>®</sup> section and the test section with the tray on the floor. Any RMI debris that began to move went all the way to the test screen. The RMI began to move at a velocity of only 6.096 cm/s (0.2 ft/s), rather than move en masse. Therefore, only a small fraction of the RMI insulation passed through the screen. The measured penetration of RMI through the screen increased with increasing flow velocity because more of the RMI got to the screen; however, the majority of the RMI remained on the floor, as shown in Figure 5-10. (Note: The reflections identified in this photograph are reflected fluorescent light due to surface ripples on the water.)

Figure 5-9. RMI—1/8-in. Screen—%Passing<sub>2</sub> (1 ft/s = 0.305 m/s).

Figure 5-11 shows some of the RMI trapped in the screen. Consistent with expectations, some RMI particles pass through the test screen when the screen-hole size and particle size are equivalent. The maximum dimension of a square-mesh screen is the diagonal, whereas the minimum dimension of a square (or nearly square) is its edge. Because the RMI pieces were not bent by water pressure, 100% of the RMI pieces would be blocked if the largest dimension of the screen (the diagonal) were smaller than the minimum dimension of the particle (any side). That is, the screen mesh spacing would have to be 70.7% ( $1/\sqrt{2}$ ) smaller than the particle minimum dimension to guarantee that no RMI would pass through the screen. For any screen mesh spacing relatively larger than this theoretical minimum, the penetration of particles becomes a distribution function based on relative particle dimension and particle orientation. This distribution function, if it were known, largely would describe the uncertainty among multiple, nominally replicate RMI tests. This uncertainty is much greater than the variations in screen mesh spacing and the measured RMI size distribution (Table 3-2). Conversely, as the minimum dimension of the particle approaches 70.7% of the minimum dimension of the screen, the penetration of RMI theoretically approaches 100% (slightly oversimplified). This theory is supported by the large penetration increase observed for RMI debris corresponding to 75% of the screen mesh spacing (Figures 5-8 and 5-9).
