Primer on Durability of Nuclear Power Plant Reinforced Concrete Structures - A Review of Pertinent Factors

Oak Ridge National Laboratory

**U.S. Nuclear Regulatory Commission
Office of Nuclear Regulatory Research
Washington, DC 20555-0001**

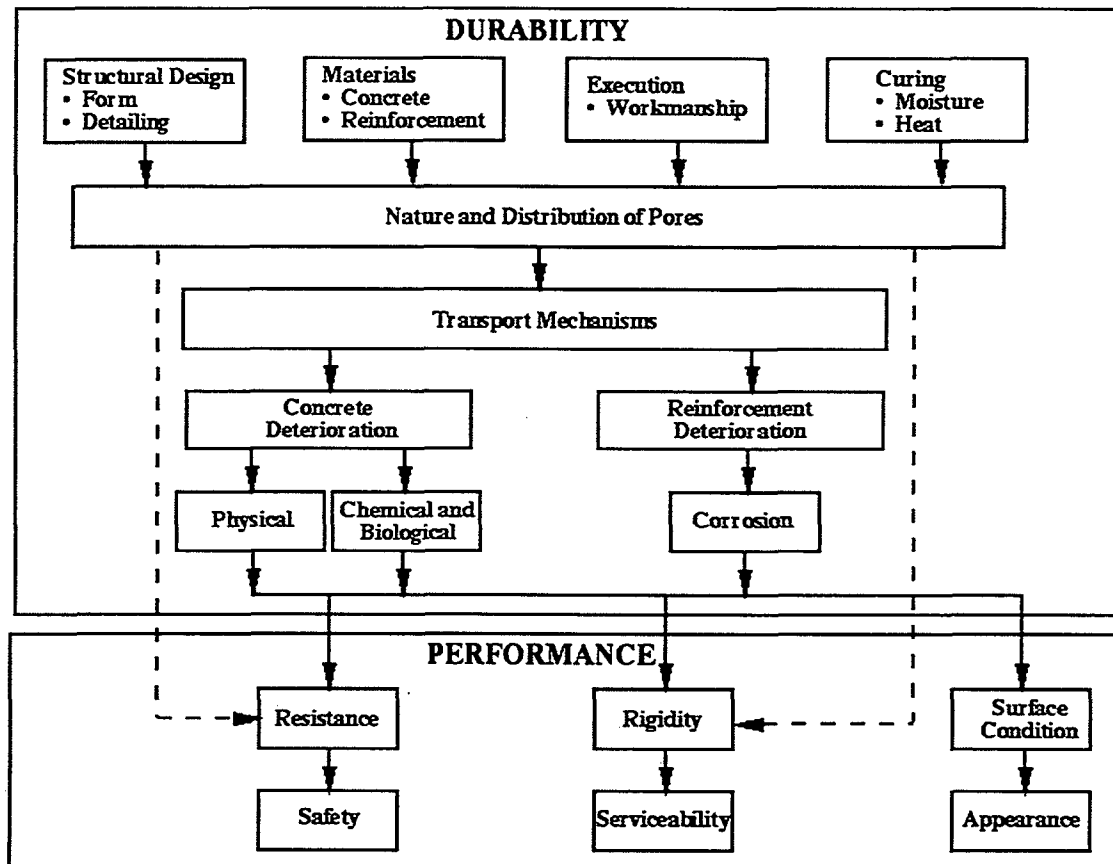
Figure 1.1 Relationship between the concepts of concrete durability and performance.

Water is the single most important factor controlling the degradation processes of concrete (i.e., the process of deterioration of concrete with time is generally dependent on the transport of a fluid through concrete), apart from mechanical deterioration. The relationship between the concepts of concrete durability and performance is illustrated in Fig. 1.1 that was obtained from Ref. 7. The rate, extent, and effect of fluid transport are largely dependent on the concrete pore structure (i.e., size and distribution), presence of cracks, and microclimate at the concrete surface. The primary mode of transport in uncracked concrete is through the cement paste pore structure (i.e., its permeability). The dominant mechanism controlling rates of water penetration into unsaturated or partially saturated concrete is absorption caused by capillary action of the concrete's pore structure. Absorption is referred to as the sorptivity of concrete, with sorptivity defined as the rate of movement of water through a porous medium under capillary action. To improve the durability of concrete, generally the capillary and pore size within the concrete matrix should be reduced to a minimum.

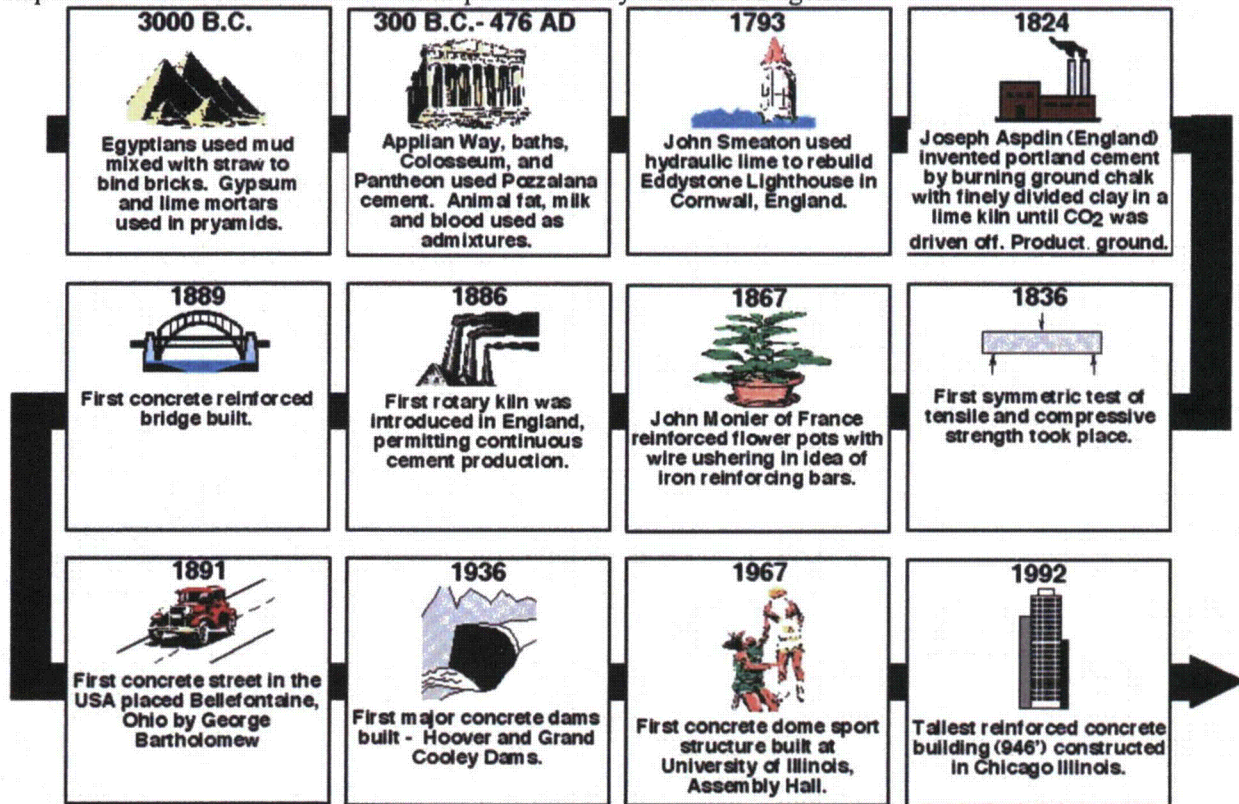
Figure 2.2 Concrete historical timeline.

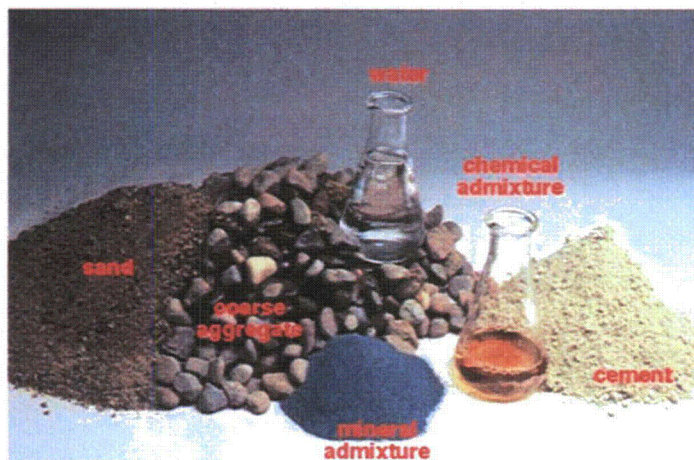
Figure 3.1 Basic concrete constituent materials

ultra-lightweight (e.g., vermiculite and perlite) to lightweight (e.g., expanded clay shale or slate-crushed brick) to normal weight (e.g., crushed limestone or river gravel) to heavy-weight (e.g., steel or iron shot). Sometimes chemical or mineral admixtures are added during the mixing process to enhance durability (air entrainment), improve workability (enhanced placement and compaction), modify hardening and setting characteristics, aid in curing, reduce heat evolution, or provide other property improvements.³⁰ Basic concrete constituent materials are identified in Figure 3.1.

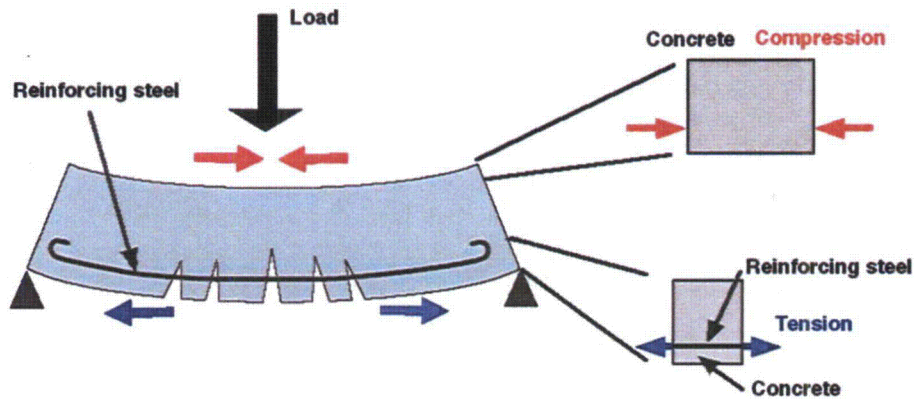
Figure 3.2 Principle of reinforced concrete.

Concrete tensile strength is about one-tenth to one-fifth its compressive strength so concrete can not be relied upon to withstand very high tensile stresses. This limitation is overcome by embedding steel reinforcement in the concrete. The concrete and steel thus work in concert, Fig. 3.2. In addition to resisting tensile loads, the bonded steel reinforcement is used to control the extent and width of cracks,

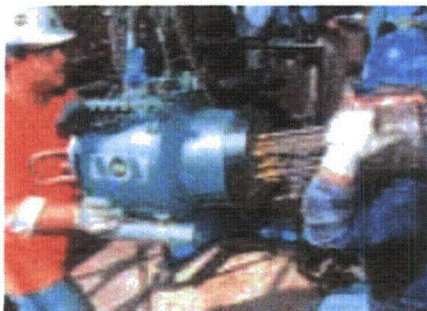
Figure 3.3 Example of a multistrand tendon.

The tendons are installed within preplaced ducts in the containment structure and post-tensioned from one or both ends after the concrete has achieved sufficient strength. After tensioning, the tendons are anchored by buttonheads, wedges, or nuts. Corrosion protection is provided by filling the ducts with wax or corrosion-inhibiting grease (unbonded), or portland cement grout (bonded). Supplemental conventional reinforcing is also used to minimize shrinkage or temperature effects and to provide local load-carrying capacity or load transfer. With the exception of Robinson 2 (bar tendons) and Three Mile Island 2 (strand tendons), plants that have post-tensioned containments utilize unbonded tendons so that the tendons can be inspected and replaced (if necessary). Bellefonte and Ginna each have grouted tendons (rock anchors) to which tendons are attached. Figure 3.3 presents an example of a multistrand tendon for a general civil engineering application.

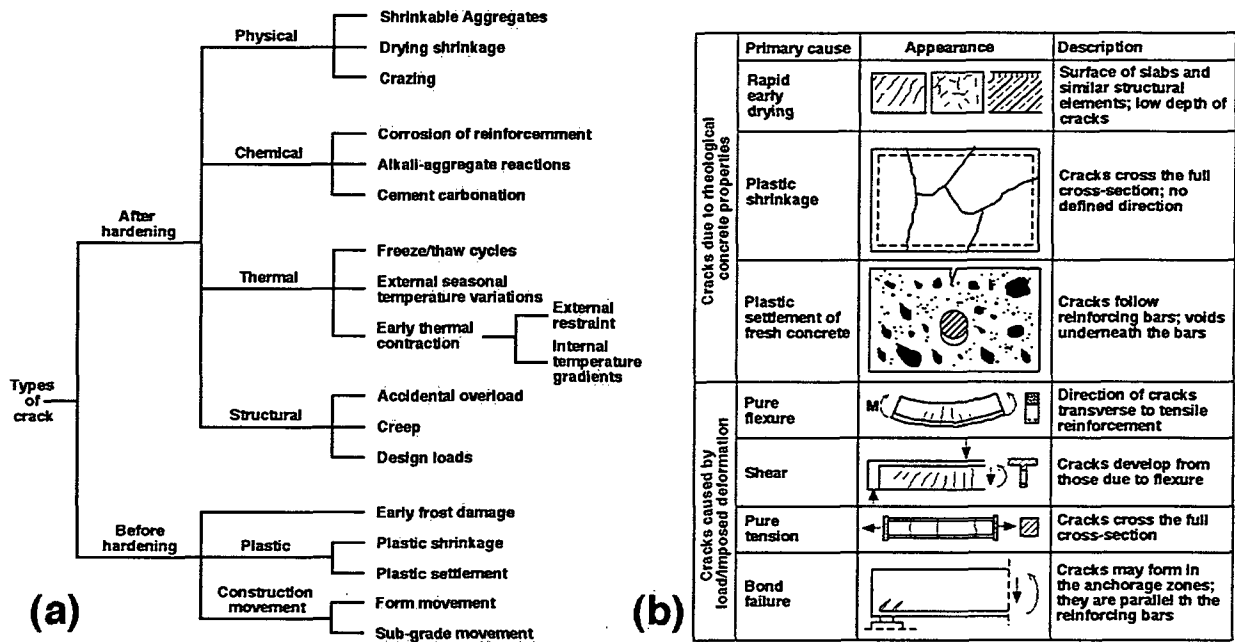
Figure 4.1 Relationship between primary causes and types of cracks in concrete.

capacity). Figure 4.1a provides information on the types of cracks that can form in concrete structures⁷ and Figure 4.1b provides a description and appearance of several of the crack forms.⁵⁷

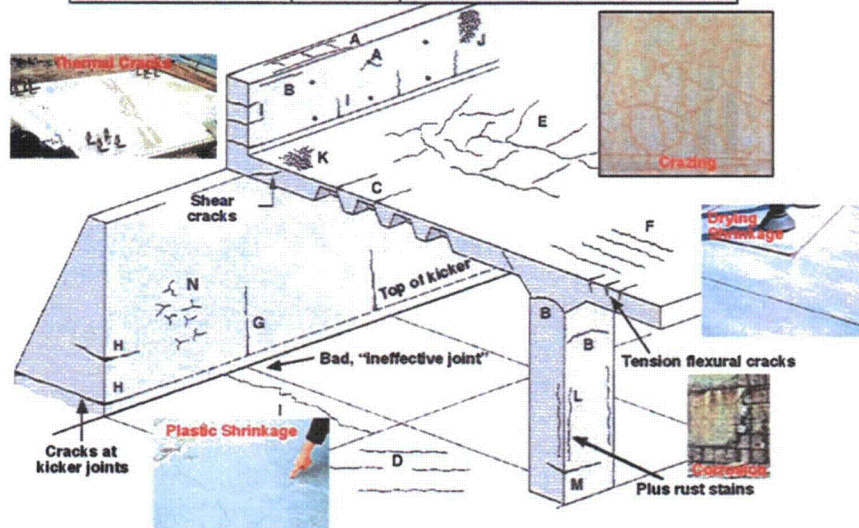
Type of Cracking	Designation	Time of Occurrence
Plastic settlement	A, B, C	Ten minutes to three hours
Plastic shrinkage	D, E, F	Thirty minutes to six hours
Early thermal contraction	G, H	One day to two to three weeks
Long-term drying shrinkage	I	Several weeks or months
Crazing	J, K	One to seven days - sometimes much later
Corrosion of reinforcement	L, M	Several years, but may be sooner
Alkali-aggregate reaction	N	More than five years

Figure 4.2 Examples of intrinsic cracks in a hypothetical structure.

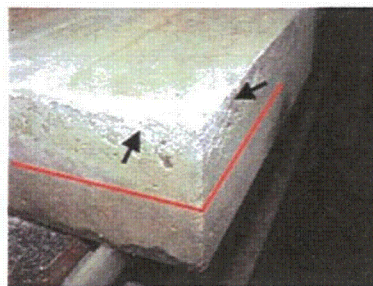
Figure 4.3 Concrete slab experiencing deterioration due to salt crystallization. (Arrows indicate concrete surface deterioration and lines the level of solution in wetting cycle.)

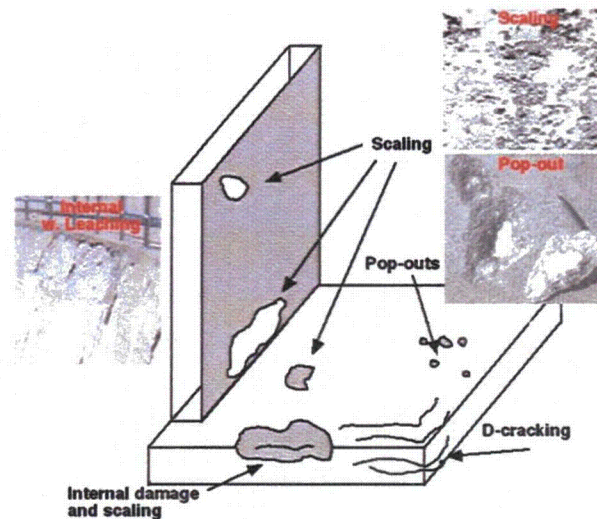
Figure 4.4 Types of freeze-thaw damage.

Damage to concrete resulting from freezing and thawing attack can take several forms:⁺ expansion, internal cracking, and spalling; scaling associated with application of salt; and pop-outs.^{61,62} Internal damage is confined primarily to the mortar and is associated with freeze-thaw damage of young concrete or mature cement paste that does not have a pore structure capable of resisting stresses that develop due to freeze-thaw occurrence. Scaling is delamination of the concrete surface. Weakness may exist at the surface due to an inherent weakness of the concrete due to excessive water, excess mortar, or treatment during construction. The surface layer may become detached if the stresses occurring exceed the tensile or bond strength holding the layer to the substrate. Scaling may develop from a shallow surface feature into internal damage. It often is associated with application of de-icing chemicals that cause the temperature of the concrete surface to change rapidly which induces a thermal shock that can cause cracking and surface scaling. Also, if salts are present in the pore solution the osmotic pressure is increased since moisture tends to move toward zones of higher salt concentrations. A pop-out is a small volume of concrete that has separated from the body of the concrete to leave a roughly conical depression. The most common cause of pop-outs is stress resulting from freeze-thaw action within the coarse aggregate particle that causes cracking of the particle and simultaneous fracture of the concrete between the particle and nearest concrete face. Aggregates that produce pop-outs are generally sedimentary (e.g., cherts, sandstones, shales, and limestones), but can be calcareous or siliceous or gravel or crushed rock, and have a high porosity.⁶³ Internal damage occurs in the form of cracking, is confined to mortar, and is associated with freeze-thaw damage to cement paste that does not have a pore structure capable of resisting the stresses that develop. Figure 4.4 presents a schematic of the types of freeze-thaw damage as well as examples.⁶¹

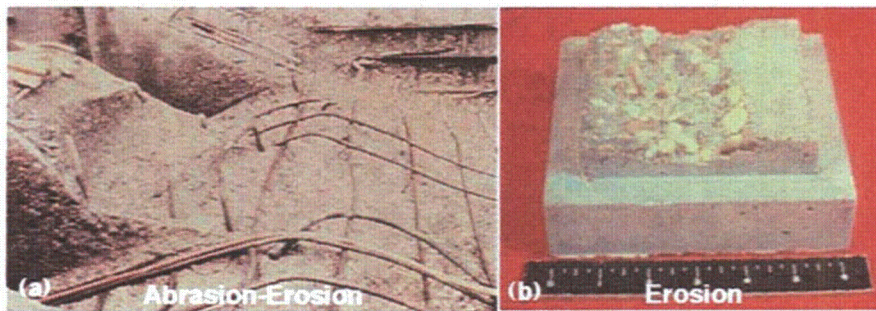
Figure 4.5 Abrasion-erosion of concrete: (a) abrasion-erosion damage in a concrete stilling basin and (b) erosion of conventional concrete.

Abrasion/Erosion/Cavitation Progressive loss of material at the concrete surface can occur due to abrasion, erosion, or cavitation. Abrasion generally refers to dry attrition due to rubbing or grinding of aggregate or other debris on the concrete surface, while erosion is normally used to describe wear by the abrasive action of fluids containing solid particles in suspension. Mechanical abrasion is usually characterized by long shallow grooves in the concrete surface and spalling along monolithic joints. Concrete surfaces abraded by water-borne debris are generally smooth and may contain localized depressions. Cavitation is the formation of bubbles or cavities in a liquid. In hydraulic structures, the liquid is water, and the cavities are filled with water vapor and air. The cavities form where the local pressure drops to a value that will cause the water to vaporize at the prevailing water temperature. Formation of these cavities is usually triggered by concrete surface irregularities that are subjected to high-velocity water flow. Cavitation bubbles will grow and travel with the flowing water to an area where the pressure field will cause collapse. When a bubble collapses or implodes close to or against a solid surface, an extremely high pressure is generated, which acts on an infinitesimal area of the surface for a very short time. A succession of these high-energy impacts will damage almost any solid material.⁶⁶ Figure 4.5 presents examples of concrete abrasion-erosion.^{66,67}

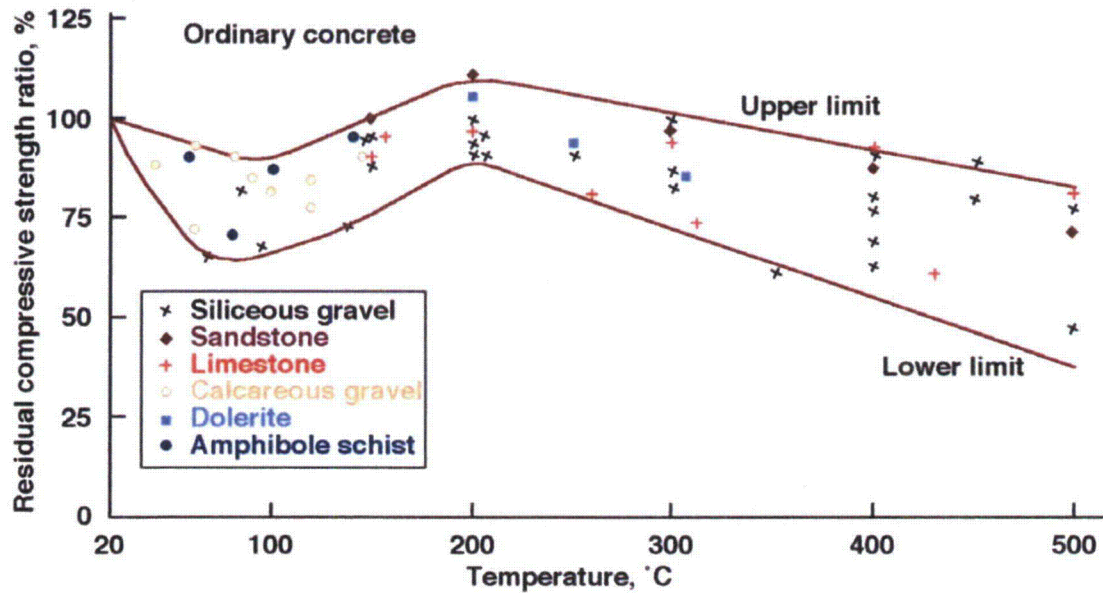
Figure 4.6 Effect of temperature on residual compressive strength: unsealed specimens.

and porosity of aggregate, rate of heating, permeability, use of pozzolans, moisture state, mix proportions, and loading and sealing conditions during heating.

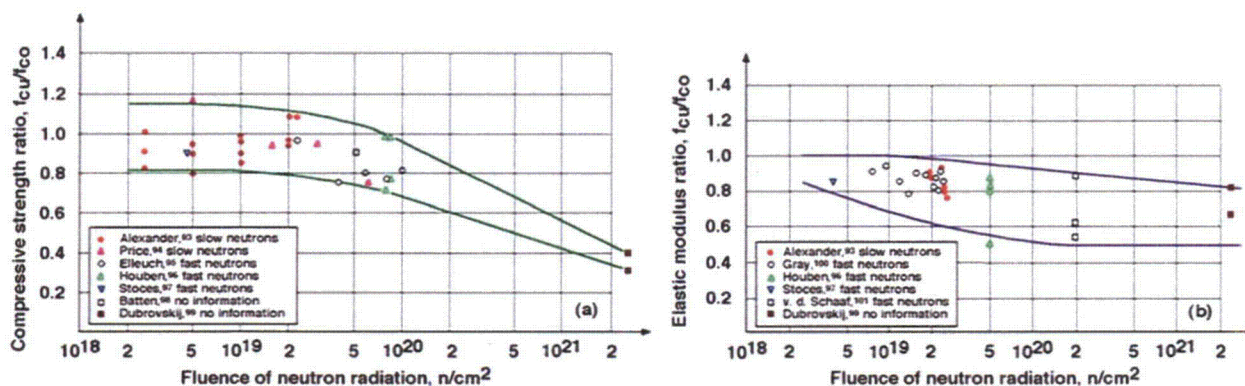
Figure 4.7 Effect of neutron radiation on concrete compressive strength and modulus of elasticity relative to unirradiated and unheated control specimen results.

Prolonged exposure of concrete to irradiation can result in decreases in tensile and compressive strengths and modulus of elasticity. Figure 4.7 presents a summary of the effects of neutron radiation on the compressive strength and modulus of elasticity of several concretes.⁹⁰ Results in the literature⁹⁰ indicate that: (1) for some concretes, neutron radiation of more than 1×10^{19} neutrons/cm² or 10^{10} rads of dose for

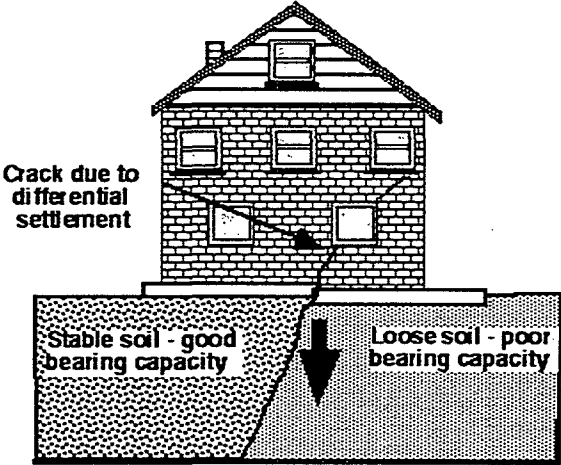
Figure 4.8 Example of differential settlement cracking in a building structure due to inadequate foundation design.

Uniform settlement will not normally cause structural distress, although if excessive it can result in damage or misalignment of connecting services or structures. Differential settlement is more of a concern as it can cause misalignment of equipment and lead to overstress conditions in structures (e.g., cracking such as illustrated in a building structure in Fig. 4.8). The amount of settlement is dependent on the physical properties of the foundation material at the site, which may range from bedrock (minimal settlement expected) to compacted soil (some settlement expected). Settlement is generally allowed for in the design of the structures and is not expected to be significant. When a structure such as a nuclear power plant is sited on soils, the potential for settlement is acknowledged and monitoring programs may be implemented to confirm that design allowables are not exceeded.

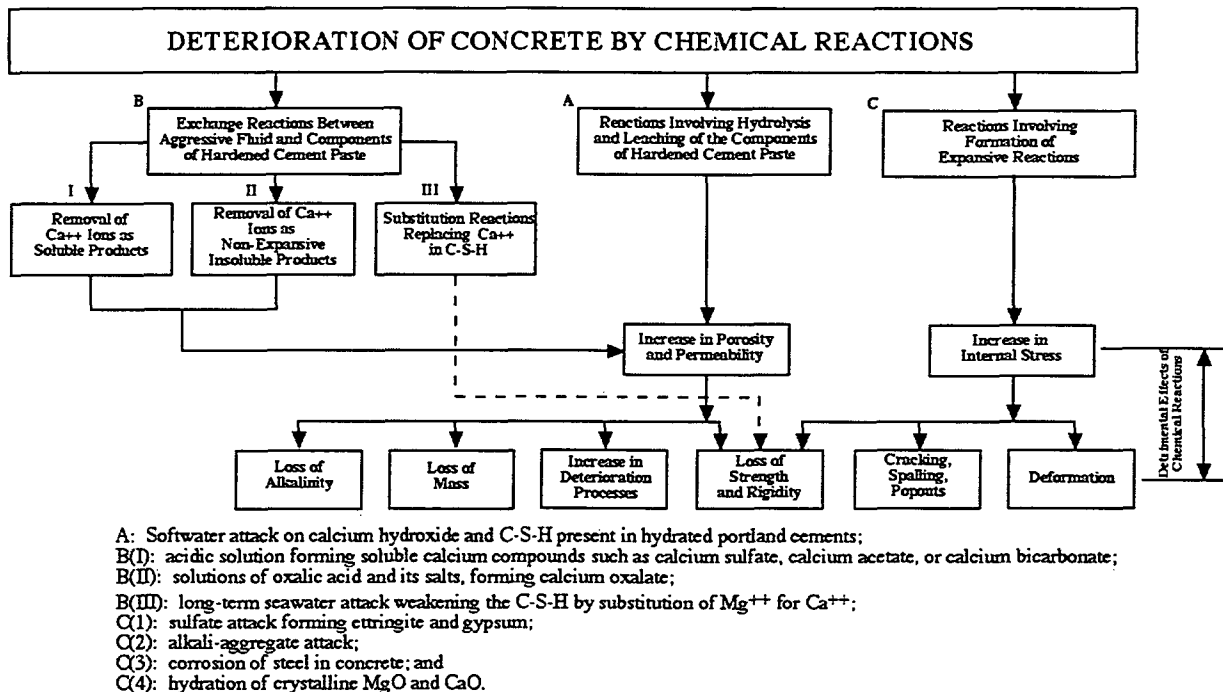
Figure 4.9 Types of chemical reactions responsible for concrete deterioration.

Chemical attack involves the alteration of concrete through chemical reaction with either the cement paste or coarse aggregate, or embedded steel reinforcement.** Generally, the attack occurs on the exposed surface region of the concrete (cover concrete), but with the presence of cracks or prolonged exposure, chemical attack can affect entire structural cross sections. Chemical causes of deterioration can be grouped into three categories: (1) hydrolysis of cement paste components by soft water; (2) cation exchange reactions between aggressive fluids and the cement paste; and (3) reactions leading to formation of expansion products.¹⁰⁹ Figure 4.9 presents a summary of the types of chemical reactions responsible for concrete deterioration and the detrimental effects that can occur.¹¹⁰ Chemical attack of concrete may occur in several different forms as highlighted in the following sections.

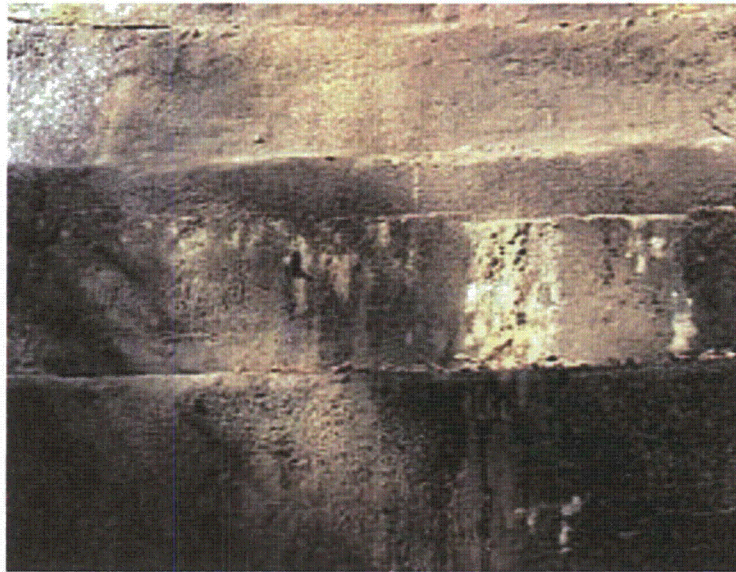
Figure 4.10 Efflorescence in water structure.

concrete or at its surfaces in contact with sulfates in the surrounding soil.¹¹¹ Typically, however, efflorescence is primarily an aesthetic problem rather than affecting the concrete mechanical properties or durability. In rare cases, excessive efflorescence deposits can occur within the surface pores of the concrete causing expansion that may disrupt the surface.¹¹² Figure 4.10 presents an example of efflorescence in a water structure.

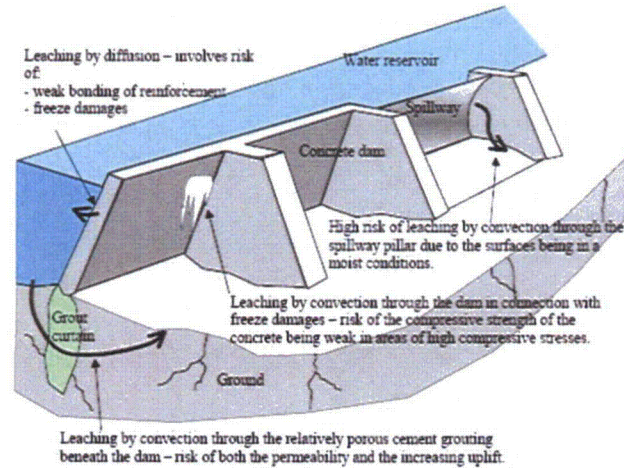
Figure 4.11 Typical leaching types observed in concrete hydraulic structures such as a dam.

Leaching of cementitious materials mainly involves the transportation of ions from the interior of the material through its pore system outwards into the surroundings. In the leaching process solid compounds in the concrete are dissolved by water that has penetrated and are transported away either by diffusion based on the concentration gradients or convection through the flow of water. Pure water that contains little or no calcium ions, or acidic ground water present in the form of dissolved carbon dioxide gas, carbonic acid, or bicarbonate ion, tends to hydrolyze or dissolve the alkali oxides and calcium-containing products. Water with a pH less than 12.5 is aggressive toward concrete since it destabilizes the cementitious hydration products. The rate of leaching is dependent on the amount of dissolved salts contained in the percolating fluid, rate of permeation of the fluid through the cement paste matrix, and temperature. Extensive leaching causes an increase in porosity and permeability thus lowering the strength of the concrete and making it more vulnerable to hostile environments (e.g., water saturation and frost damage, or chloride penetration and corrosion of embedded steel). Figure 4.11 shows a schematic of different types of leaching found in concrete hydraulic structures.¹¹³ Examples of leaching in a concrete dam and a tendon gallery of a nuclear power plant are shown in Figure 4.12. Concrete leaching is basically of three types: (1) leaching at free surfaces of the concrete, (2) leaching from the interior of concrete, and (3) leaching at surfaces of cracks in concrete.¹¹⁴ Figure 4.13 presents conceptual models for each of the leaching types. Of these types, (a) is generally of little importance, (b) is serious and can result in serious damage, and (c) is difficult to deal with and complicated to assess. Concretes produced using low water-cement ratios, adequate cement content, and proper compaction and curing are most resistant to leaching.

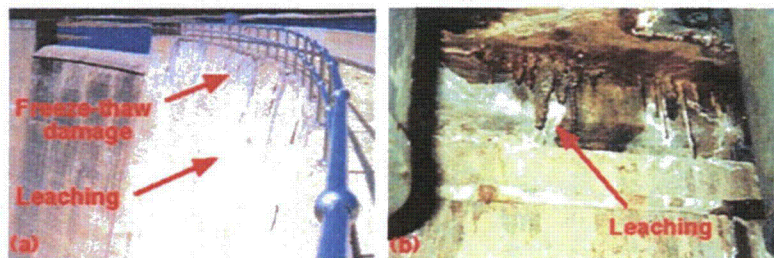
Figure 4.12 Examples of leaching of concrete: (a) dam with freeze-thaw damage and leaching, (b) nuclear power plant tendon gallery leaching.

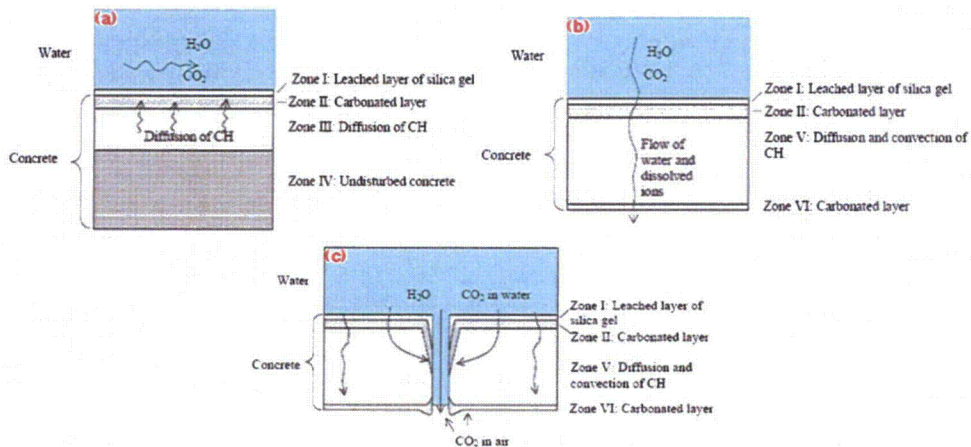
Figure 4.13 Conceptual models for concrete leaching mechanisms: (a) leaching from free surfaces, (b) homogeneous percolation through porous concrete, and (c) leaching from surfaces of cracks. CH = calcium hydroxide.

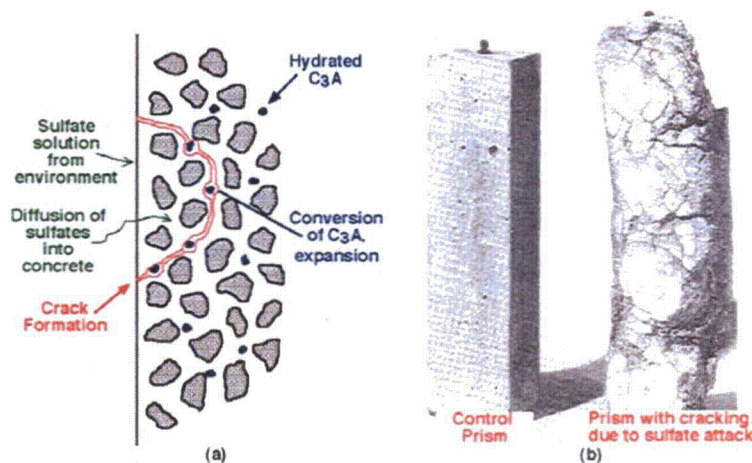
Figure 4.14 Concrete cracking due to sulfate attack: (a) mechanism, (b) example of concrete cracking due to sulfate attack.

Sulfate Attack All sulfates are potentially harmful to concrete. Sulfate attack of concrete is caused by exposure of concrete products or structures to an excessive amount of sulfate from internal or external sources. Internal sulfate attack results when a soluble source of sulfates is incorporated into the concrete at the time of mixing through the hydraulic cement, presence of natural gypsum or pyrite in the aggregate, and admixtures. External sulfate attack is most common and typically occurs when water containing dissolved sulfates penetrates the concrete. Magnesium, sodium, calcium, and potassium sulfates present in soils, ground water, and sea water react with the calcium hydroxide and if enough water is present, result in expansion and irregular cracking of the concrete that can lead to progressive loss of strength and mass. The degree of sulfate attack depends on water penetration, the sulfate salt and its concentration and type, the means by which the salt develops in the concrete (e.g., is it rising and drying causing crystallization), and the chemistry of the binder present in the concrete. Sulfate attack of hardened concrete generally appears in two forms: expansive formation of ettringite and gypsum in the hardened concrete causing cracking and exfoliation, and softening and dissolution of the hydrated cementing compounds due to direct attack on these compounds by sulfate or by their decomposition when calcium hydroxide reacts with the sulfates and is removed.⁴⁷ The end result of sulfate attack can be excessive expansion, delamination, cracking, and loss of strength. Figure 4.14 illustrates the mechanism of sulfate (sodium) attack and presents an example of cracking resulting from sulfate attack. It has been reported that at a concentration of about 0.2% sulfate content in ground water concrete may suffer sulfate attack, magnesium sulfate can be more aggressive than sodium sulfate, and there are three key chemical reactions between sulfate ions and hardened cement pastes: (1) recrystallization of ettringite, (2) formation of calcium sulfoaluminate (ettringite), and (3) decalcification of the main cementitious phase (calcium silicate hydrate).¹¹⁵

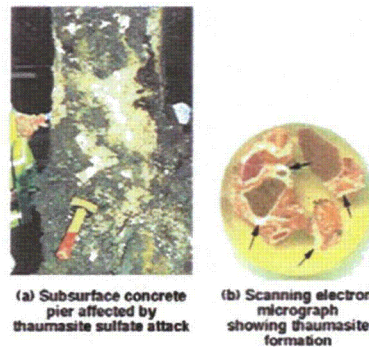
Figure 4.15 Thaumasite sulfate attack.

A rare form of sulfate attack is through formation of thaumasite as a result of the reaction between the calcium silicates in the cement, calcium carbonate from limestone aggregates or fillers, and sulfates, usually from external sources.⁵⁶ Coincident factors for thaumasite sulfate attack in susceptible concrete include: source of sulfates, presence of mobile ground water, source of calcium silicate hydrate, presence of carbonate, and a low temperature (<10°C).¹²⁰ Thaumasite sulfate attack forms slowly and can destroy a significant part of the calcium silicate hydrate that eventually results in a soft, white, pulpy mass that causes total disintegration of the concrete and exposes the steel reinforcement. Figure 4.15 presents a subsurface concrete pier affected by thaumasite sulfate attack in the United Kingdom. However, serious damage to concrete or masonry due to thaumasite formation has not been a common occurrence.

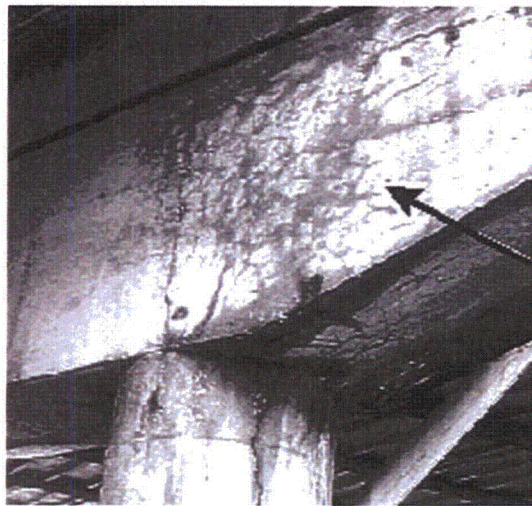
Figure 4.16 Cracking damage in a concrete structure due to DEF.

Delayed Ettringite Formation Ettringite formation by reaction of internal or external sulfate with anhydrous or hydrated calcium aluminates has an expansive character. When it occurs within several hours in a fresh concrete mixture, there is no destructive expansion. However, when ettringite forms at later ages (e.g., months or years) in a hardened concrete, delayed ettringite formation (DEF) can exhibit expansion and cracking. The distress often is attributed to improper heat-treatment of concrete in which the ettringite formation is prevented or the ettringite that is normally formed during the early hydration of portland cement decomposes ($T > 70^{\circ}\text{C}$). Use of cements having high sulfate contents in which the sulfate has very low solubility also can lead to DEF. In this case, the sulfate concentrations in the pore liquid are high for an unusually long period of time in the hardened concrete. Eventually the sulfate will react with the calcium- and aluminum-containing phases of the cement paste and the cement paste expands forming cracks around the aggregate particles. In one case where this has been reported, it was thought that the occurrence of DEF was due to the sulfate formed in the clinker of the cement being present as anhydrite and as a component of the silicate phases that are slowly soluble.¹²¹ If structures susceptible to DEF are later exposed to water, ettringite can reform in the paste as a massive development of needle-like crystals, causing expansive forces that result in cracking. The extent of development of DEF is dependent on the amount of sulfate available for late ettringite development in the particular concrete and on the presence of water during the service life. Elevated temperatures also increase the potential for damage due to DEF. Prevention or minimization of DEF can be accomplished by lowering the curing temperature, limiting clinker sulfate levels, avoiding excessive curing for potentially critical sulfate to aluminate ratios, preventing exposure to substantial water in service, and using proper air entrainment. Neither the mechanisms involved in DEF nor their potential consequences relative to concrete durability are completely understood. DEF leads to a degradation in concrete mechanical properties such as compressive strength, and can promote increased permeability. A detailed review of over 300 publications dealing with DEF is available.¹²² Figure 4.16 presents an example of cracking damage in a concrete structure due to delayed ettringite formation.

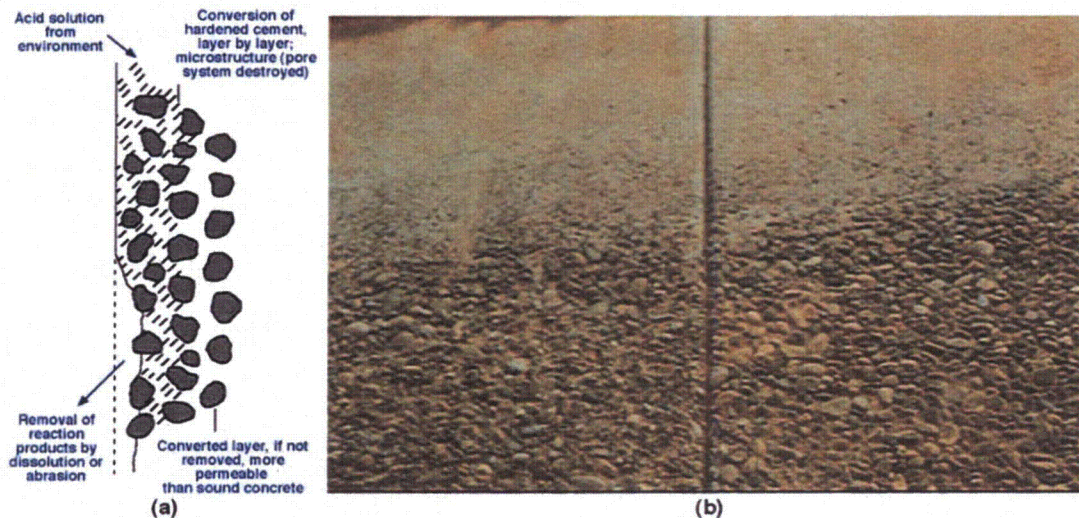
Figure 4.17 Surface loss due to acid attack: (a) mechanism, (b) example of acid attack on concrete wall.

so much the aggressiveness of the attacking acid, but more the solubility of the resulting calcium salt. The rate of deterioration is also accelerated if the aggressive chemical solution is flowing. Since under acid attack there is a conversion of the hardened cement, the concrete permeability is not as important as for other types of chemical attack (e.g., leaching and sulfate attack). Nitric, hydrochloric, and sulfuric acids are very aggressive as their calcium salts are readily soluble and removed from the acid front. Organic acids such as formic, acetic, and lactic are also corrosive to portland cement concrete. Other acids such as phosphoric, carbonic, tannic, and humic are less harmful as their calcium salts have low solubility and inhibit the attack by blocking the pathways within the concrete. Oxalic acids have negligible effect on portland cement concretes. Carbonic, humic, and sulfuric acids are the acids most commonly encountered by concrete since they are found in natural ground waters. Visual examination of concrete undergoing acid attack will show disintegration of the concrete in the form of loss of cement paste and aggregate from the matrix. Due to the large buffering capacity of concrete and the relatively small amount of acid contained in rain, acid rain will convert only an insignificant amount of the concrete.⁵⁷ Acid rain is even a smaller threat to nuclear power plant structures than general civil engineering concrete structures because of their massive cross sections. Surface coatings and a dense concrete with a low water-cement ratio provide improved resistance to acid environments. Figure 4.17 illustrates the mechanism of acid attack and presents an example of acid attack on a concrete wall.

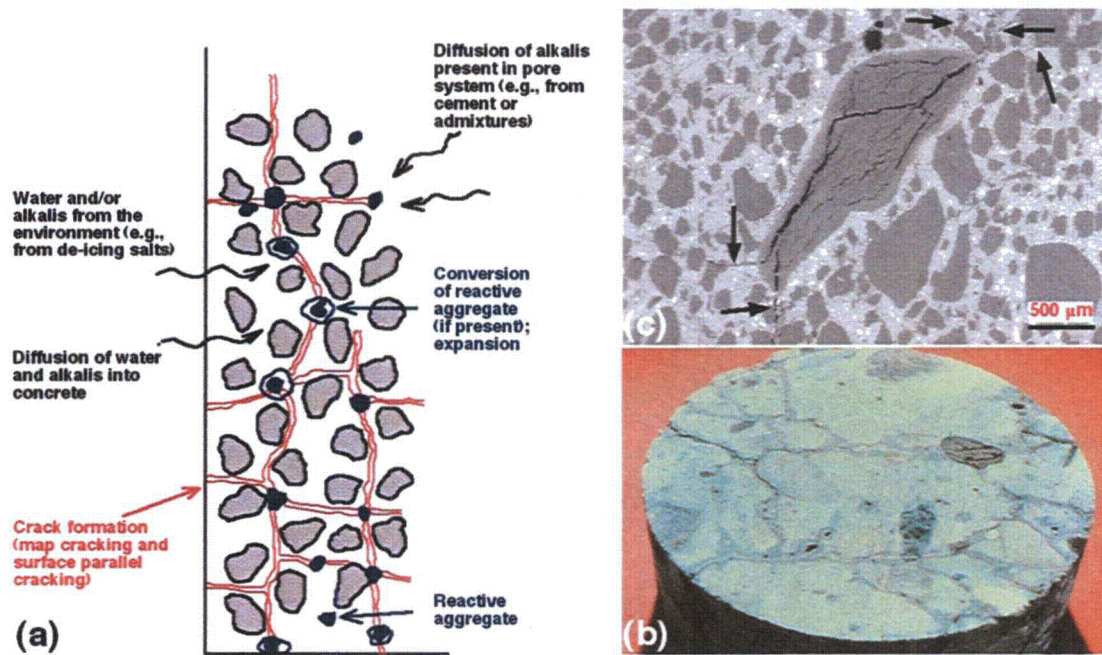
Figure 4.18 Concrete cracking due to alkali-silica reaction: (a) mechanism, (b) resulting gel that causes expansion and cracking, (c) polished section of concrete showing chert particle with extensive internal cracks extending from aggregate as noted by arrows.

the alkali-silicate ions and expands, which can disrupt the concrete.* Figure 4.18 presents the mechanism of alkali-silica reaction (ASR) and the gel resulting from alkali-aggregate reaction that causes expansion

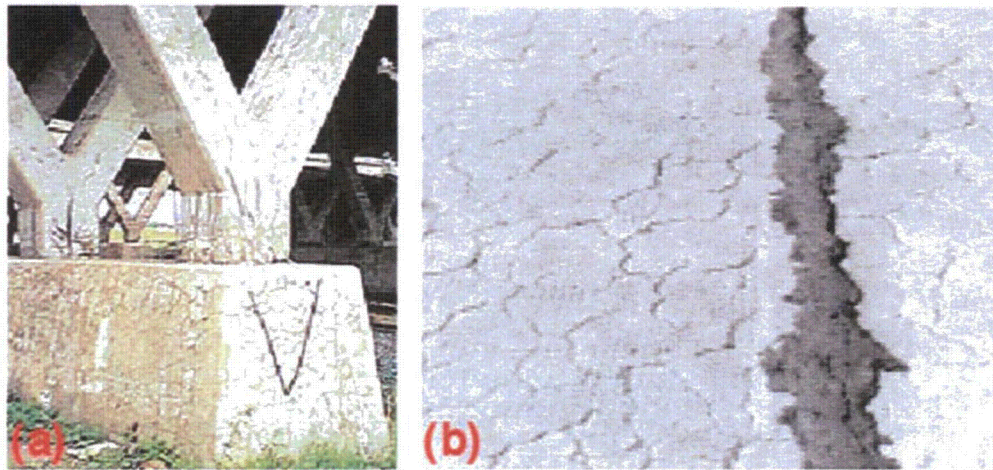
Figure 4.19 Examples of concrete cracking: (a) alkali-silica reaction in bridge pier, (b) alkali-carbonate reaction in sidewalk with exudation of joint material.

strength in excess of 50% with losses for smooth bars greater than for ribbed bars.^{135,136} Prestress developed by the ASR expansion can enhance the shear strength and stiffness of beams.¹³⁷ Figure 4.19 presents examples of alkali-aggregate reactions in concrete structures.

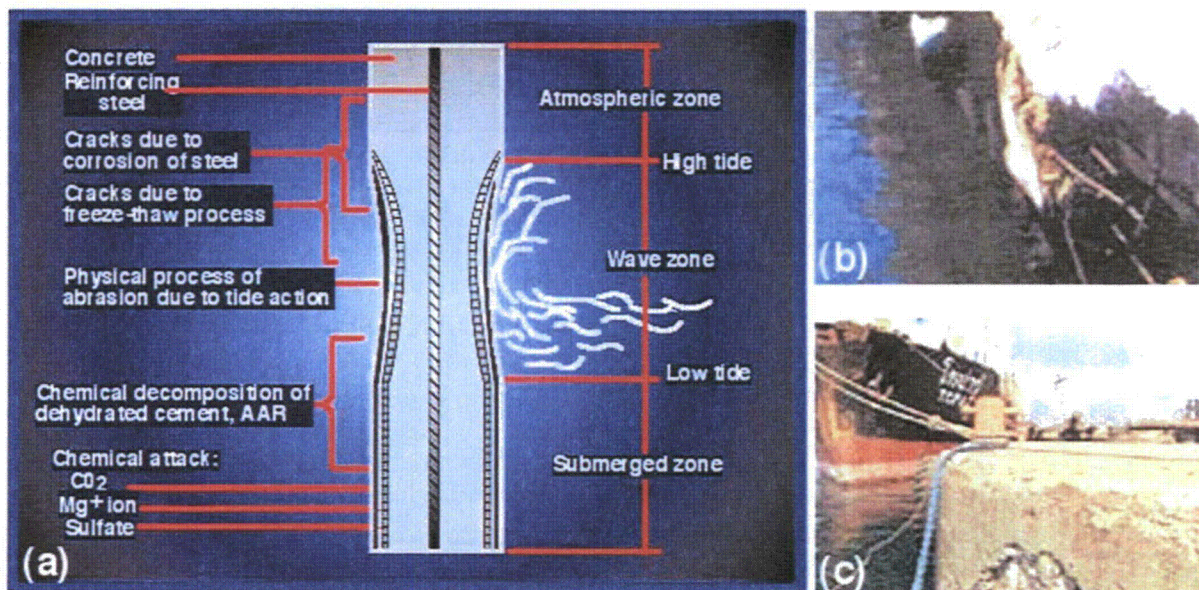
Figure 4.20 Sea water attack of concrete: (a) mechanism, (b) and (c) examples of attack.

Aggressive Water Attack# Concrete in service may be exposed to aggressive waters, with the most common deleterious ion being sulfate.¹⁴³ In other waters, acids and chemical by-products from industrial processes may be present. Some locations have sea water or brackish water in contact with concrete. Most sea waters have a pH of 7.5 to 8.4, are fairly uniform in chemical composition, contain about 3.5% soluble salts by weight, with Na^+ and Cl^- having the highest ionic concentrations, but Mg^{2+} and SO_4^{2-} are also present.¹⁰⁹ Reaction of magnesium sulfate with the cement hydration products leads to formation of ettringite, calcium sulfate, and insoluble magnesium hydroxide (brucite) that reduces the rate of attack of dense concrete. The rate of attack is further reduced by the formation of aragonite (calcium carbonate) which forms more readily in the tidal zone than the surface layers of a completely immersed element.⁴⁶ Concrete exposed to a marine environment may deteriorate as a result of combined effects of chemical action of sea water constituents on cement hydration products, alkali-aggregate expansion if reactive aggregates are present, crystallization pressure of salts within concrete if one face of the structure is subject to wetting and others to drying conditions, frost action in cold climates, corrosion of embedded steel reinforcement, and physical erosion due to wave action or floating objects. Figure 4.20 presents a diagrammatic representation of deterioration of concrete exposed to sea water as well as examples of sea water attack.

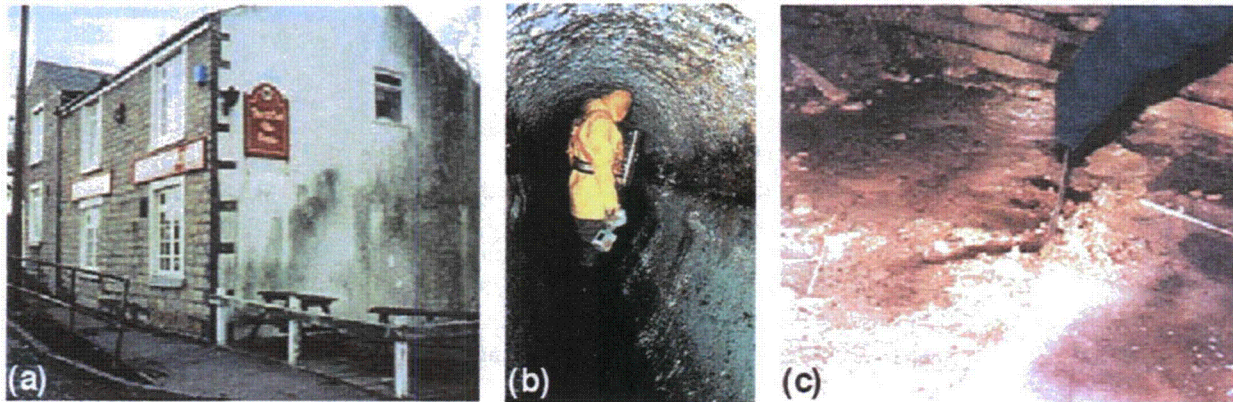
Figure 4.21 Concrete biological attack: (a) algae growth on outside wall of house, (b) biogenic sulfuric acid attack in sewer system, (c) decaying concrete floor in flooded cellar.

Formation of capillaries within the concrete during the hydration process and the capillary action of water provide a means for penetration of microorganisms into concrete. The metabolism of microorganisms results in the excretion of sulfuric or nitric acid that can contribute substantially to the degradation of cementitious materials. A number of organisms are capable of causing the dissolution of concrete through leaching of calcium and other alkaline binding materials.¹⁴⁶ These organisms are known to cause serious damage to sewer lines, buildings, and monuments. In environments where reduced sulfur compounds are present, such as sewers, the production of sulfuric acid by sulfur oxidizing bacteria (thiobacilli) forms a corrosive layer that causes extensive cement degradation. The sulfuric acid reacts with the free lime [$\text{Ca}(\text{OH})_2$] to form gypsum ($\text{CaSO}_4 \cdot 2\text{H}_2\text{O}$) that produces a corroding layer on the concrete surface that penetrates into the concrete. The newly formed gypsum crystals react with calcium aluminate in the cement to produce ettringite that further contributes to the degradation of concrete by increasing the internal pressure leading to formation of cracks that, in turn, provide a larger surface area for the corrosion process.¹⁴⁷ In environments where reduced sulfur compounds are limiting, such as on buildings, nitric acid-producing nitrifying bacteria have been found to play a role in concrete degradation.¹⁴⁸ The action of nitric acid on the calcareous components of concrete results in the production of calcium nitrate (soluble salt) that is either lost from the concrete resulting in formation of corrosion pits or remains to add salt to the pore water. The sulfate-reducing bacteria are primarily responsible for degradation of concrete above ground and the nitrifying bacteria for degradation below ground.¹⁴⁹ Microbes have extremely diverse modes of metabolism, are natural inhabitants of soil, and can survive extreme environments such as the inner wall of a geothermal cooling tower.¹⁵⁰ Concrete can also be corroded by gluconic, malic, and oxalic acids produced by fermentative bacteria that are natural soil inhabitants.¹⁵¹ Figure 4.21 presents examples of biological attack of concrete and Table 4.8 provides a summary of the effects of microorganisms on building materials.

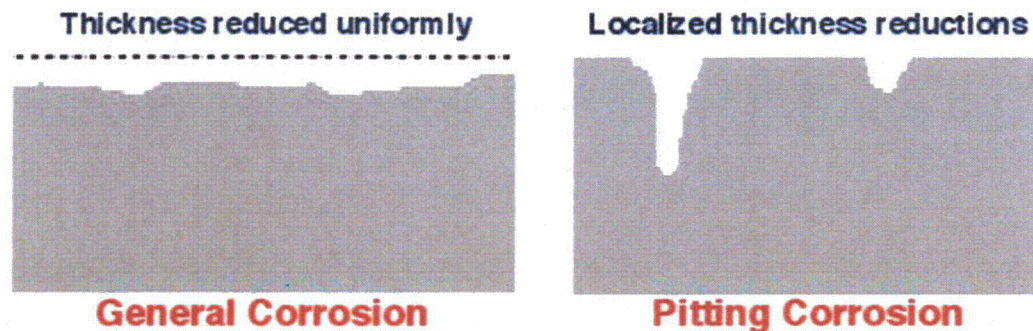
Figure 4.22 Illustrations of general and pitting corrosion of a metal surface.

Corrosion of conventional steel in concrete is an electrochemical process that can assume the form of either general or pitting corrosion. General corrosion refers to a relatively uniform reduction of thickness over the surface of a corroding material. It is relatively easy to measure and monitor. Pitting corrosion is a localized form of corrosion in which the bulk of the surface remains unattacked. Pitting corrosion is often found at locations where resistance against general corrosion provided by passive surface films has broken down. Figure 4.22 presents schematics illustrating general and pitting corrosion.

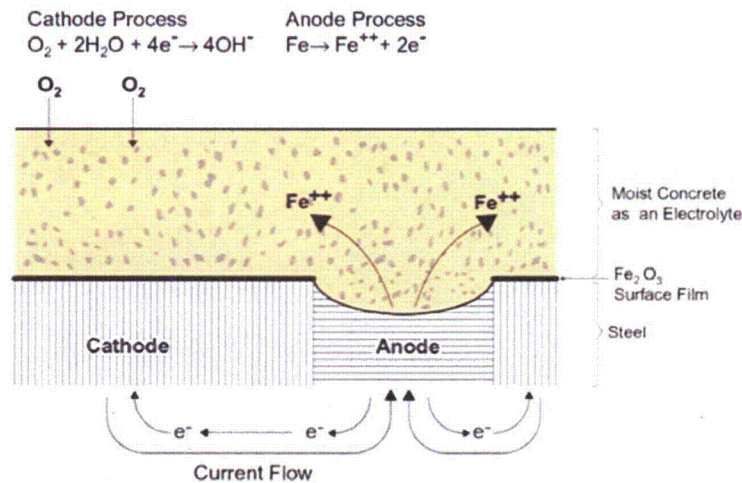
Figure 4.23 Electrochemical reaction illustrating corrosion of steel in concrete.

causes of corrosion include the effects of stray electrical currents or galvanic action with an embedded steel of different metallurgy. Figure 4.23 illustrates the electrochemical process of steel corrosion in moist and permeable concrete. Four fundamental components are necessary for an electrochemical corrosion cell: (1) anode, (2) cathode, (3) electrolyte, and (4) electrical connection between anode and cathode. Figure 4.24 presents examples of steel reinforcement corrosion in general civil engineering structures.

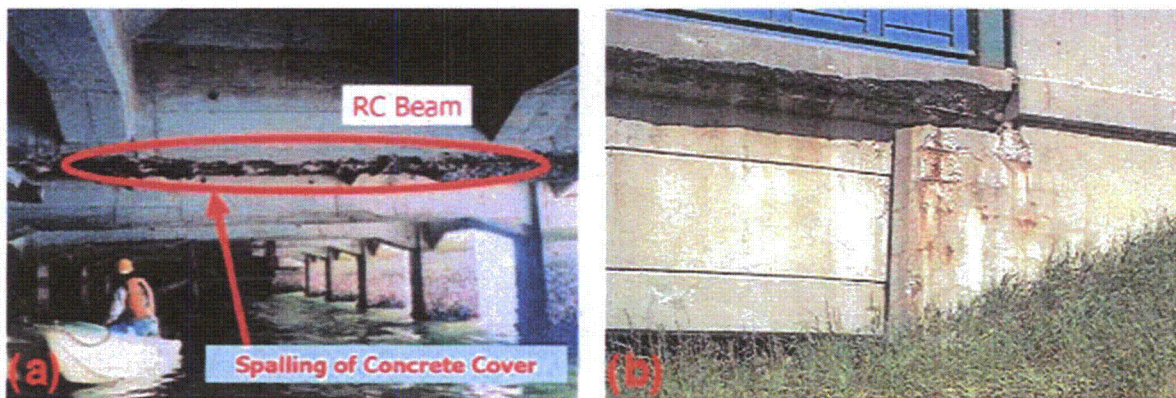
Figure 4.24 Corrosion of reinforced concrete: (a) sea water structure, (b) bridge structure.

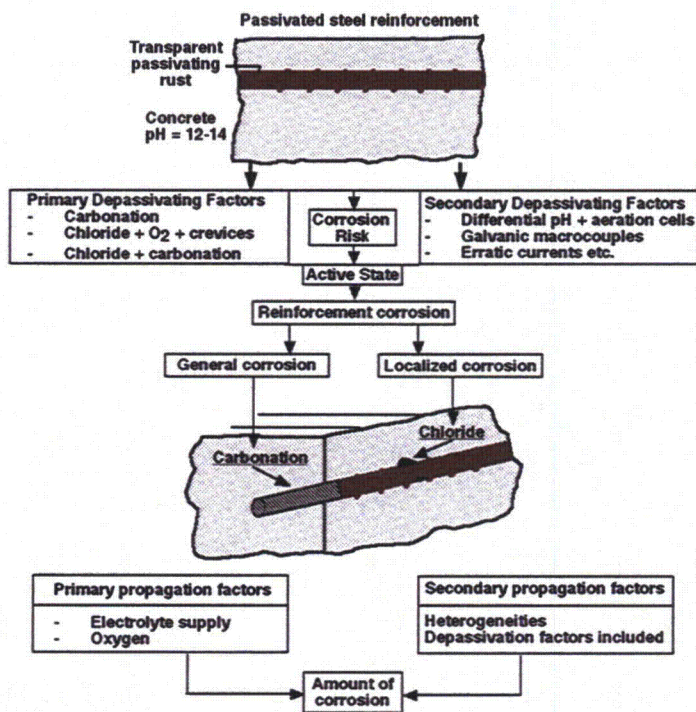
Figure 4.25 Factors leading to depassivation of steel in concrete.

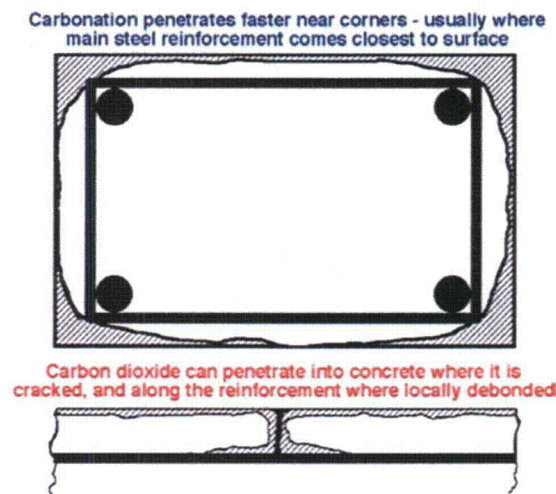
Figure 4.26 Carbonation penetration.

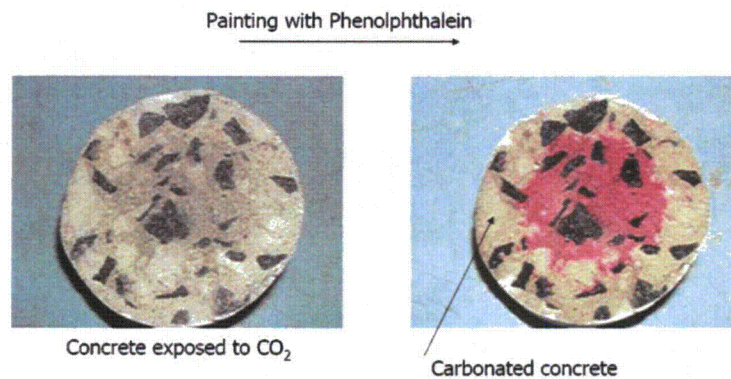
Figure 4.27 Use of phenolphthalein to identify carbonated concrete.
