Primer on Durability of Nuclear Power Plant Reinforced Concrete Structures - A Review of Pertinent Factors

Oak Ridge National Laboratory

**U.S. Nuclear Regulatory Commission
Office of Nuclear Regulatory Research
Washington, DC 20555-0001**

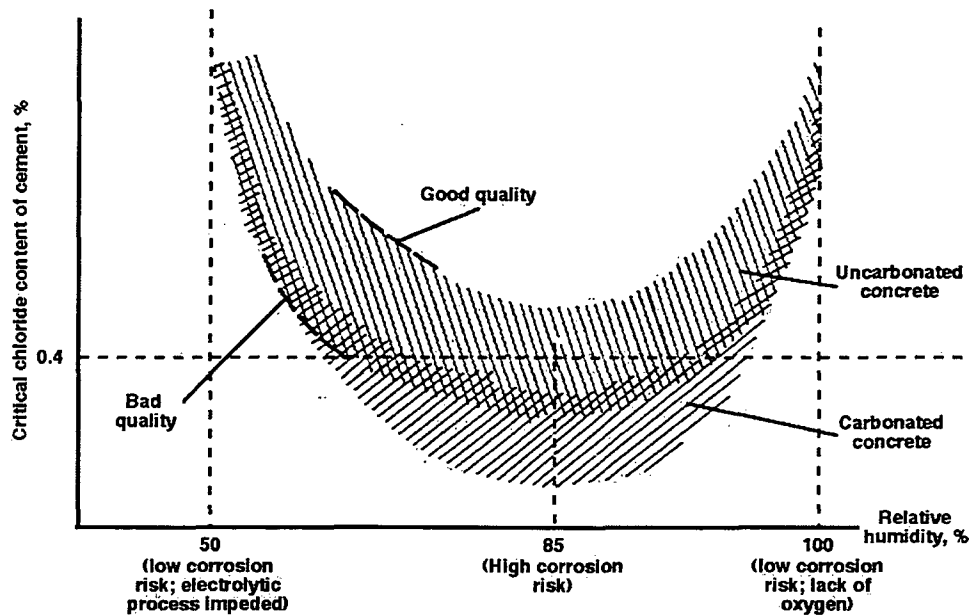
Figure 4.28 Variation of critical chloride content with environment.

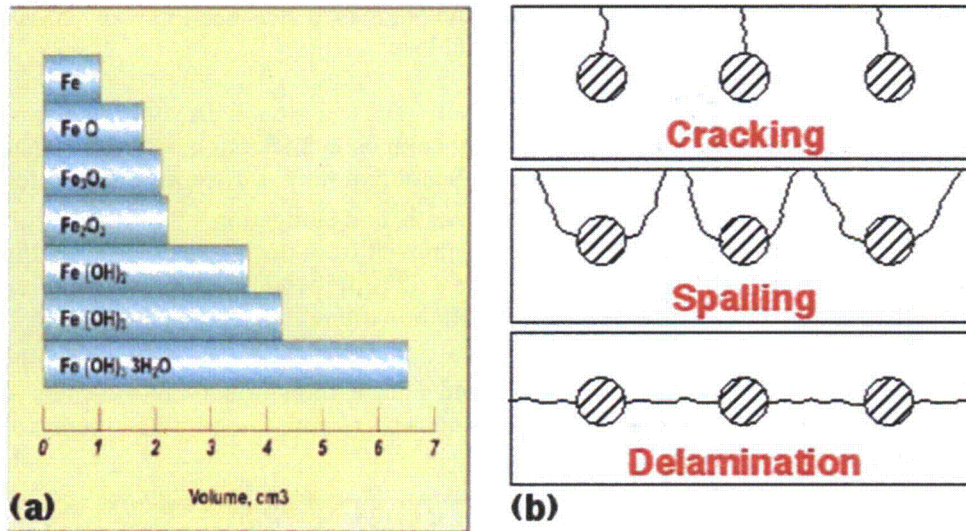
Figure 4.29 Oxidation states of iron and representations of visible forms of corrosion.

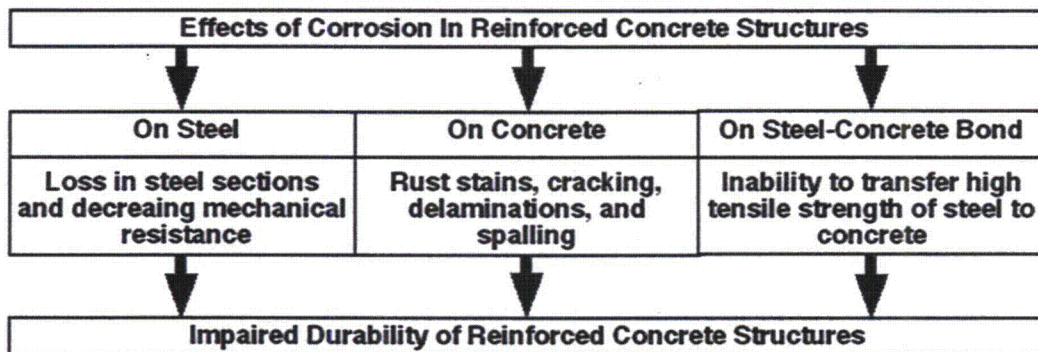
Figure 4.30 Effects of corrosion on reinforced concrete structures.

deterioration at the concrete surface is apparent. Figure 4.30 summarizes the effects of corrosion on reinforced concrete structures.¹⁵³

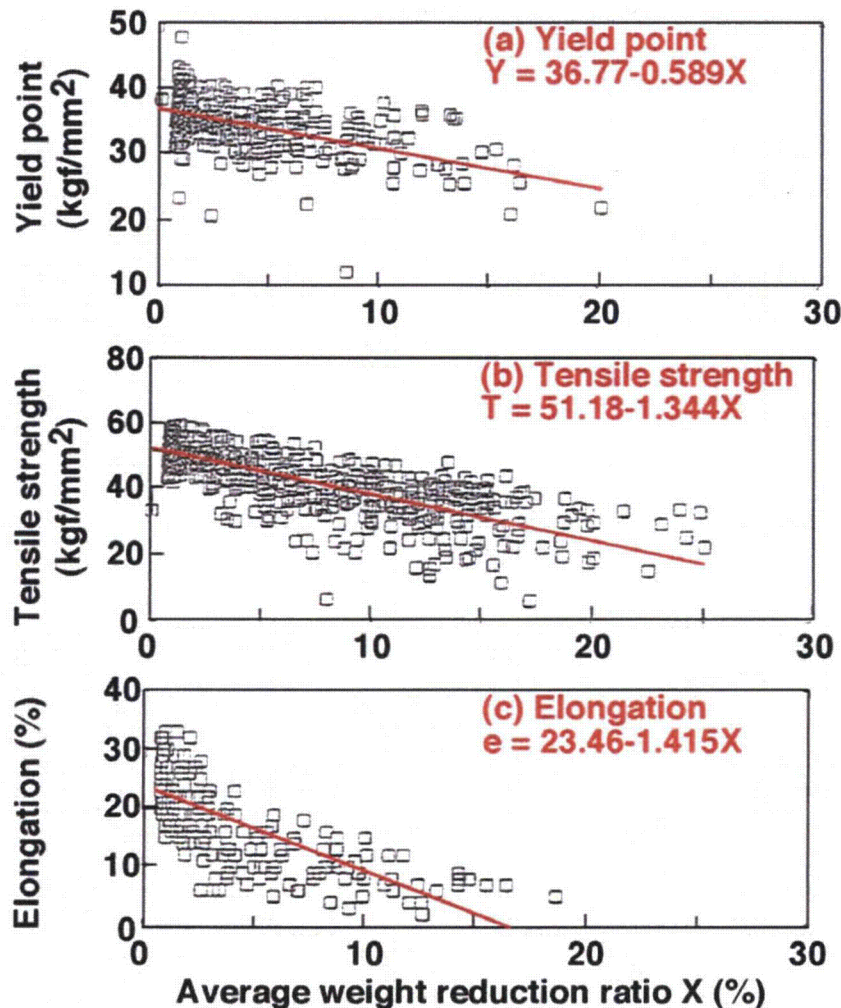
Figure 4.31 Properties of corroded steel reinforcement.

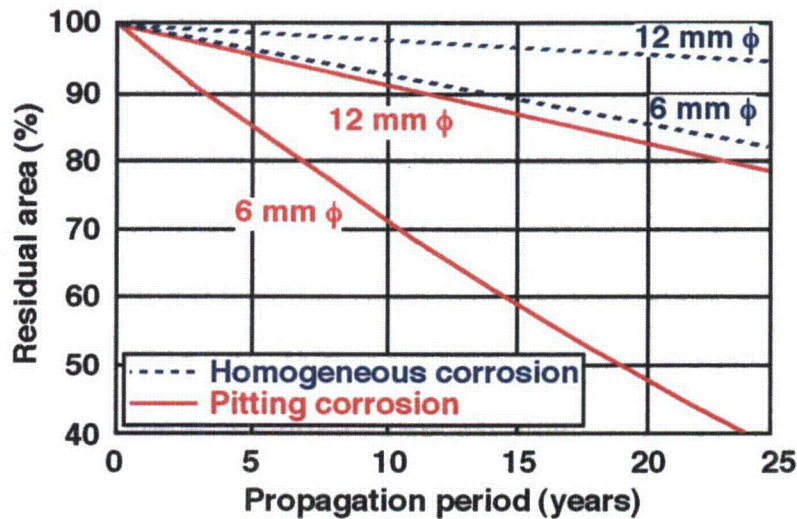
Figure 4.32 Residual cross-sectional area of steel reinforcement as a function of type and longevity of corrosion.

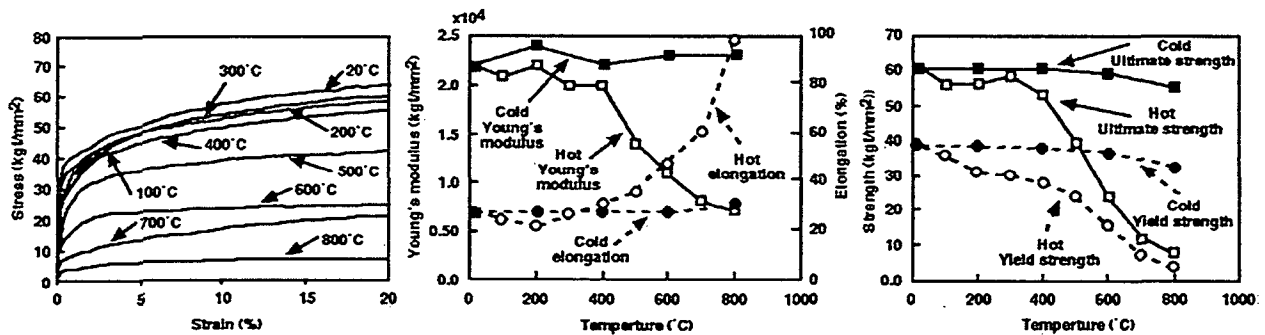
Figure 4.33 Effect of temperature on properties of a 3,500 kgf/cm² minimum specified yield strength steel bar.

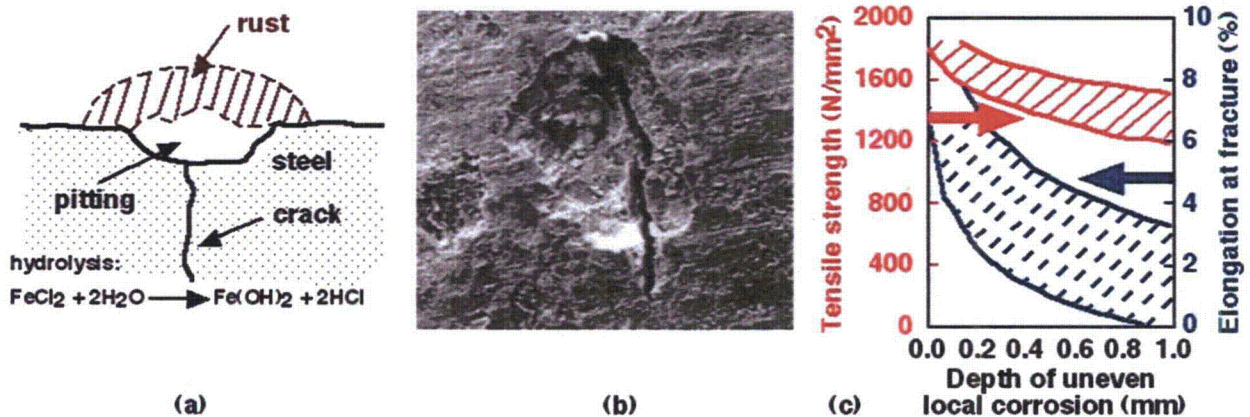
Figure 4.34 Pitting corrosion of prestressing steel: (a) mechanism, (b) pitting-induced stress-corrosion cracking, (c) effect of pit depth on tensile strength and elongation.

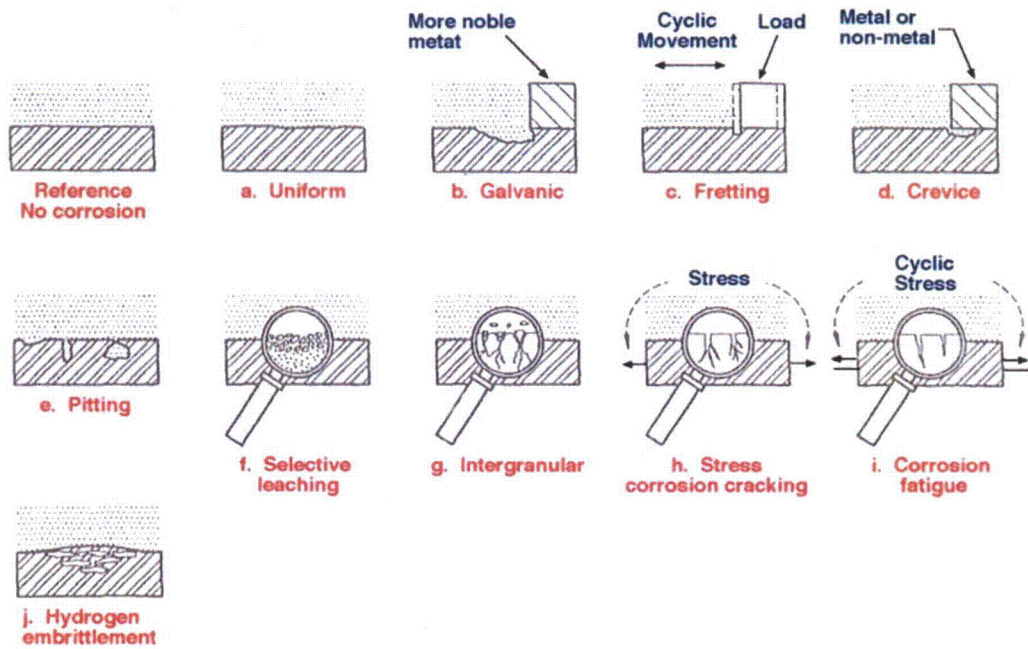
Figure 4.35 Schematic representations of forms of corrosion that may be found in metals.

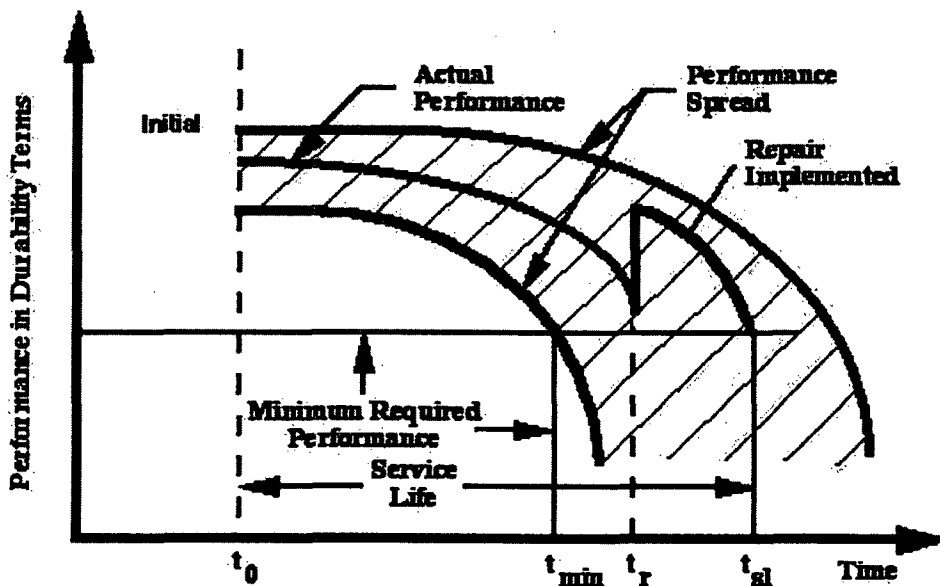
Figure 5.1 Relationship between performance and service life.

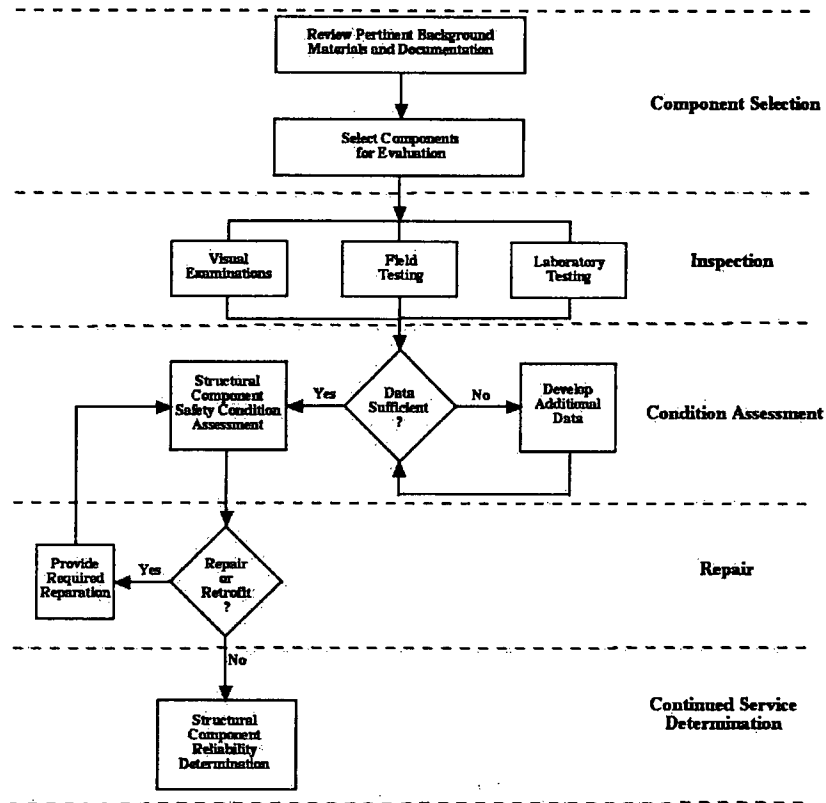
Figure 5.2 Evaluation methodology for nuclear power plant concrete structures.

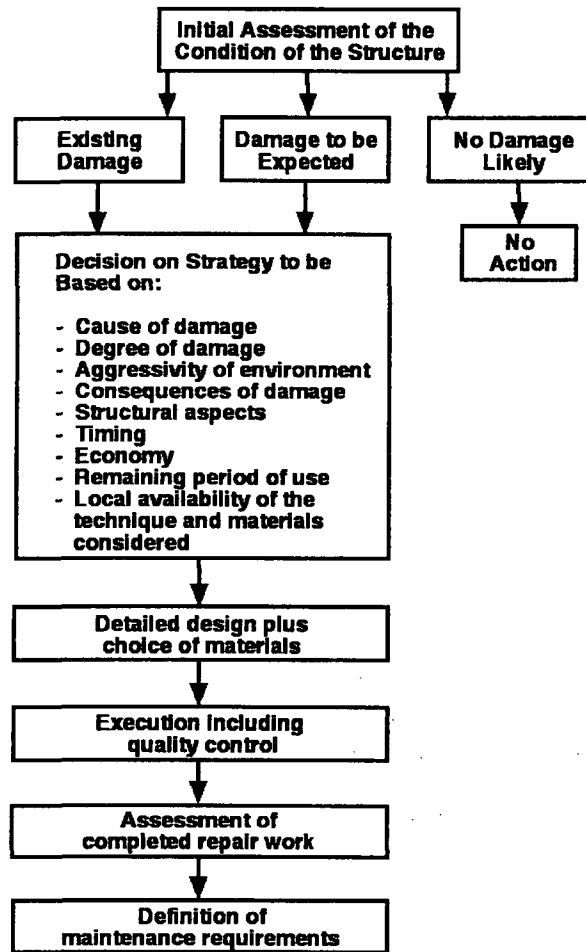
Figure 5.3 Steps to be taken in a repair process.

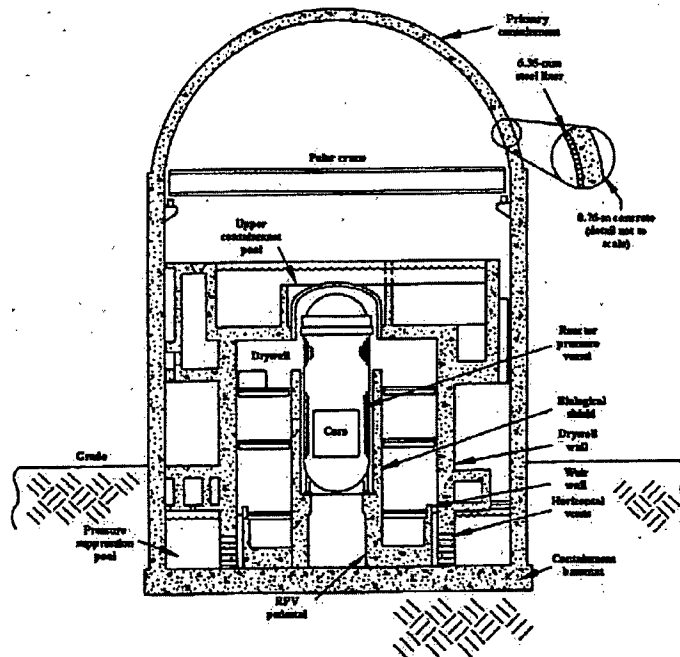
Figure A.3. BWR Mark III type reinforced concrete containment.

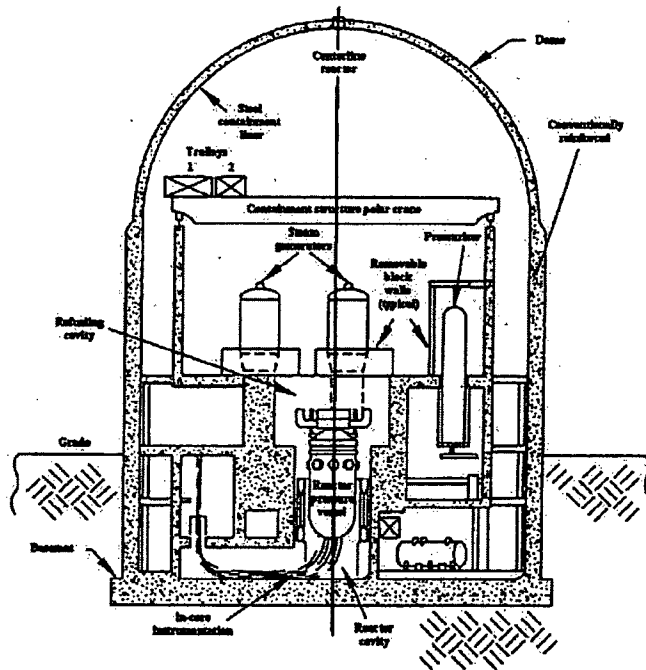
Figure A.4. PWR subatmospheric type reinforced concrete containment.

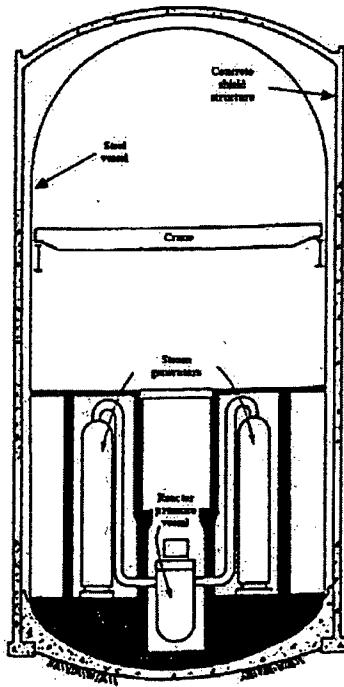
Figure A.7. PWR free-standing steel containment with elliptical bottom.

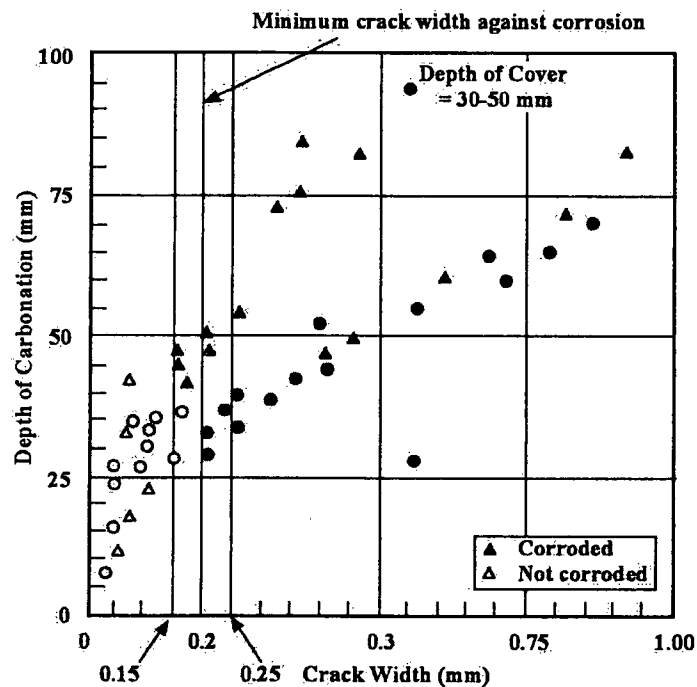
Figure C.1 Surface crack width, carbonation depth, and corrosion.

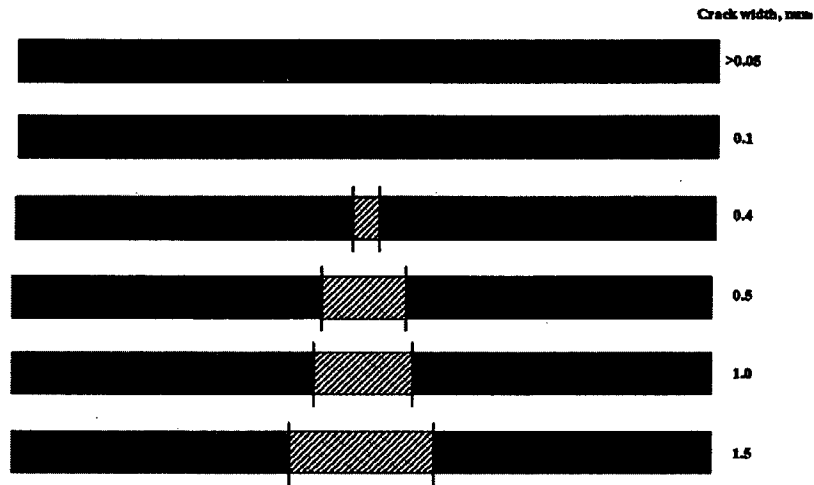
Figure C.2 Effect of crack width on corrosion length.

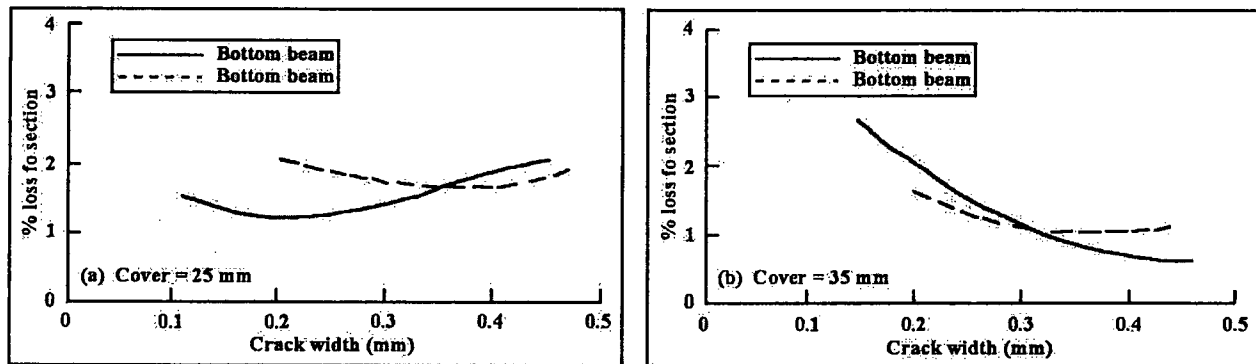
Figure C.3 Crack width and corrosion of 8-mm-diameter bar in marine environment (after 10-year exposure).

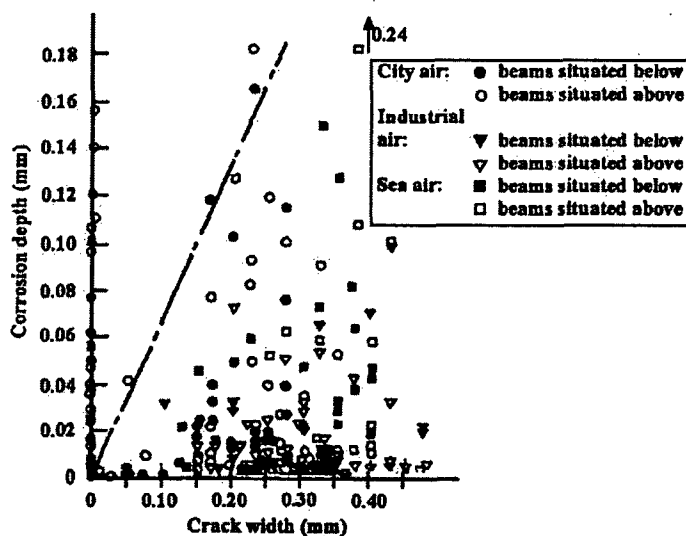
Figure C.4 Corrosion depth versus crack width after 10-year exposure.

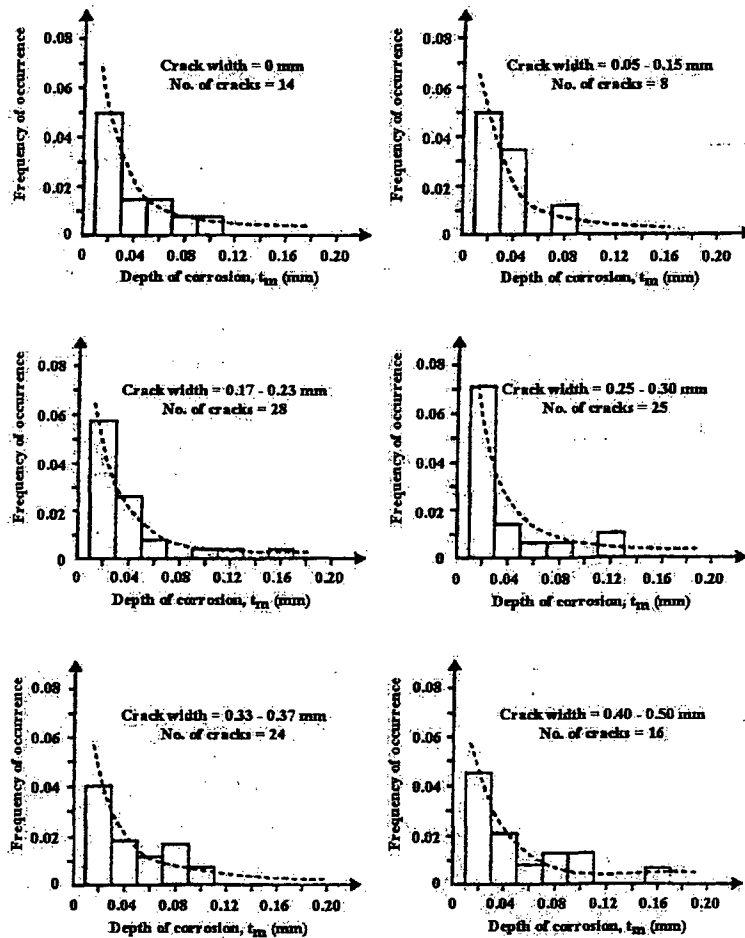
Figure C.5 Distribution of corrosion depths in Figure C.4.

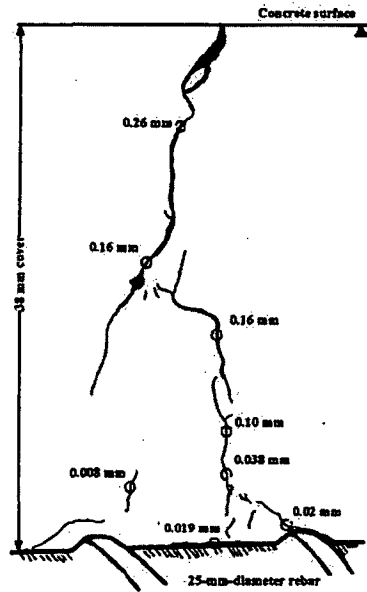
Figure C.6 Variation of crack width with depth.

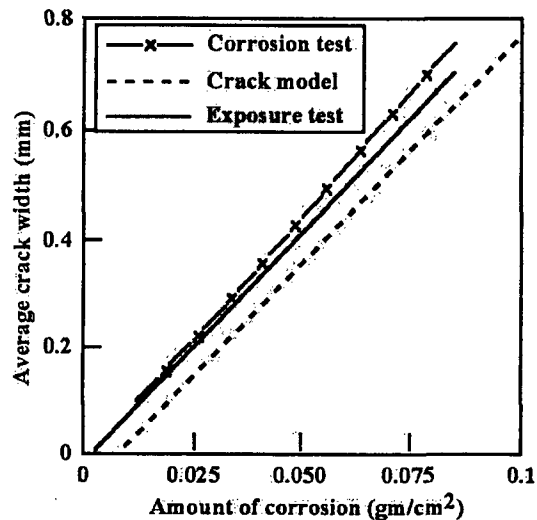
Figure C.7 Crack width versus amount corrosion.
