## Ambient Testing in the ESF

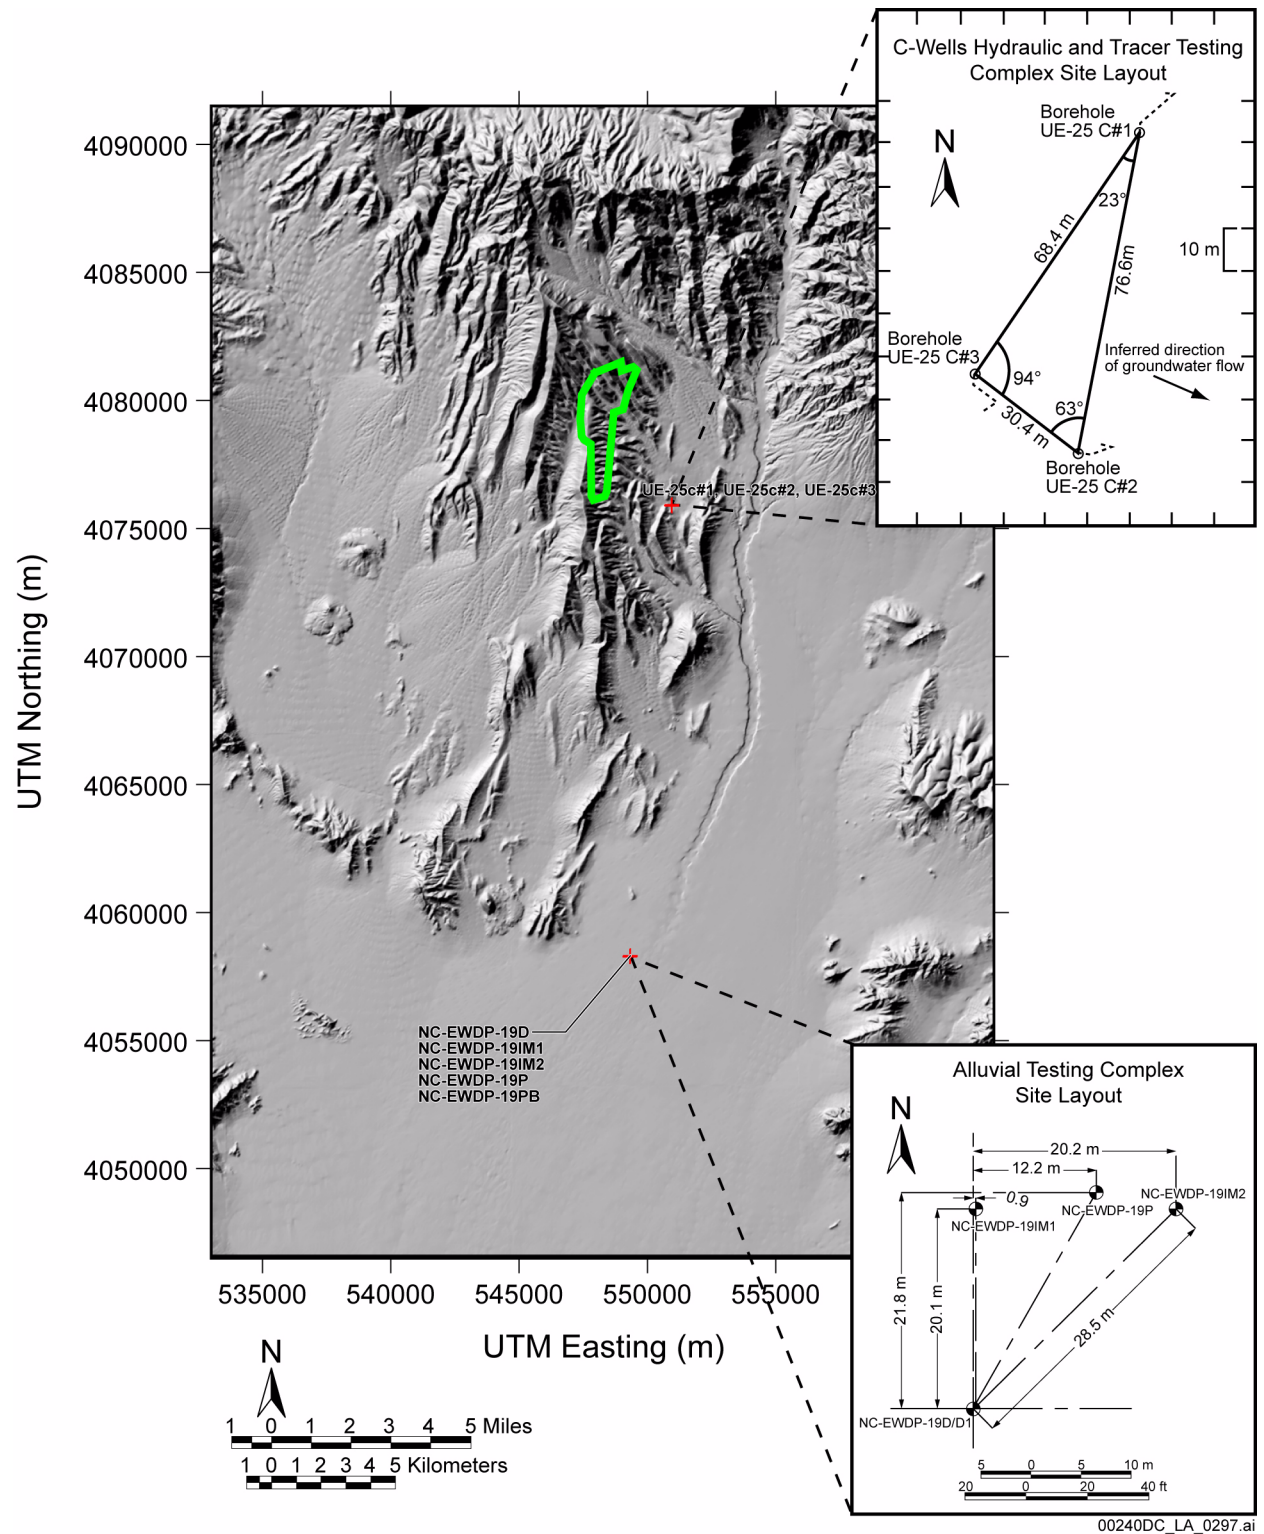
Figure 5-11. Location of the C-Wells and the Alluvial Testing Complex

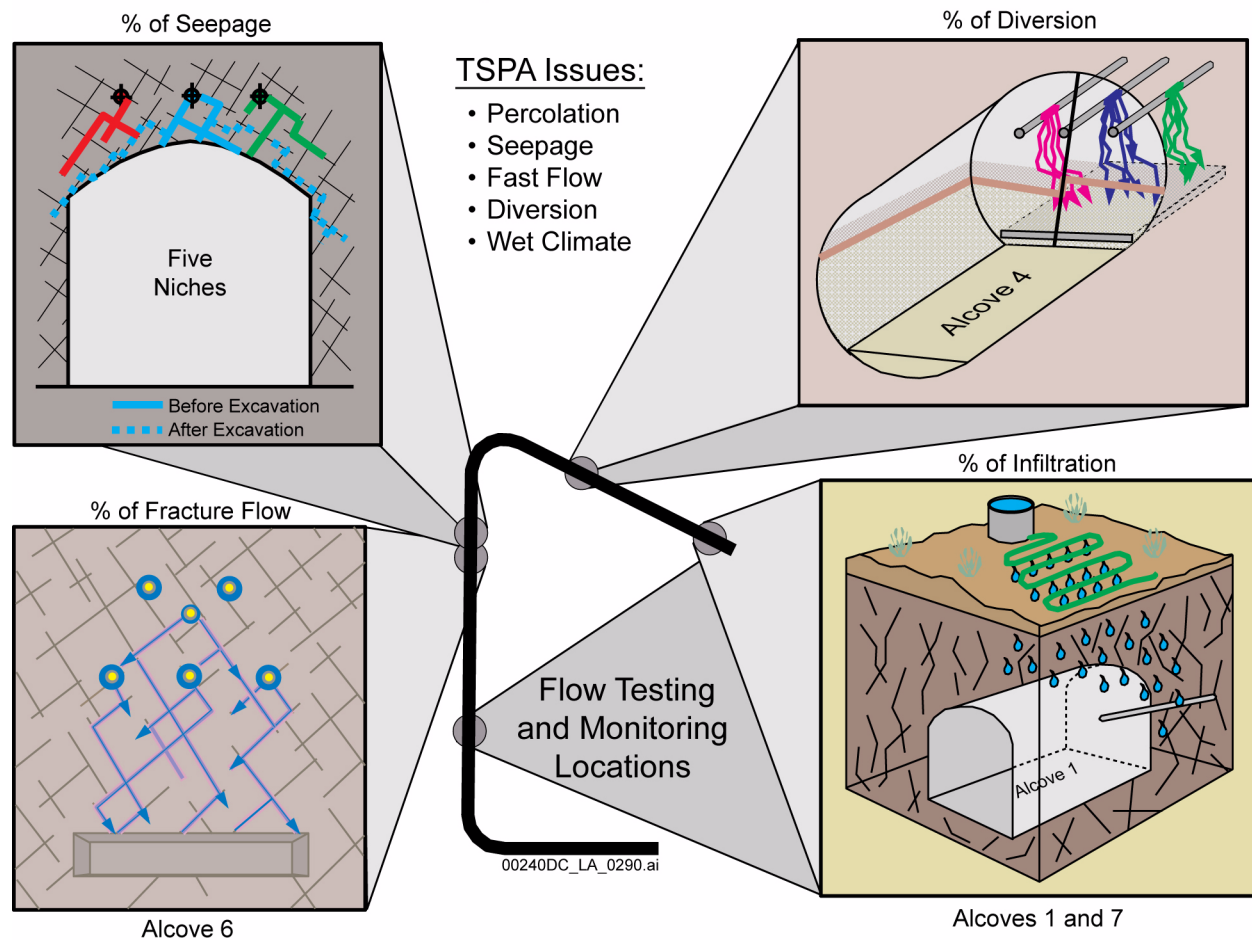
Figure 5-12. Schematic Illustration of Flow Tests in the Exploratory Studies Facility at Yucca Mountain

NOTE: The tests evaluate functional relationships between unsaturated zone processes to resolve TSPA issues. Different colors are used to schematically track the source of the water to its respective release point.

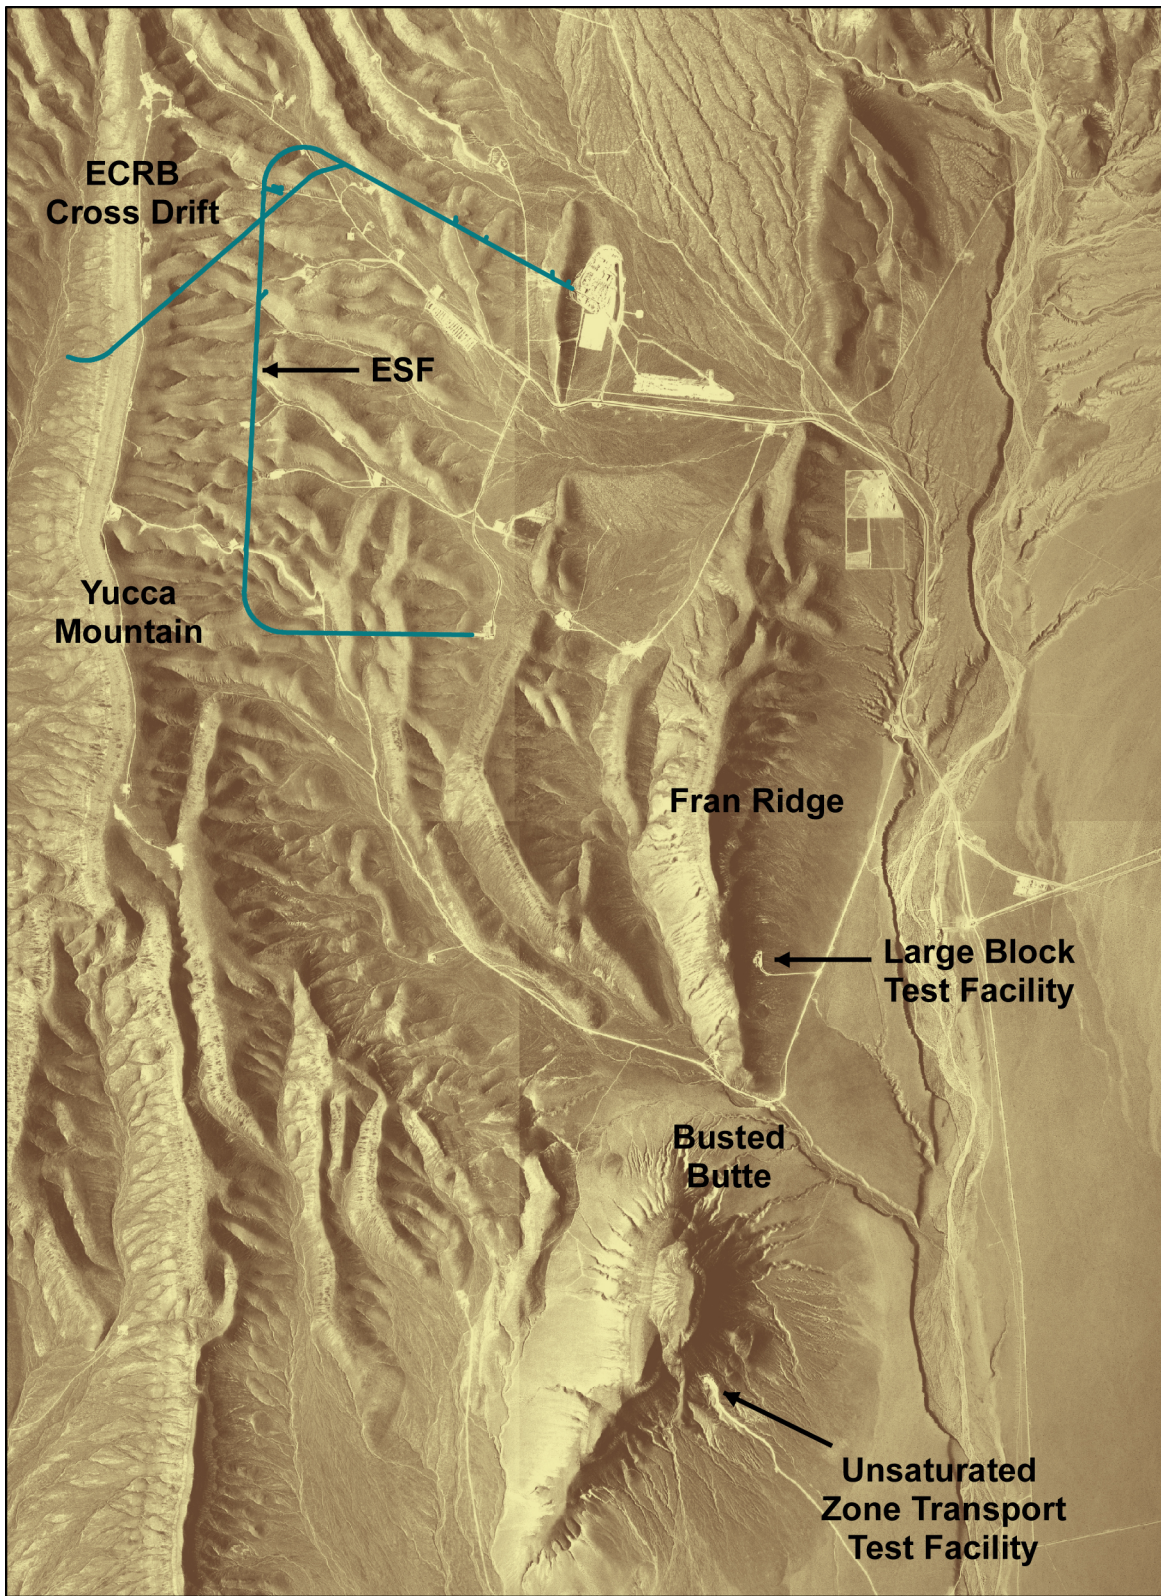
Figure 5-13. Location of the Unsaturated Zone Transport Test at Busted Butte and the Large Block Test on Fran Ridge

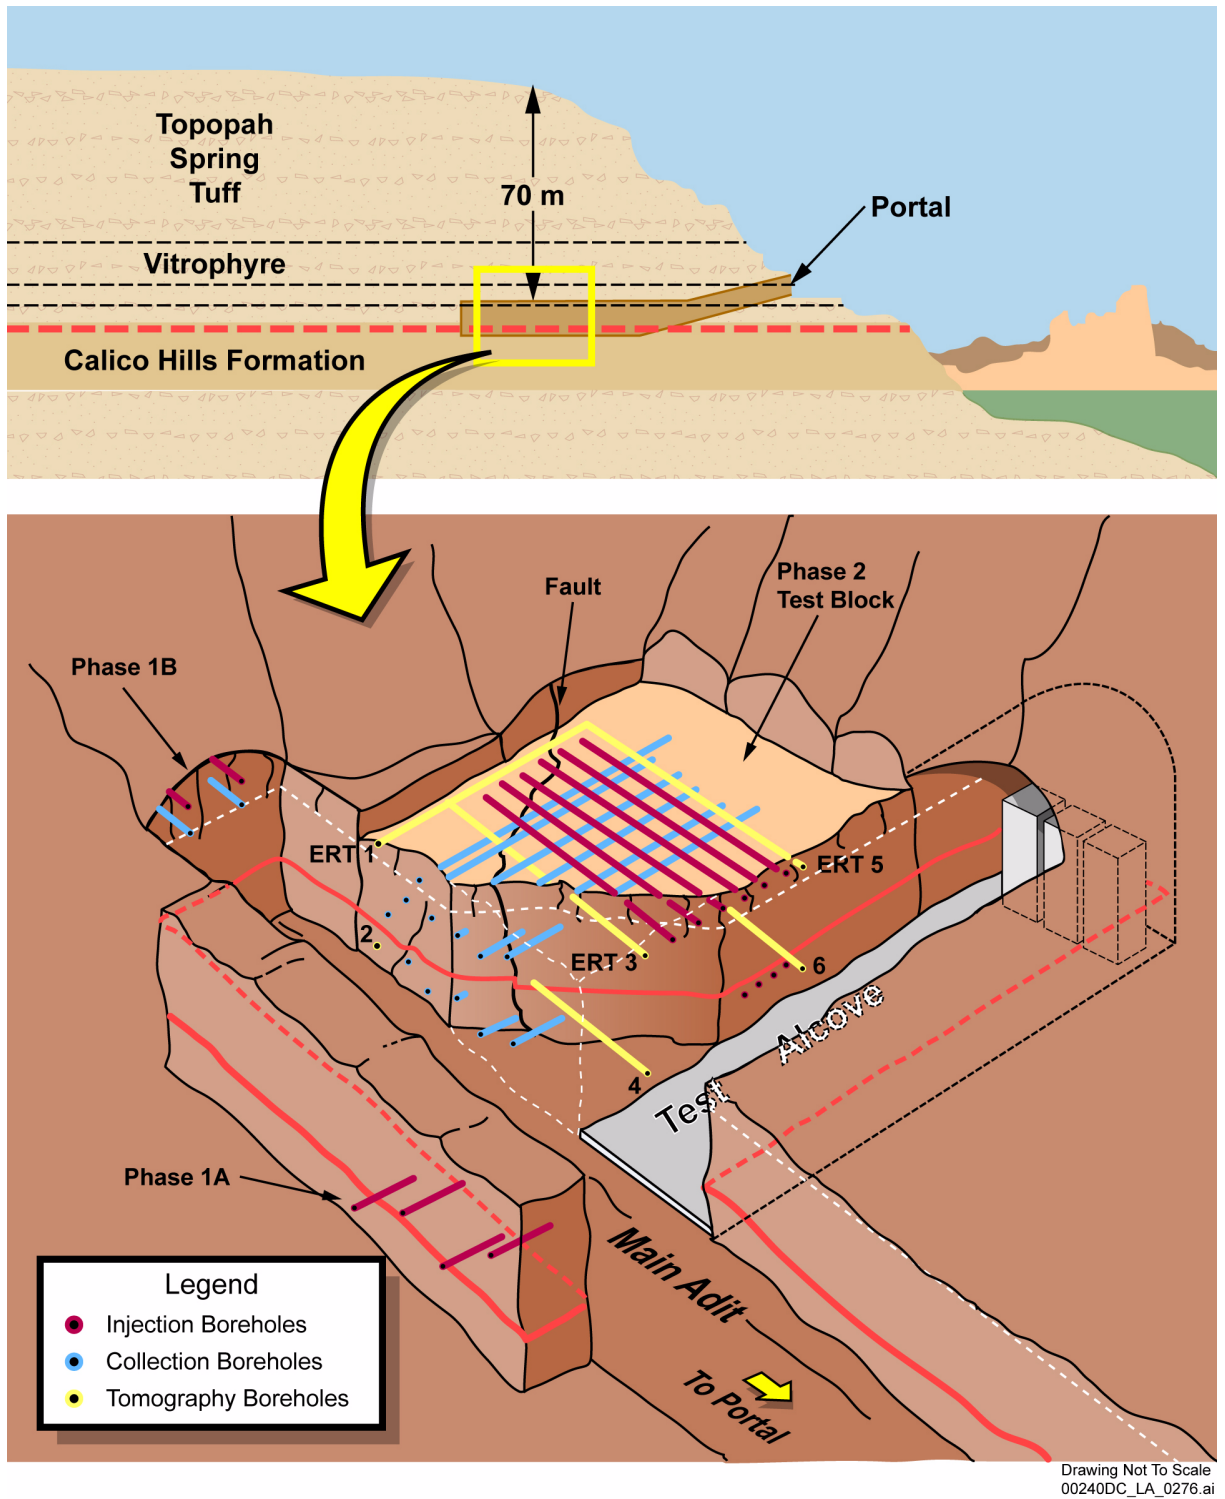
Figure 5-14. Schematic Layout of Busted Butte Unsaturated Zone Transport Test

NOTE: The shows the relative locations of the test's phases and borehole locations. Orange solid and dotted line indicates contact between Tptpv1 and Tac units.  
ERT = electrical resistivity tomography.

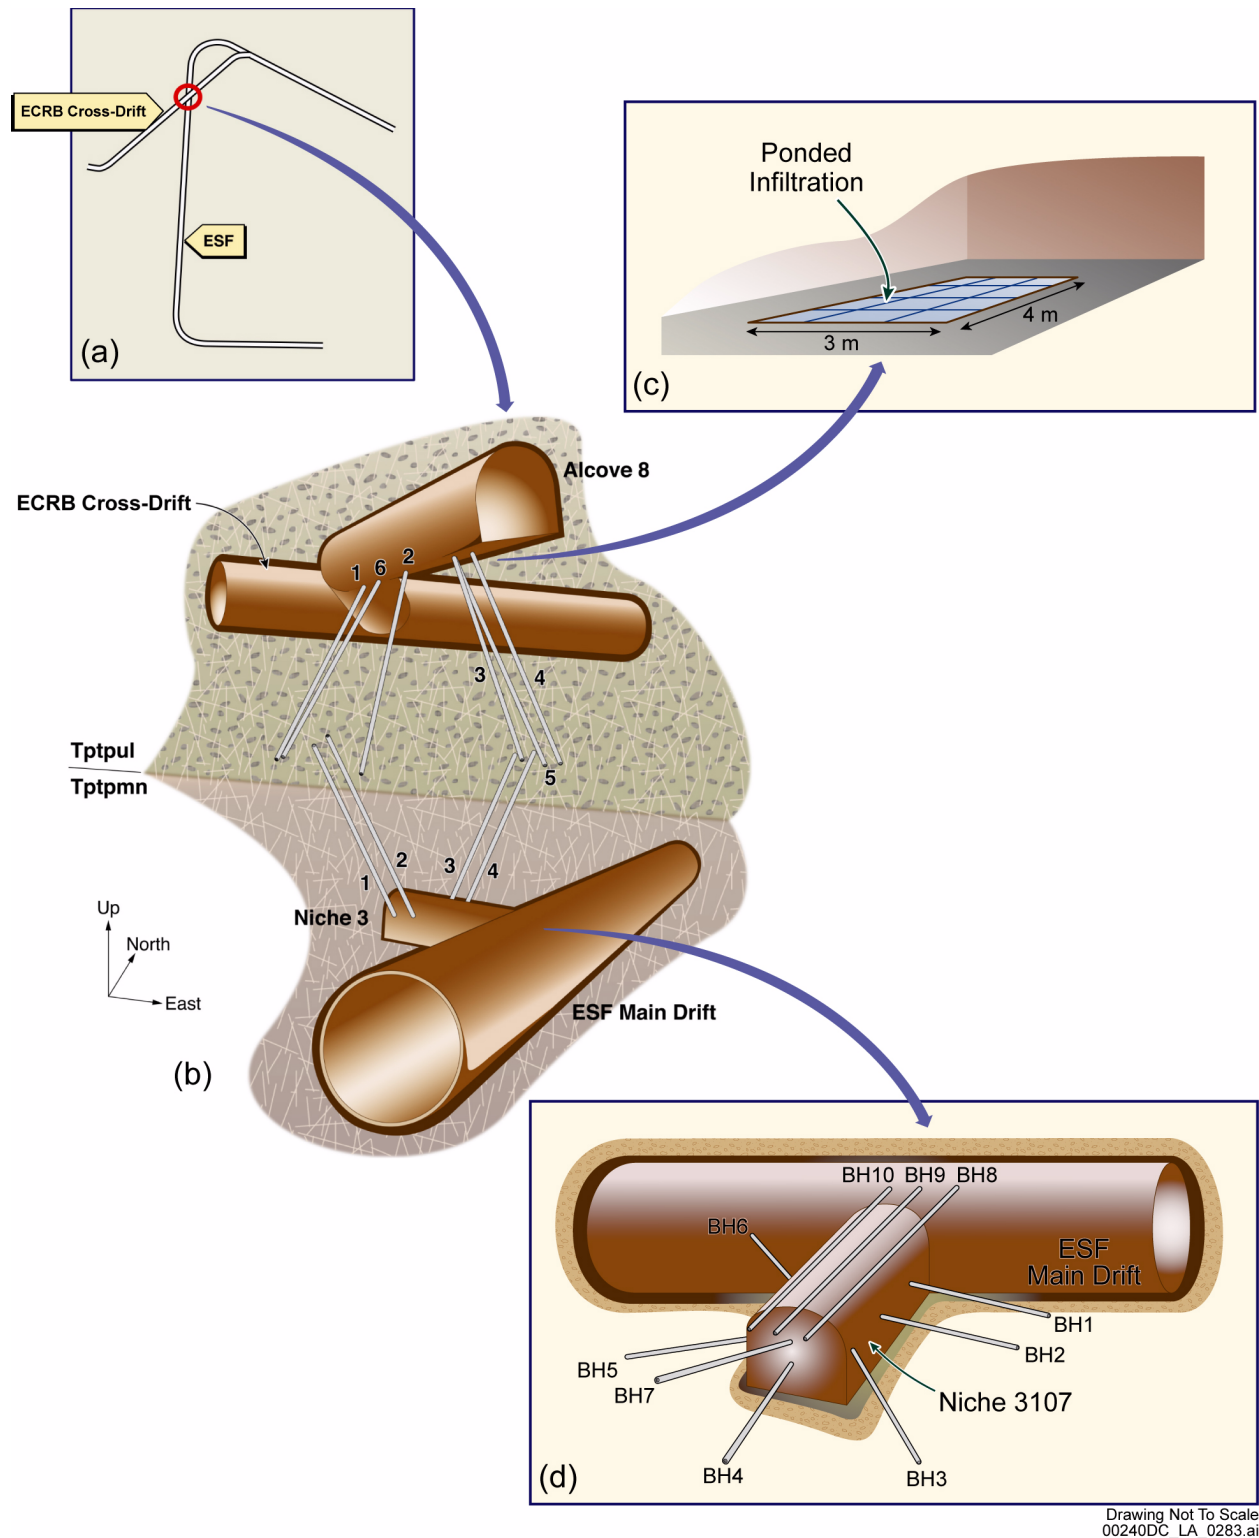
Figure 5-15. Test Bed for the Alcove 8–Niche 3 Tests

NOTE: The ECRB Cross-Drift crosses the ESF at a distance of about 20 m above the ESF (Insert (b)).

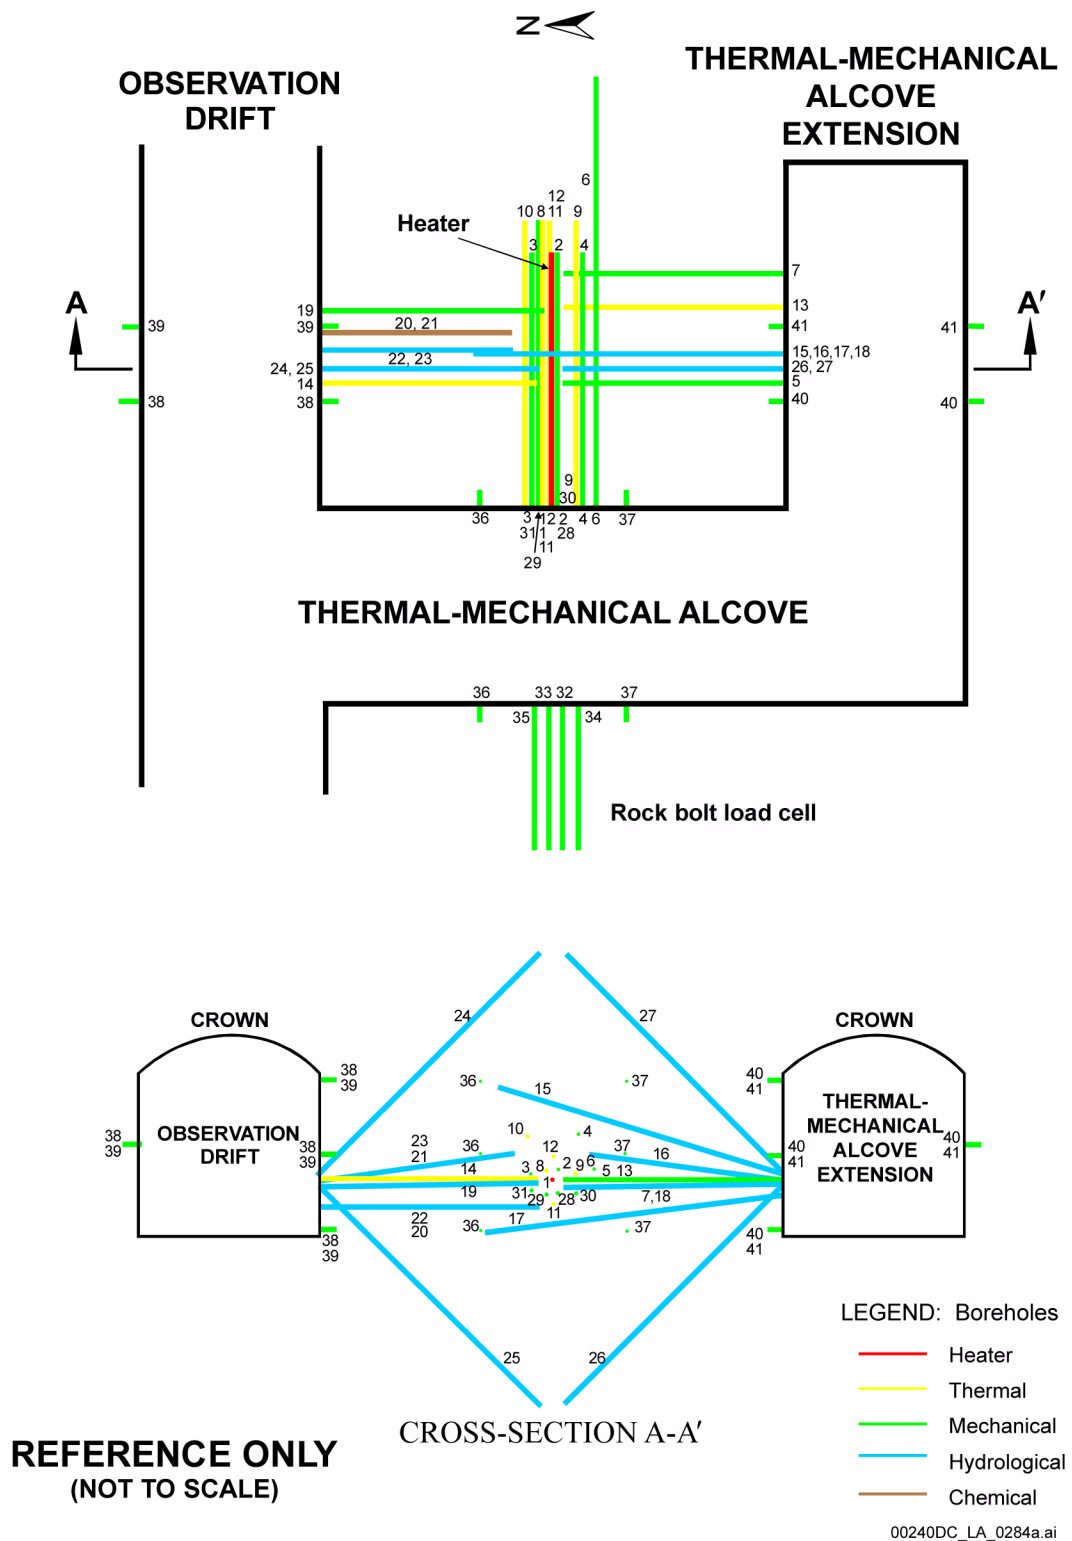
Figure 5-17. Schematic of the Single Heater Test Layout of the Instrumentation Boreholes

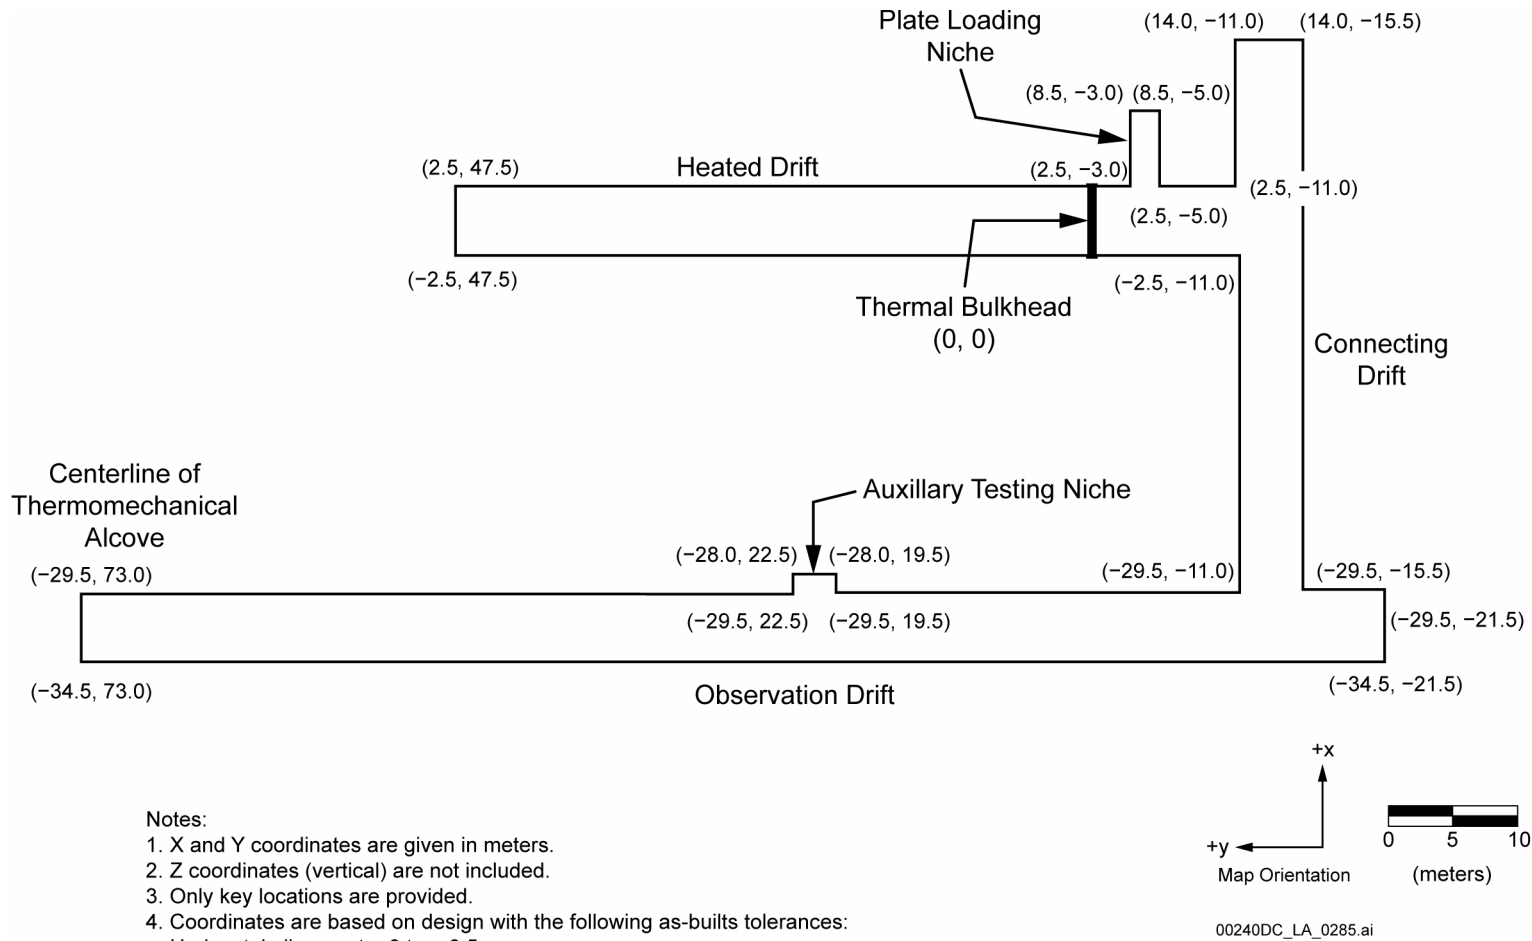
Figure 5-18. Drift Scale Test As-Built Plan View with Two-Dimensional Coordinates of Key Locations

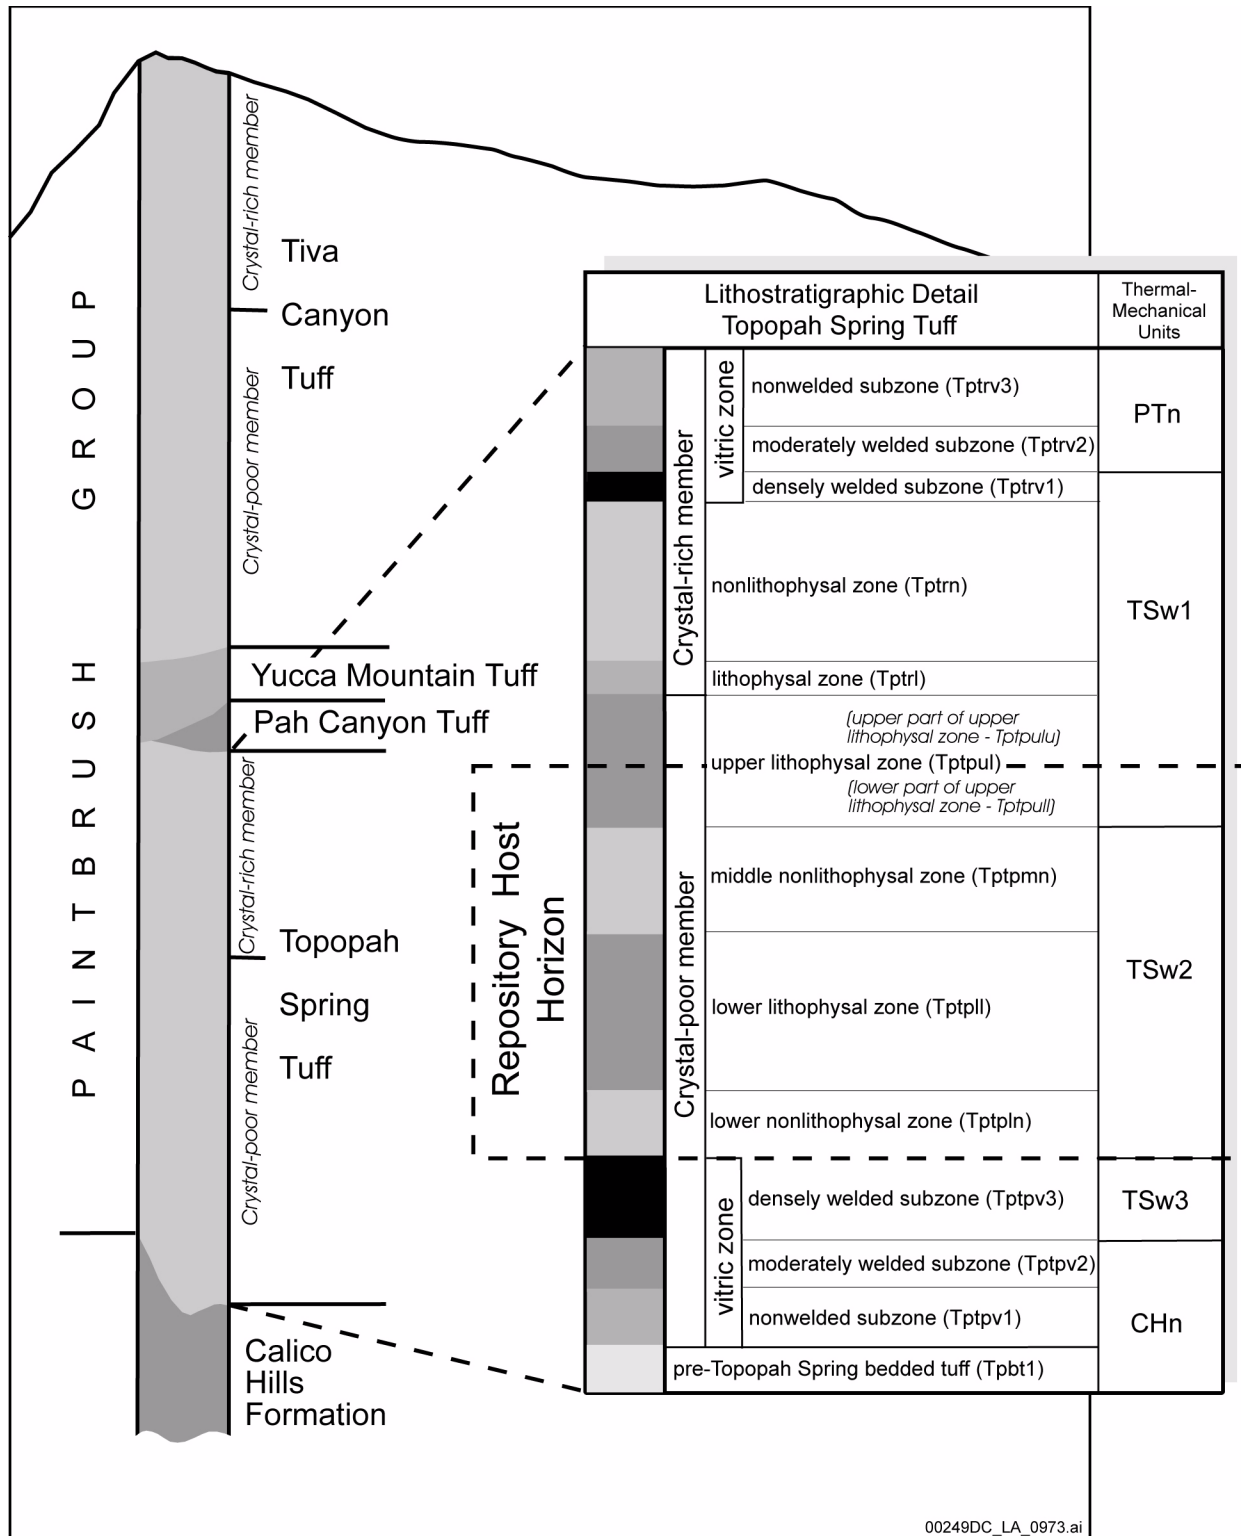
Figure 5-31. Stratigraphic Column with Lithostratigraphic Detail for the Repository Host Horizon

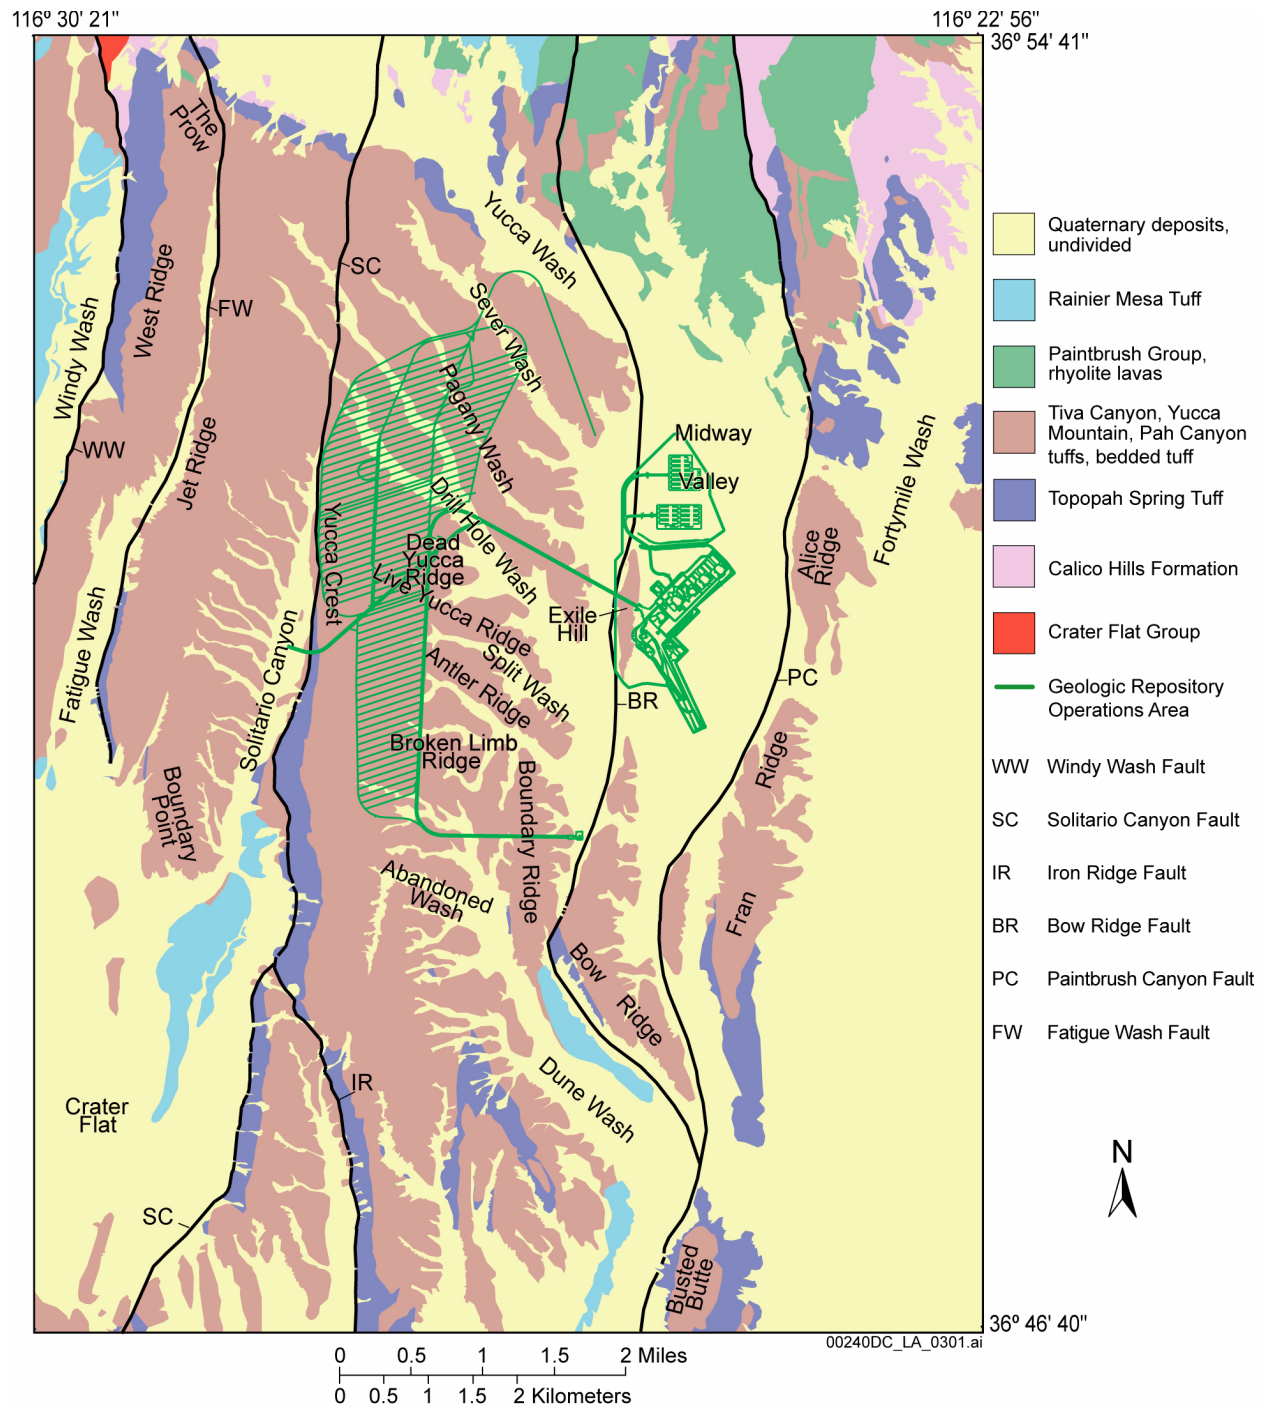
Figure 5-32. Generalized Geologic Map of Yucca Mountain Repository Area

NOTE: Major faults are shown with solid lines, although large segments of some are concealed or inferred beneath Quaternary deposits. The geologic repository operations area is shown for illustration purposes only.

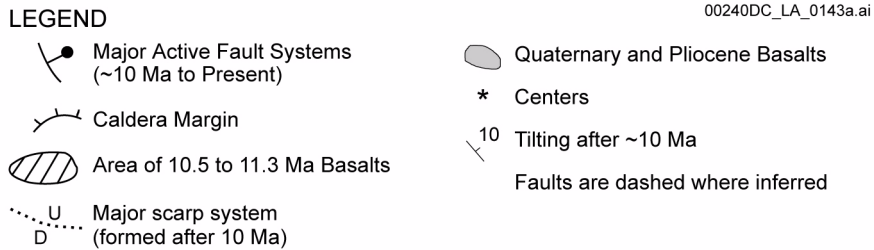
Figure 5-34. Selected Structural Features near Yucca Mountain

NOTE: Bar and ball symbols for faults are shown on downthrown side. Areal extent of 10.5 and 11.3 Ma basalts in southwestern Crater Flat is uncertain.

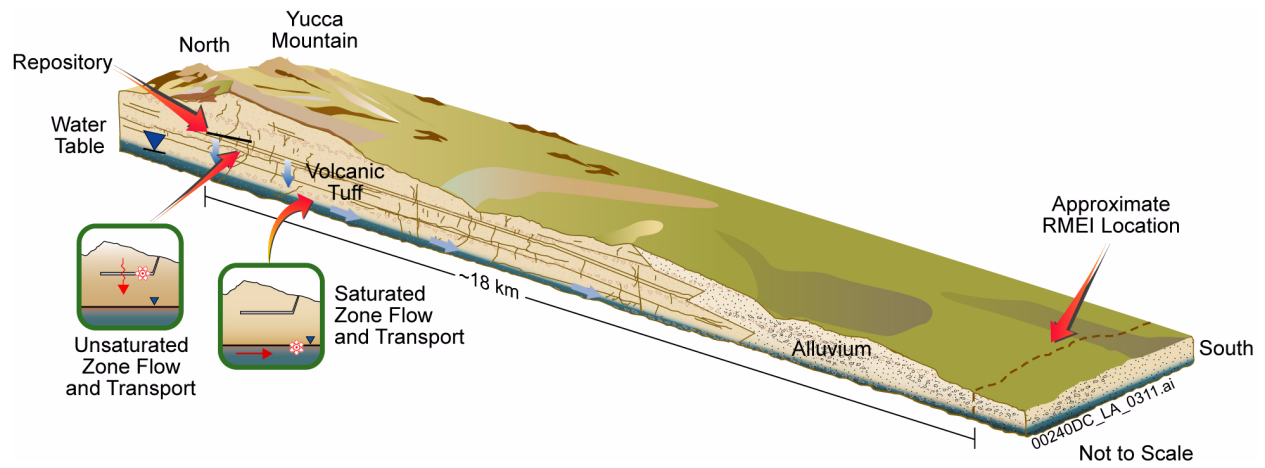
Figure 5-39. Schematic Showing Conceptual Flow Path From the Repository to the Accessible Environment

NOTE: The approximate RMEI location is the southern-most edge of the controlled area at 36°40'13.6661" North latitude. This is approximately 18 km south of the repository along the predominant direction of groundwater flow.

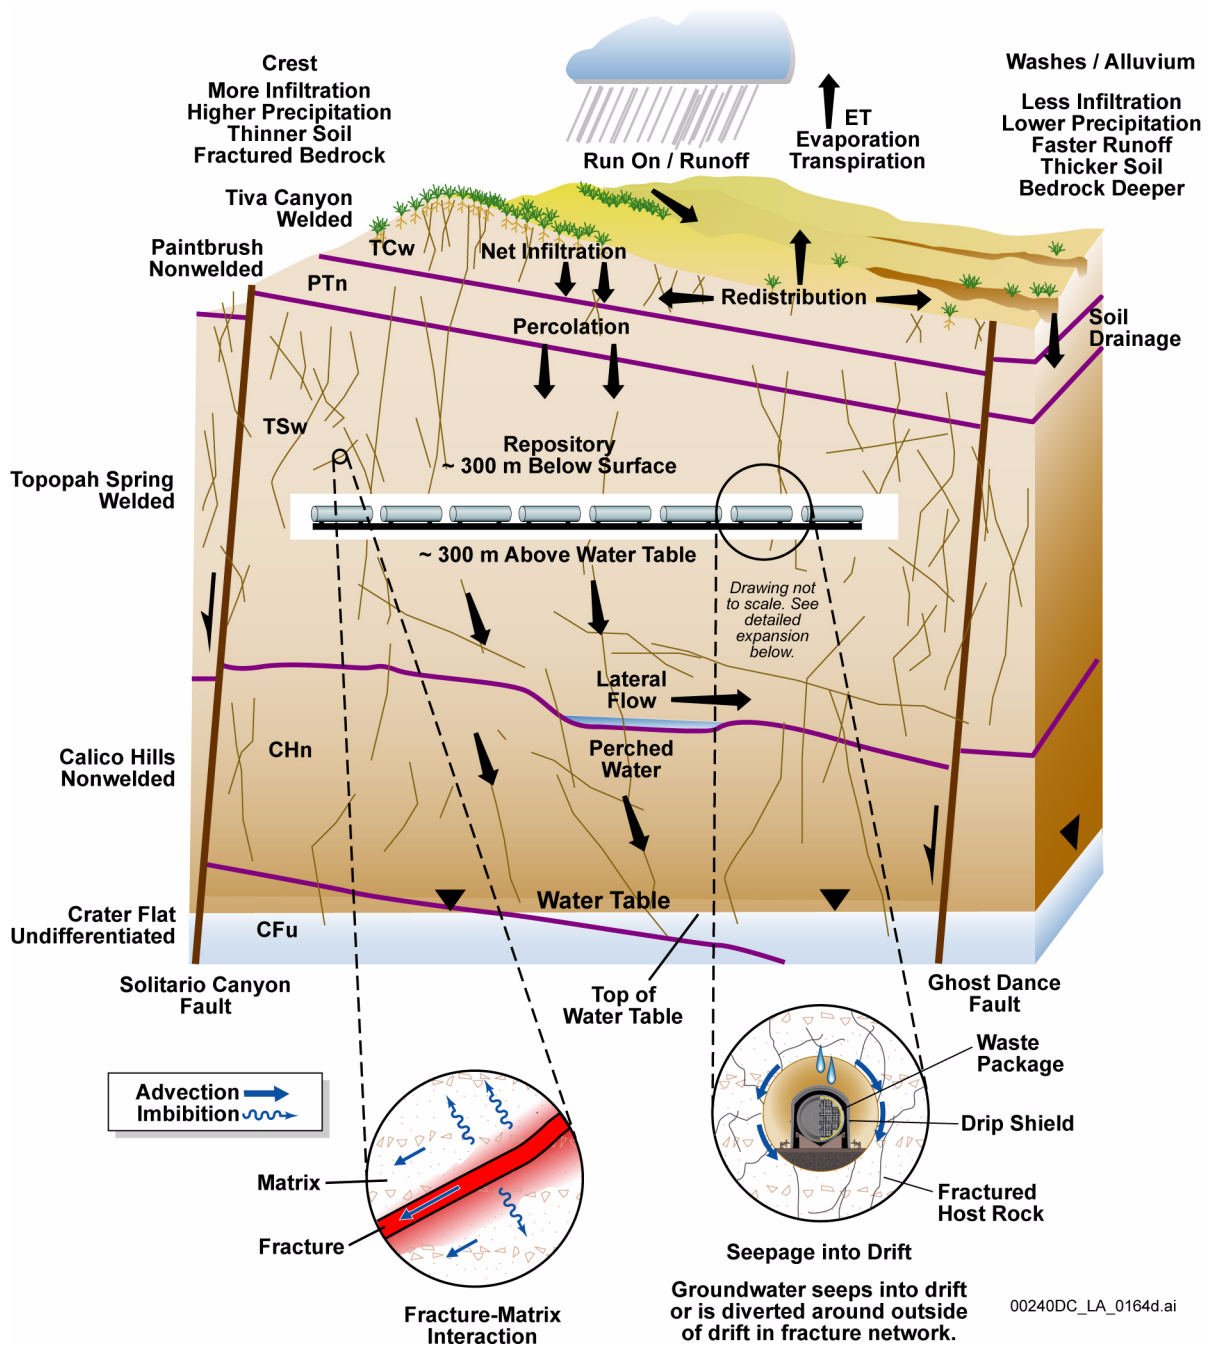
Figure 5-40. Conceptual Drawing of Unsaturated Zone Flow Processes
