ATTACHMENT 4

UNIT 1 – AREA WALK-BY CHECKLISTS

NO. SNCV061-RPT-01

Area Walk-By Checklist (AWC)

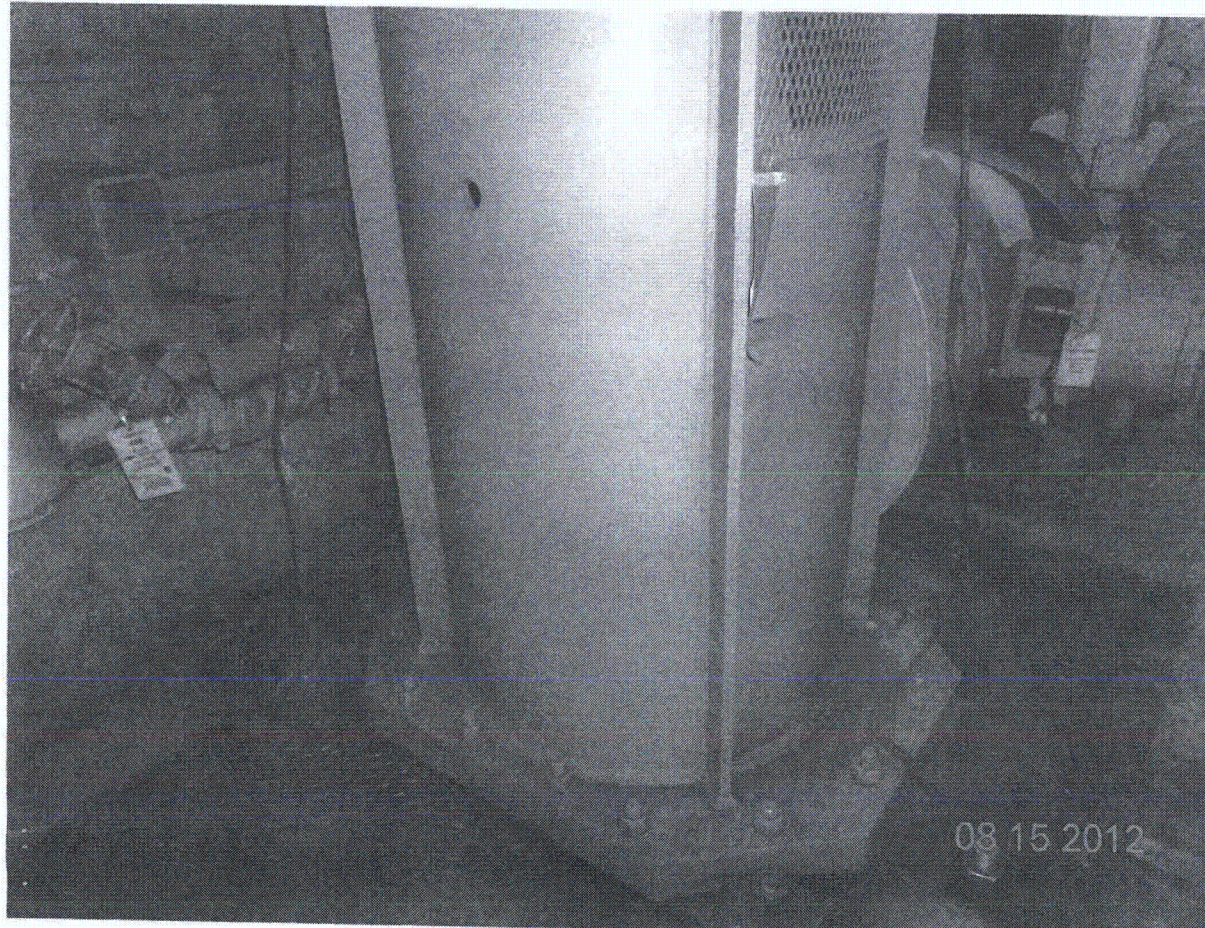
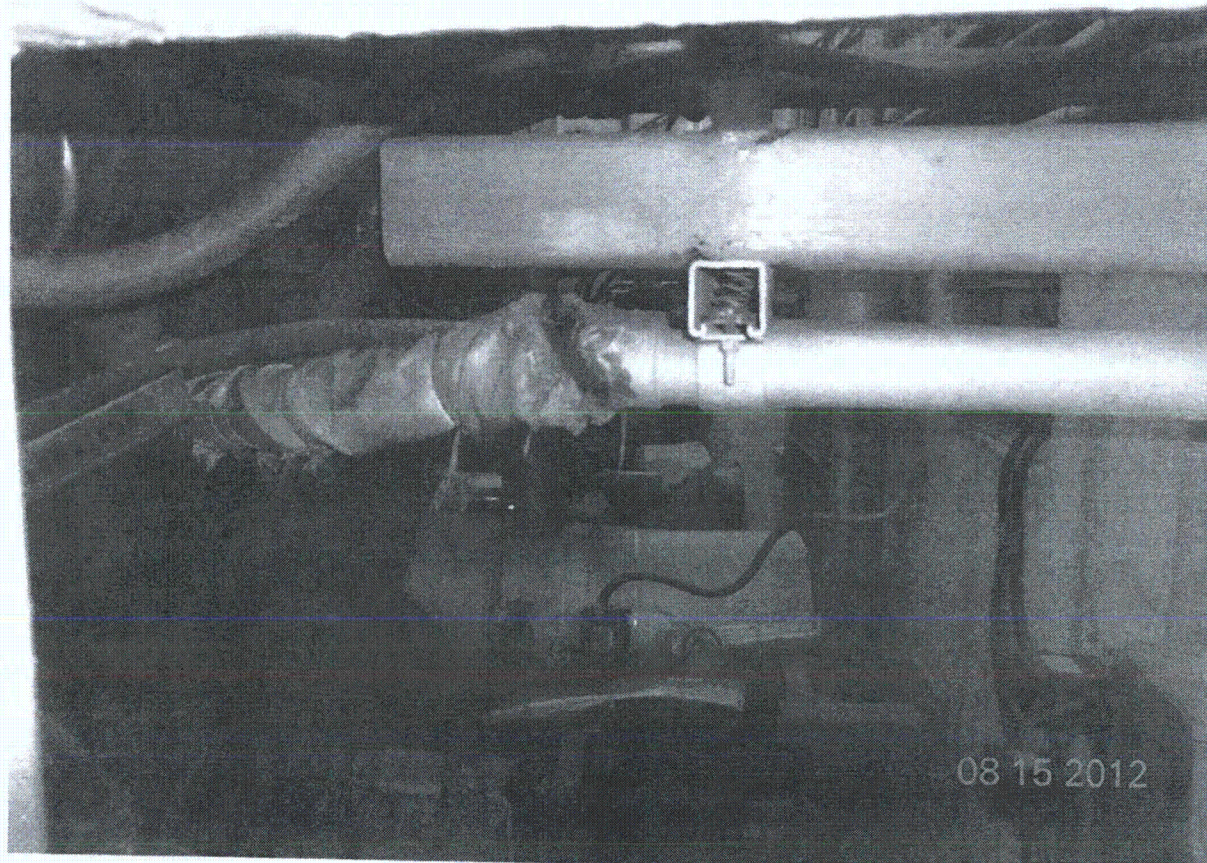
*OVERHEAD VALVE SHOWS MINOR/MODERATE CORROSION
NOT A SEISMIC CONCERN*

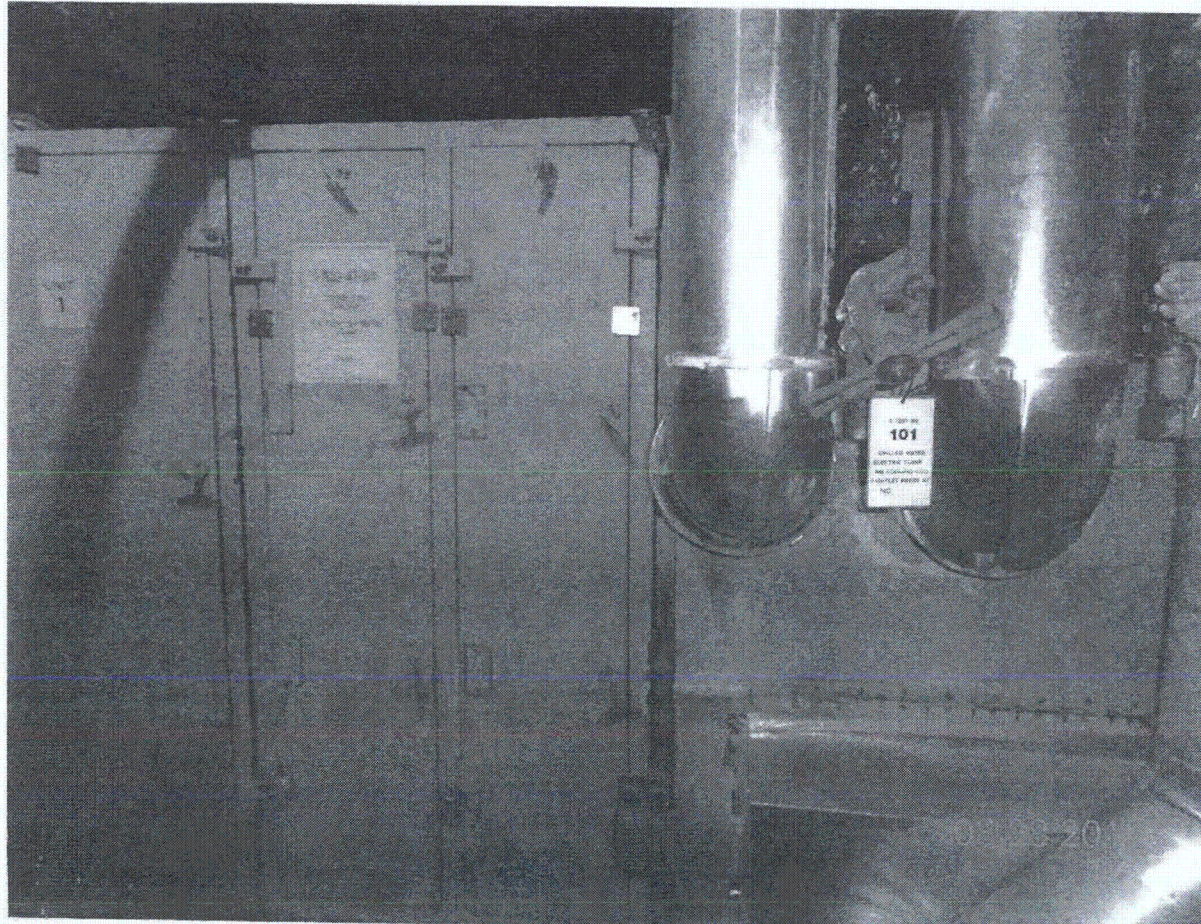
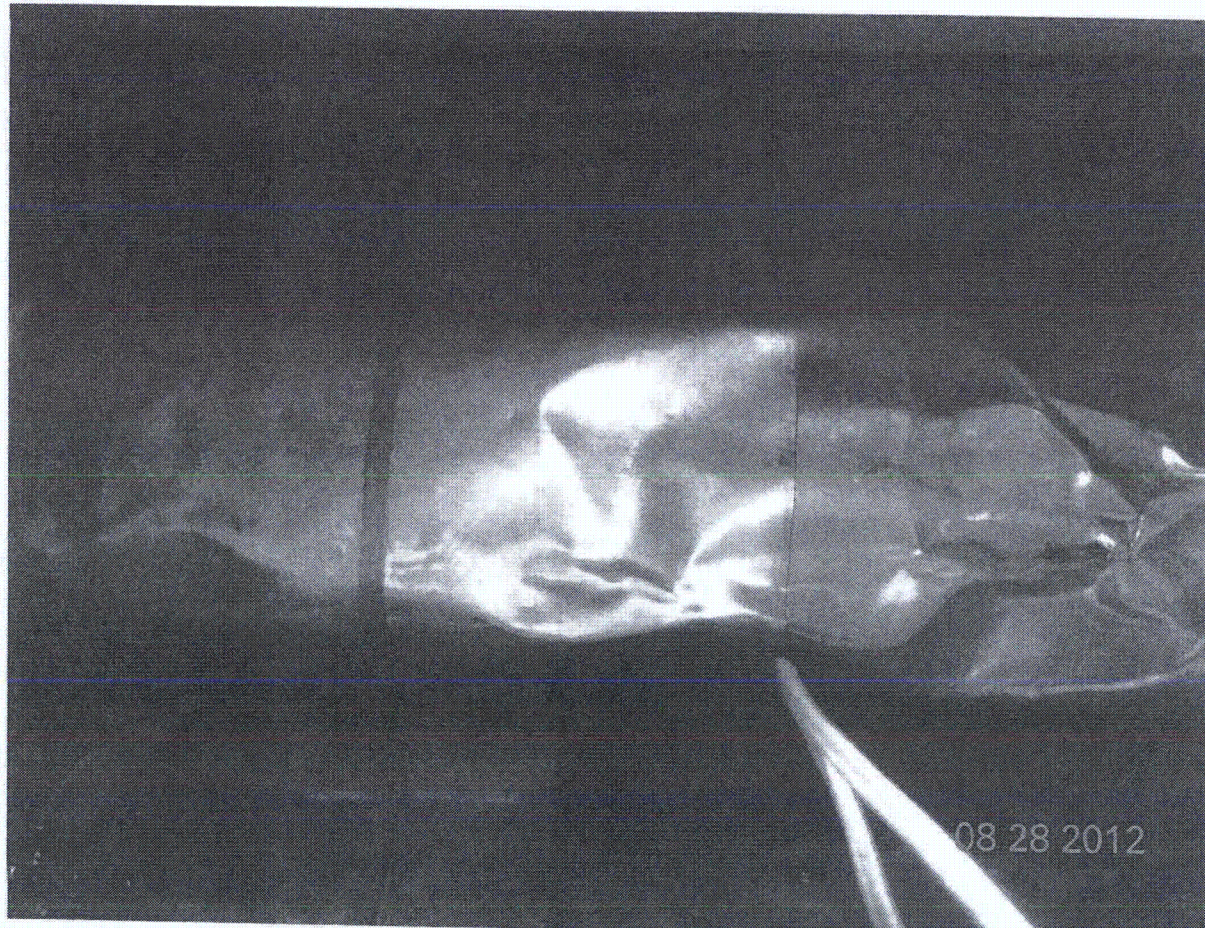
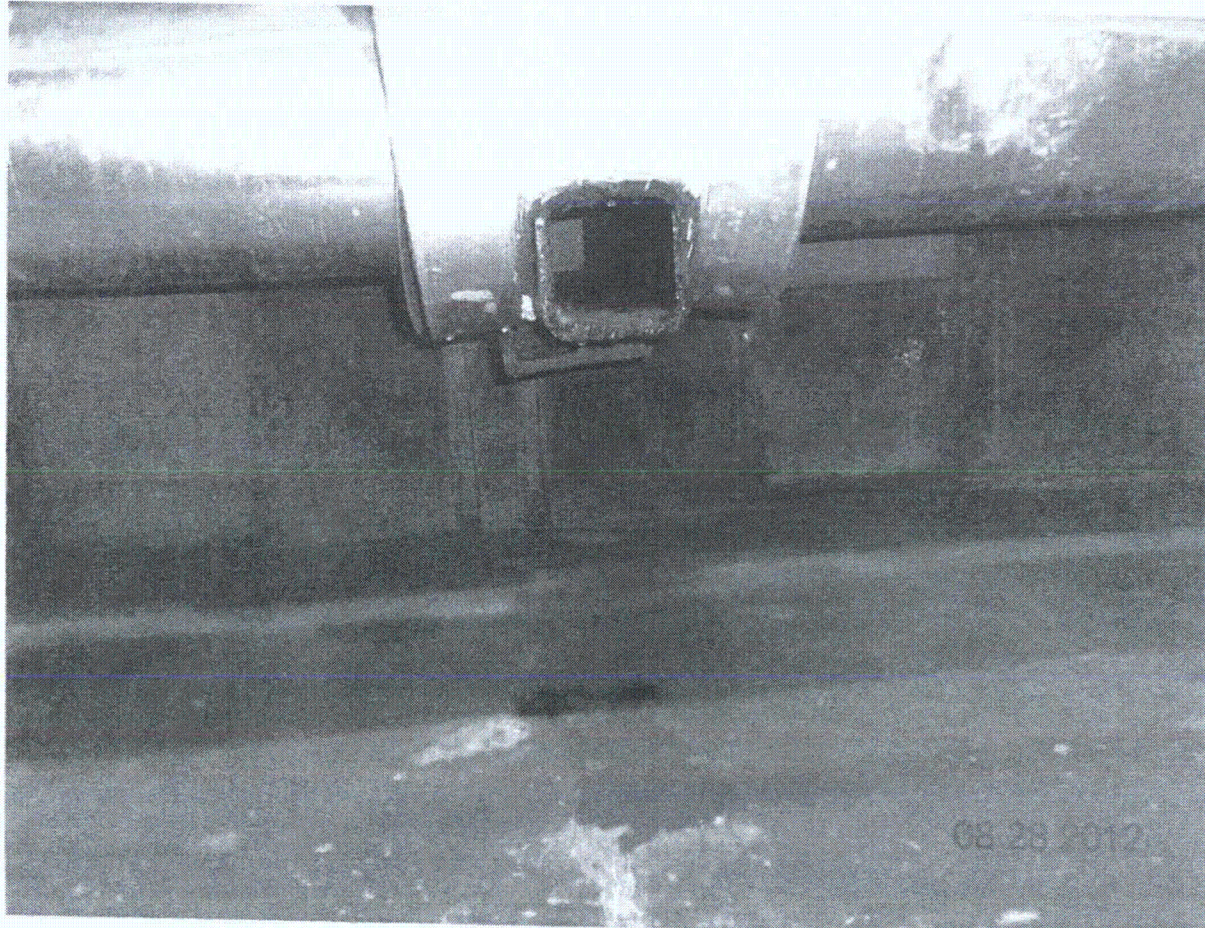
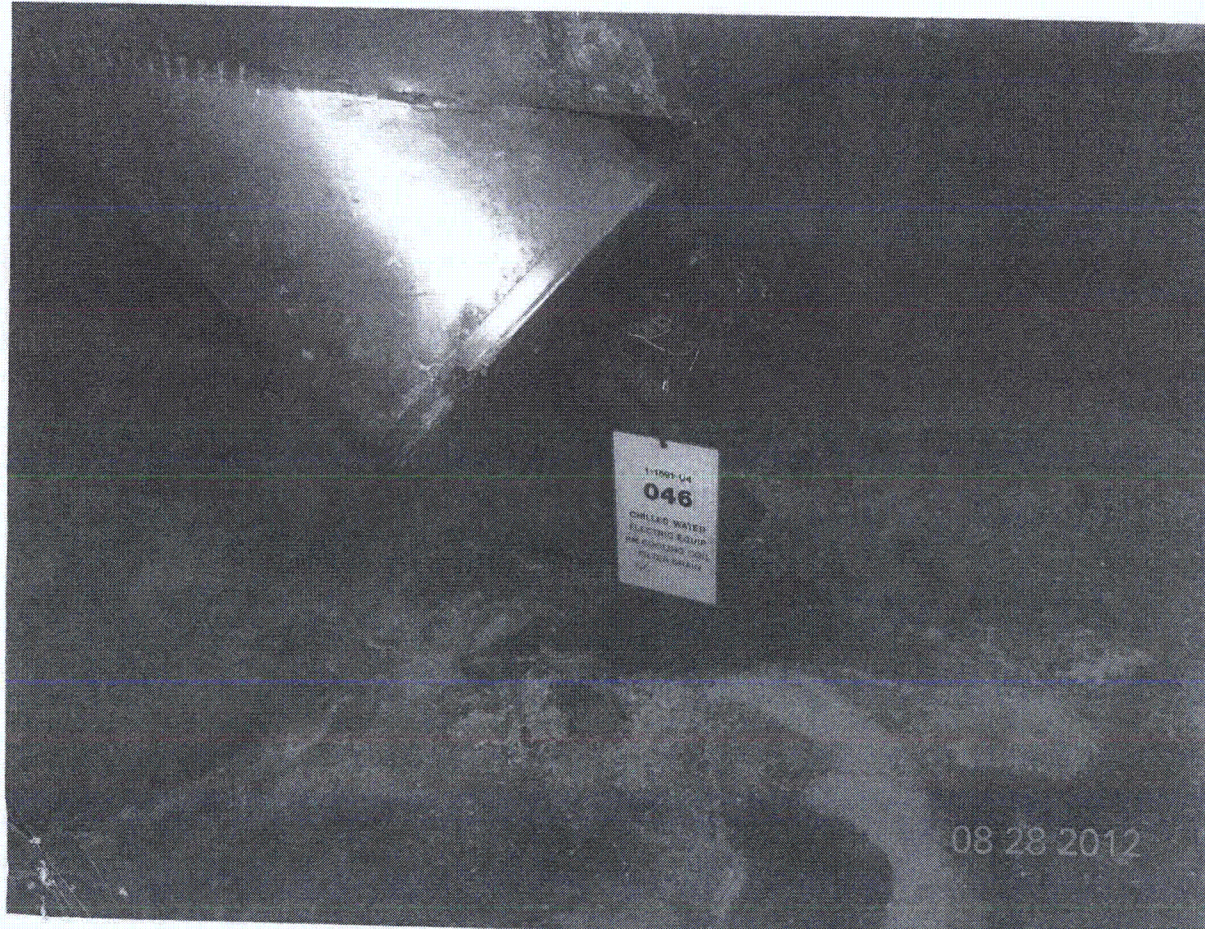
2. Does anchorage of equipment in the area appear to be free of significant degraded conditions? Y N U N/A
See comment

CR 509142
Hanger V-1591-027-H006 TB corrosion & Drain Valve
I-1591-04-046 corrosion under CR 509138 tracking
for further evaluation/action.
