**Area Walk-By Checklist (AWC)**

Location: Bldg. CB Floor El. 240'-0" Room, Area<sup>13</sup> R230

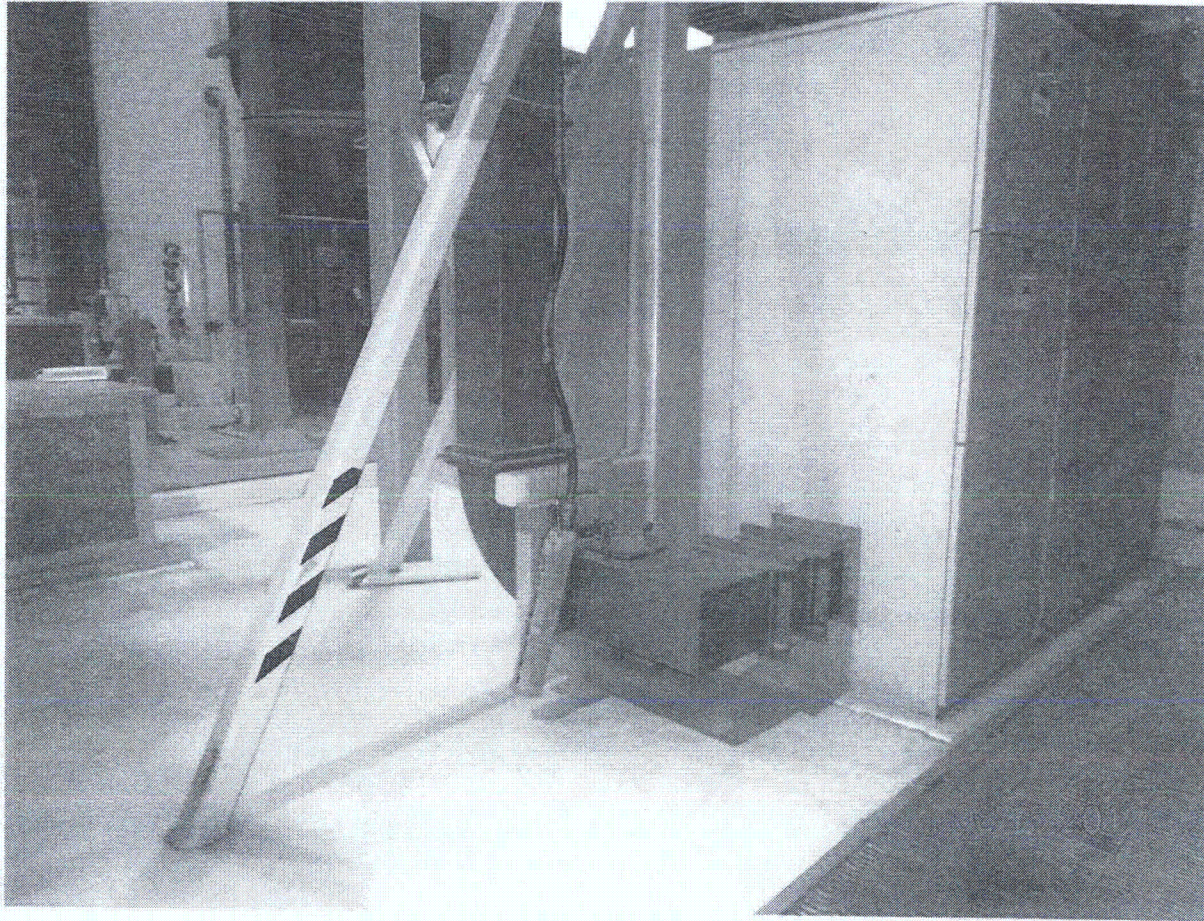
*Floor grating near Engine Control Panel Diesel Generator 1B (1-2403-PS-064) is not bolted down. The grating is also slightly bent. This is not a seismic/structural concern based on the configuration (shape) and location of the cover. - CR 502522.*
