F2-65	Sheet 1 of 2/2 Status: Y N U
Area Walk-By Checklist (AWC)	
Location: Bldg. Aux Bldg Floor El, 100' Room, Area 2192	
Instructions for Completing Checklist	
This checklist may be used to document the results of the Area Walk-By near on space below each of the following questions may be used to record the results of Additional space is provided at the end of this checklist for documenting other co	judgments and findings.

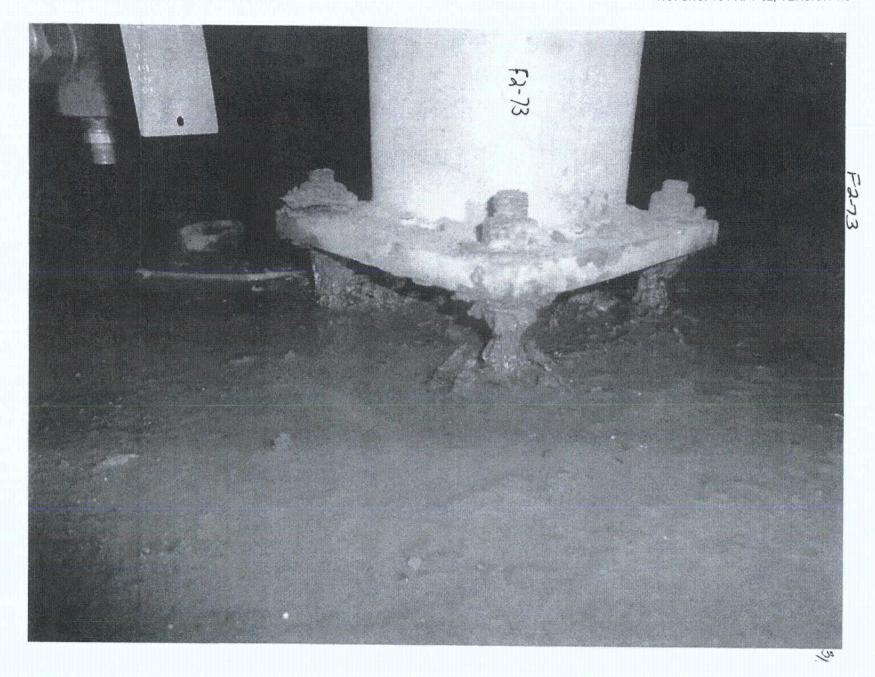
Page 72 of 143

8. Have you looked for and found no other seismic conditions that could adversely affect the safety functions of the equipment in the area?	YO NO UO
Comments (Additional pages may be added as necessary) Train B - Q2P16V514, Q2P16V516 CR 515556 was written to document covide in	
Evaluated by: famia Maclay Laura Maclay	Date: 9/11/12

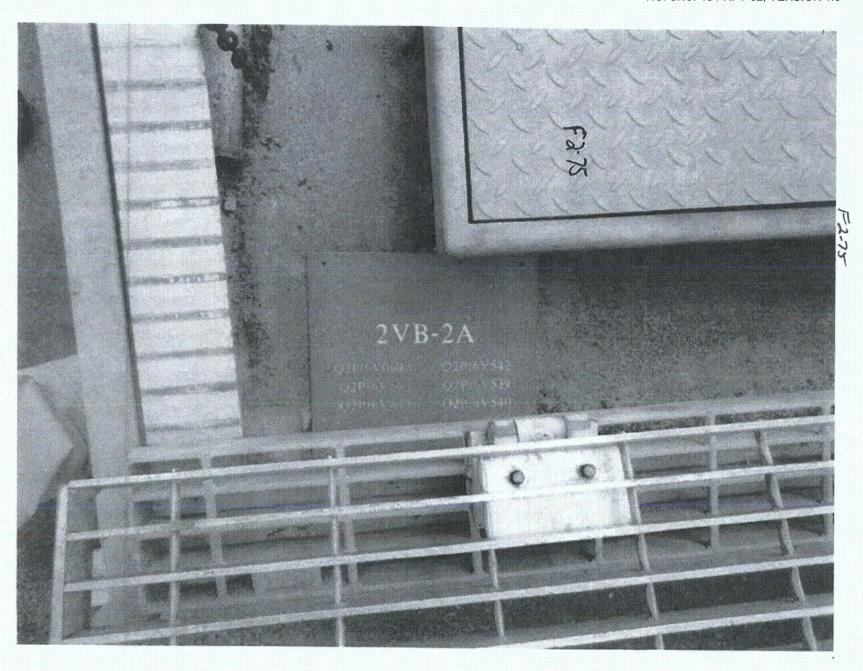
Page 77 of 143

8. Have you looked for and found no other seismic conditions that could adversely affect the safety functions of the equipment in the area?	YŒ N□ U□
Comments (Additional pages may be added as necessary) Train A - Q2P 16V539	
Evaluated by: Laura Maclay Laura Maclay Laura Maclay Laura Maclay Laura Maclay	Date: 8 27-12

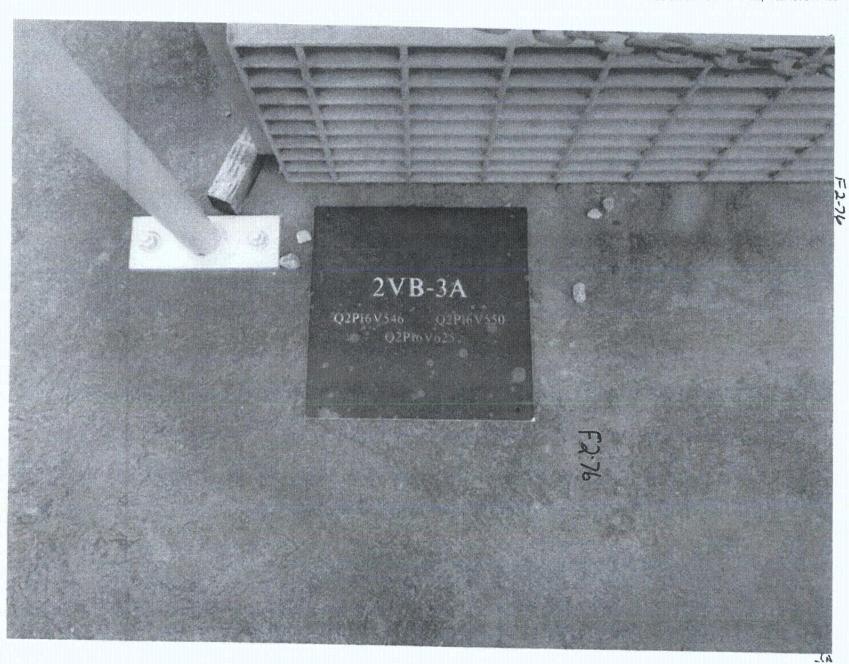
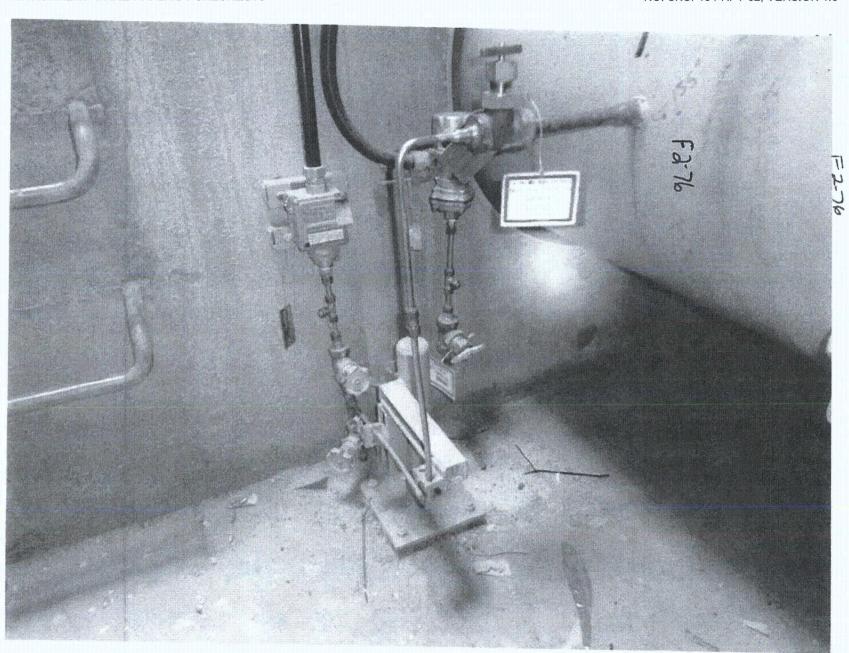
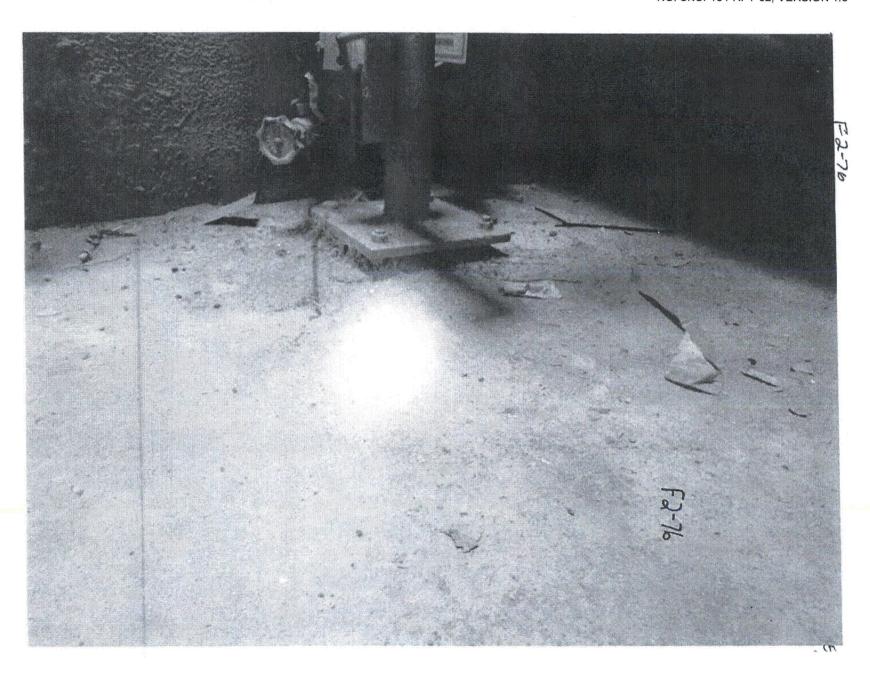
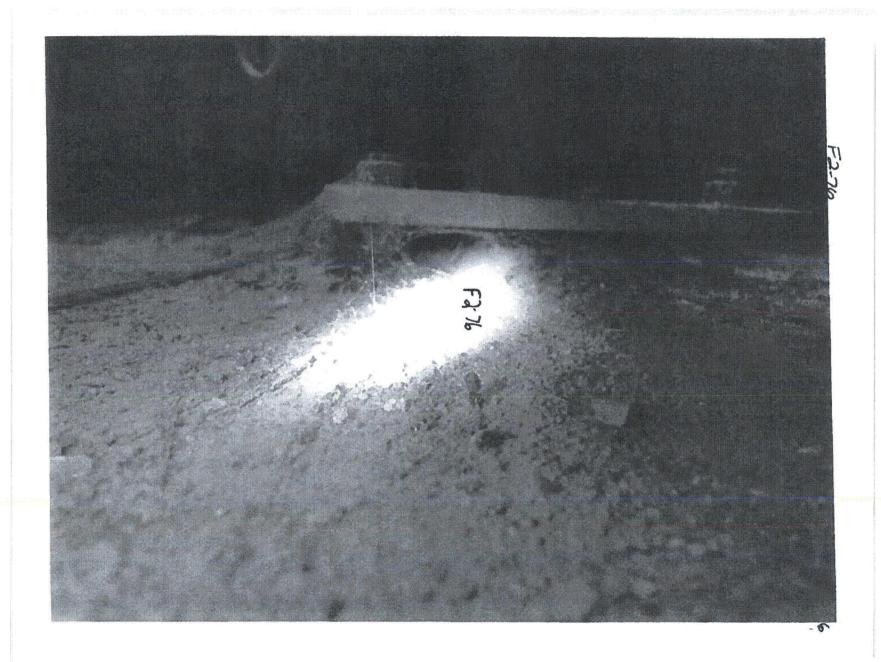
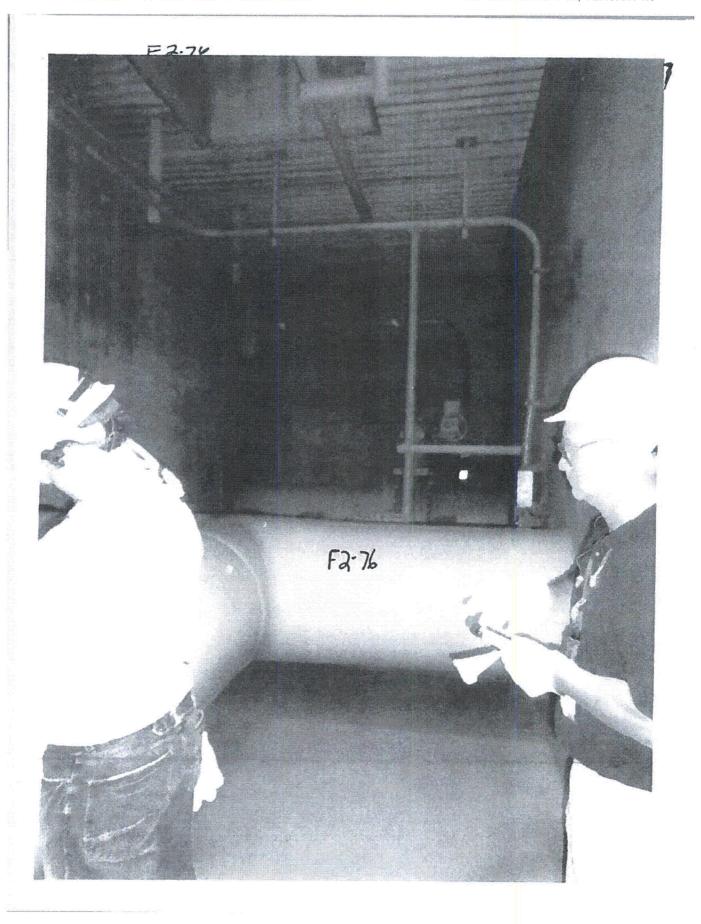
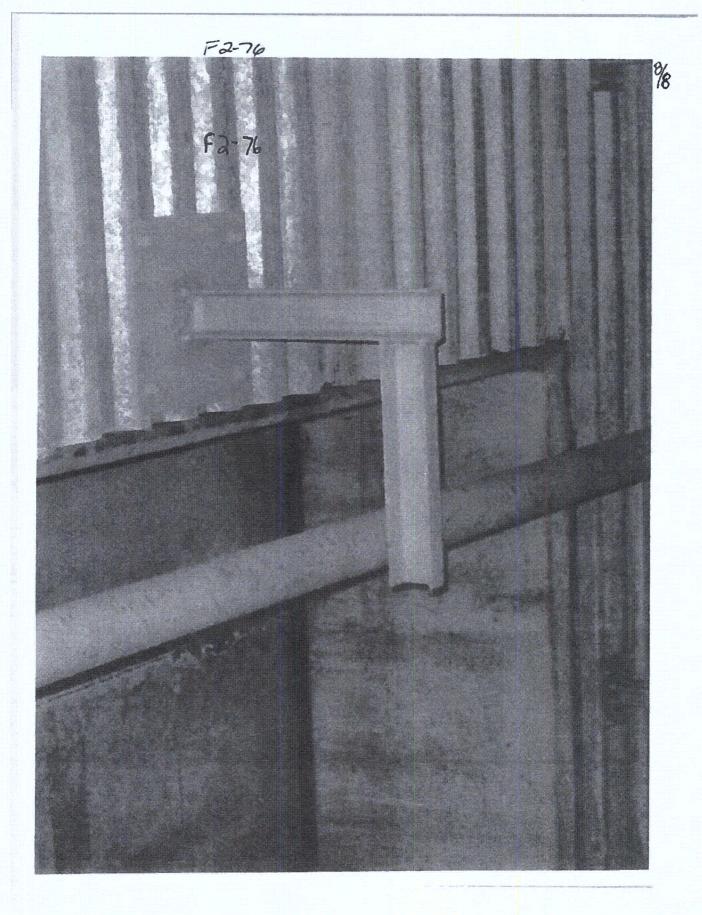
1. Does anchorage of equipment in the area appear to be free of potentially adverse seismic conditions (if visible without necessarily opening cabinets)? An instrumentation support the fixet for ID 02PI&PSO&B3 is missing grout under the gap is approx. I" and a ce was writter issue. The instrumentation being supported. 2. Does anchorage of equipment in the area appear to be free of significant degraded conditions?	the base plate. I to address the I is lightweight and therefore

be seismically adequate. ref CR504922 TAM IIJIII/2012

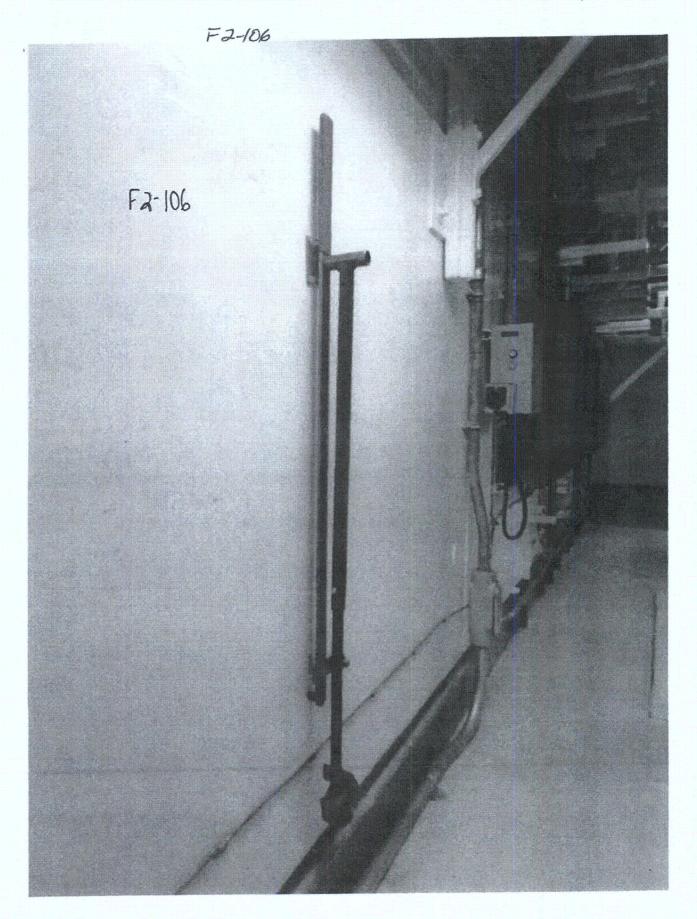
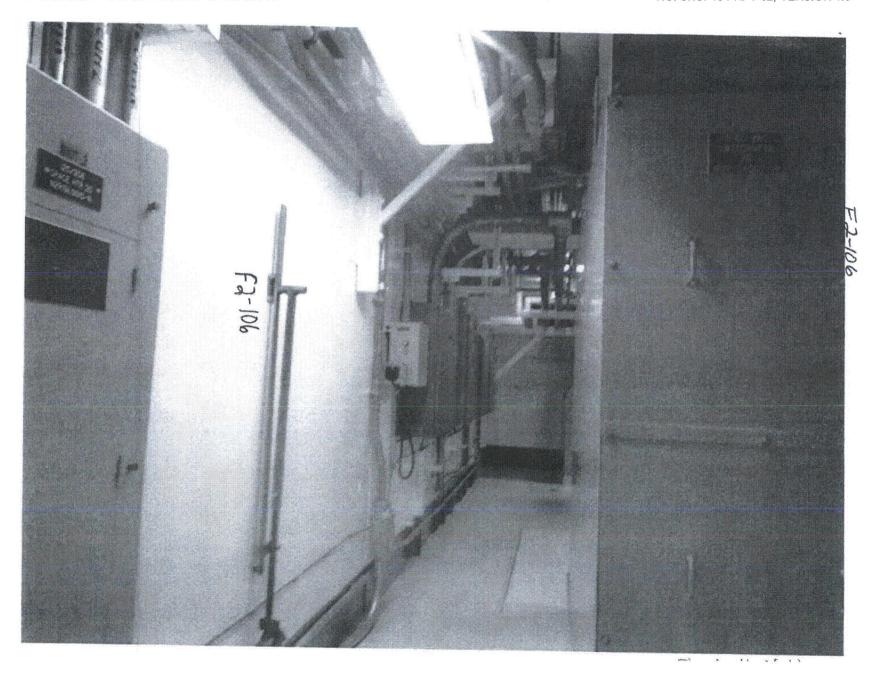
4. Does it appear that the area is free of potentially adverse seismic spatial interactions with other equipment in the area (e.g., ceiling tiles and lighting)? Two room lights had one missing screw each (out of four) where the light is attached to the light junction box. The light fixtures are light weight components and three screws are sufficient to hold the fixtures. Thus, there is no seismic interaction concern. A corrective action report was issued to replace these missing screws. (CR 506 252)	YM NO UO NIAO
en e	ng na ji Ng Ar na
