# **Electrical Cable Test Results and Analysis During Fire Exposure (ELECTRA-FIRE)**

**A Consolidation of Three Major  
Fire-Induced Circuit and Cable  
Failure Experiments Performed  
Between 2001 and 2011**

Final Report

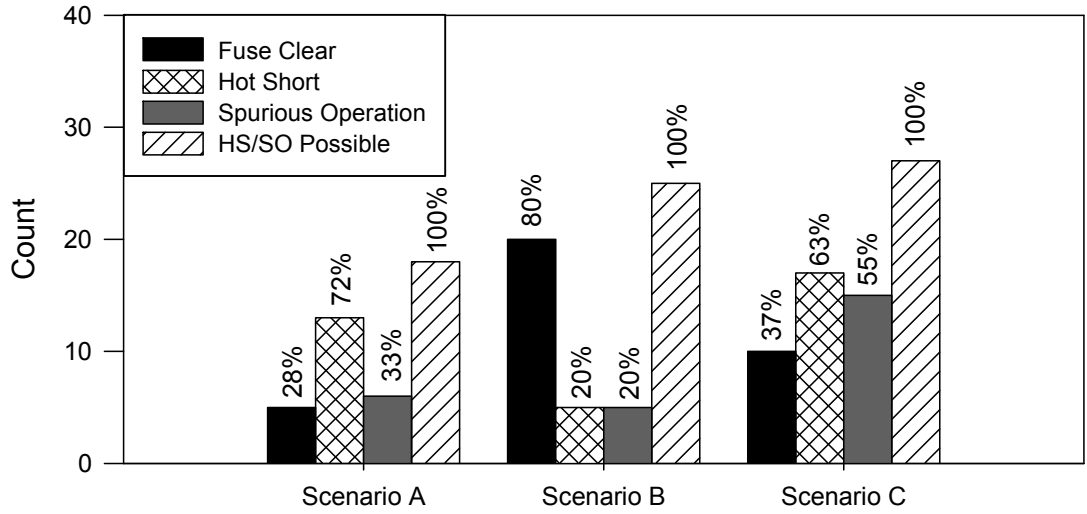
Scenario A	Scenario B	Scenario C
Fuse Clear	5	20	10
Hot Short	13	5	17
Spurious Operation	6	5	15
HS/SO Possible	18	25	27

Figure 1-1. Examples global approach failure mode column plot

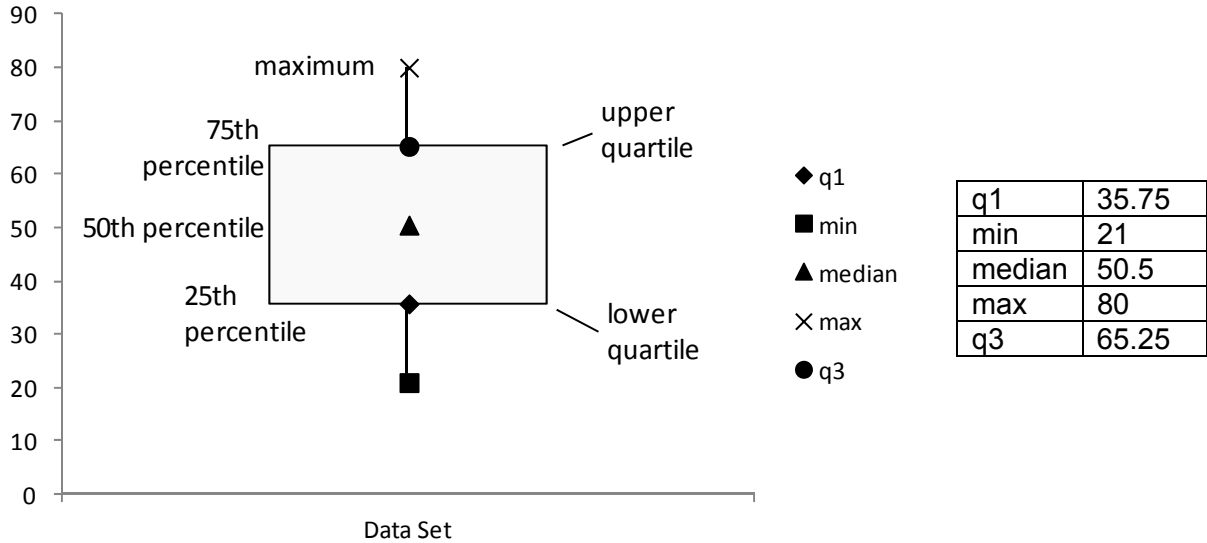
To provide a realistic and simple graphical representation of the duration data set, this report provides hot short and spurious operation duration box plots, also known as box and whisker plots. An example of a box and whisker plot is provided in Figure 1-2. The example data set used to prepare this example plot is a continuous set of integers ranging from 21 to 80.

Figure 1-2. Box and whisker plot example

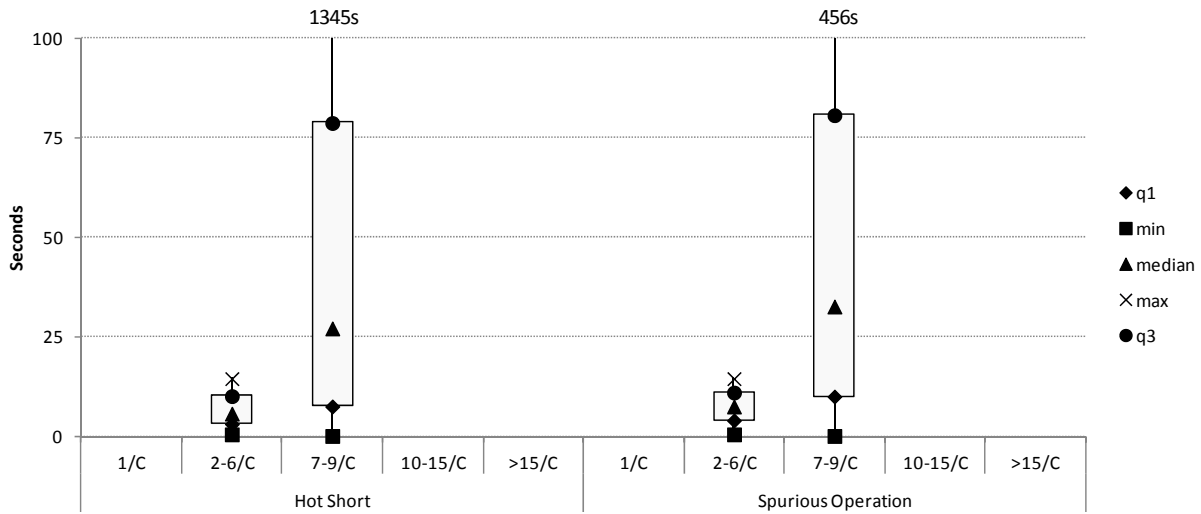
Hot Short					Spurious Operation				
	1/C	2-6/C	7-9/C	10-15/C	>15/C	1/C	2-6/C	7-9/C	10-15/C	>15/C
q1	-	3	8	-	-	-	4	10	-	-
min	-	1	1	-	-	-	1	1	-	-
median	-	6	27	-	-	-	8	33	-	-
max	-	15	1345	-	-	-	15	456	-	-
q3	-	10	79	-	-	-	11	81	-	-
mean	-	7	69	-	-	-	8	61	-	-

**Figure 2-3. Conductor count box plot, duration, AC tests**

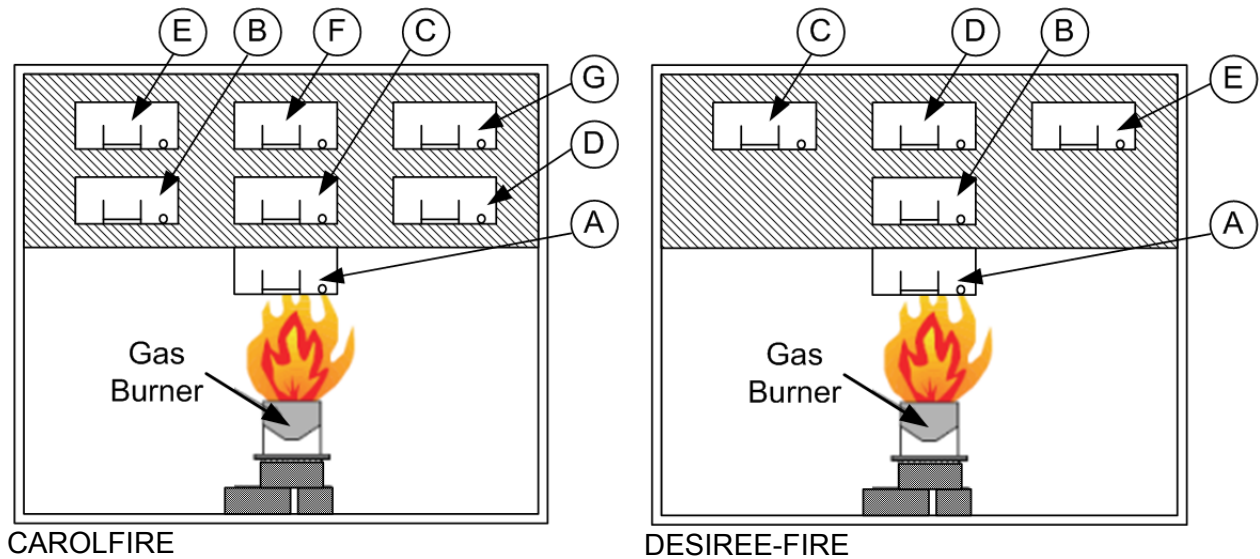
**Figure 2-4. Intermediate-scale cable raceway location**

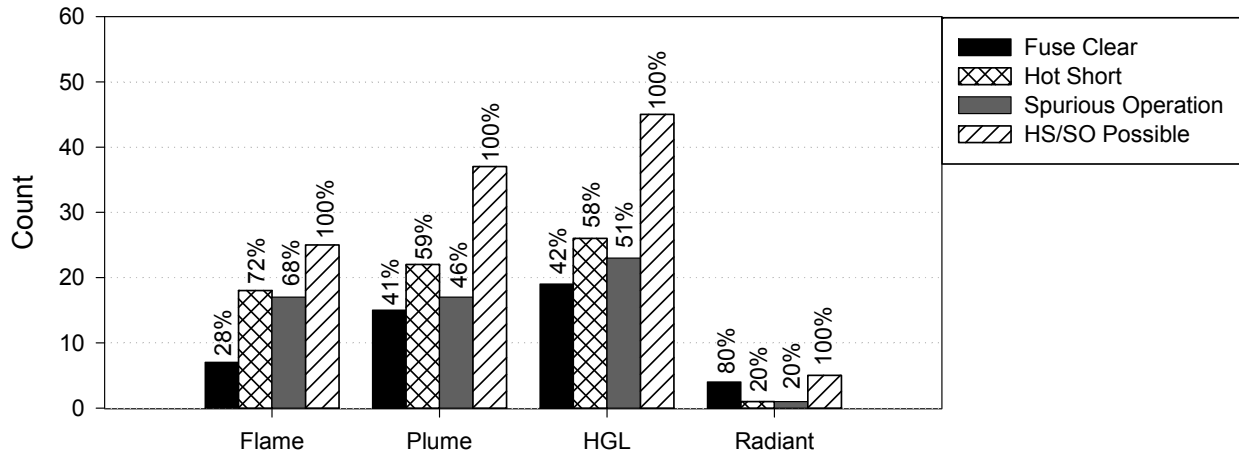
Global Approach	Flame	Plume	HGL	Radiant
Fuse Clear	7	15	19	4
Hot Short	18	22	26	1
Spurious Operation	17	17	23	1
HS/SO Possible	25	37	45	5

**Figure 2-5. Thermal exposure conditions column plot, global approach, AC tests**

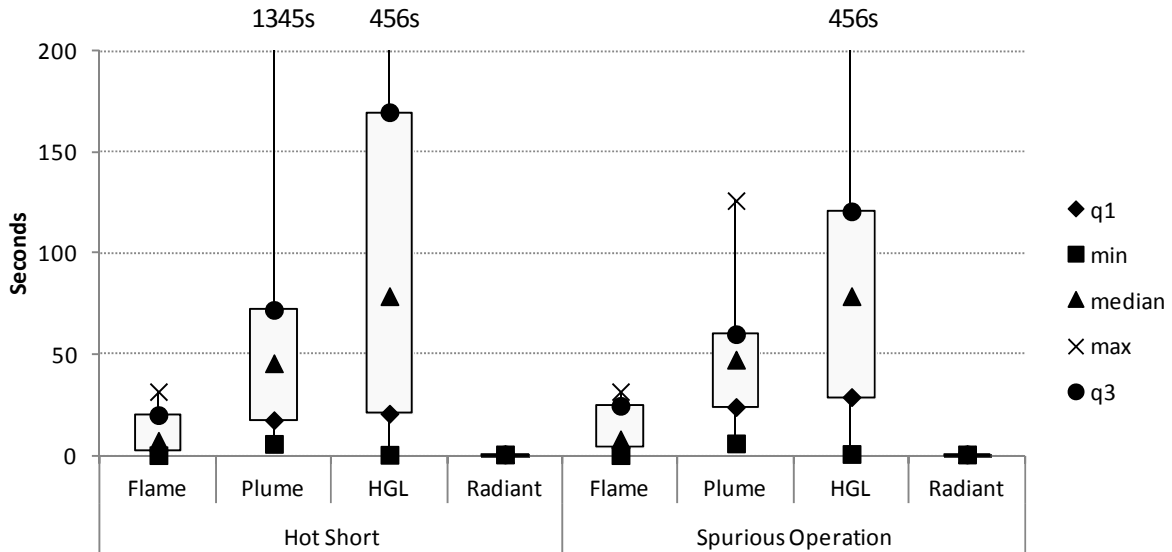
<sup>4</sup> Note that one duration for the hot short plume data set was 1345 seconds. This data point has been removed from the generalized discussion, but is important when considering maximum test data durations.

Figure 2-6. Thermal exposure conditions box plot, duration, AC tests

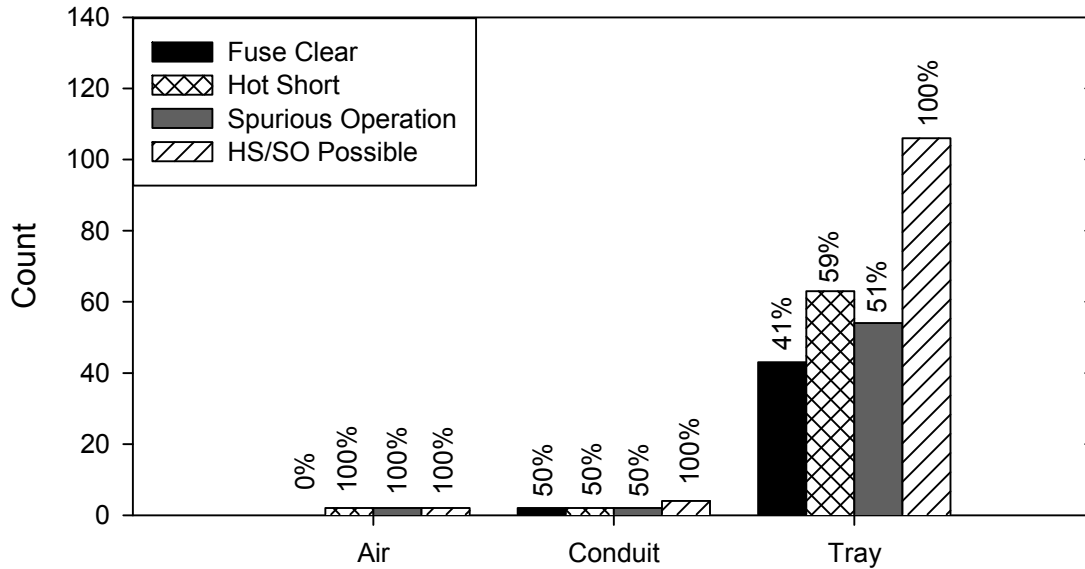
Global Approach	Air	Conduit	Tray
Fuse Clear	0	2	43
Hot Short	2	2	63
Spurious Operation	2	2	54
HS/SO Possible	2	4	106

**Figure 2-9. Raceway routing column plot, global approach, AC tests**

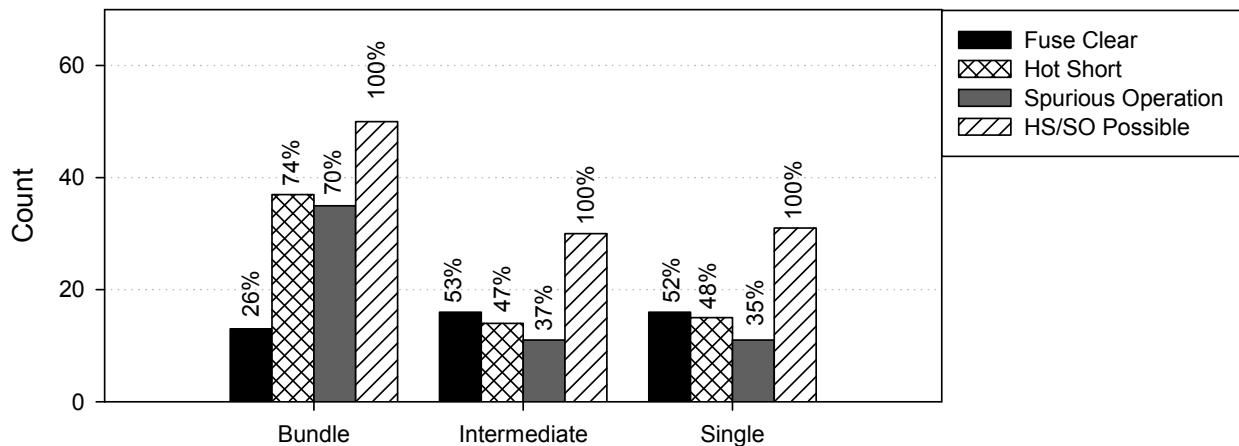
Global Approach	Bundle	Intermediate	Single
Fuse Clear	13	16	16
Hot Short	37	14	15
Spurious Operation	35	11	11
HS/SO Possible	50	30	31

**Figure 2-14. Raceway fill column plot, global approach, AC tests**

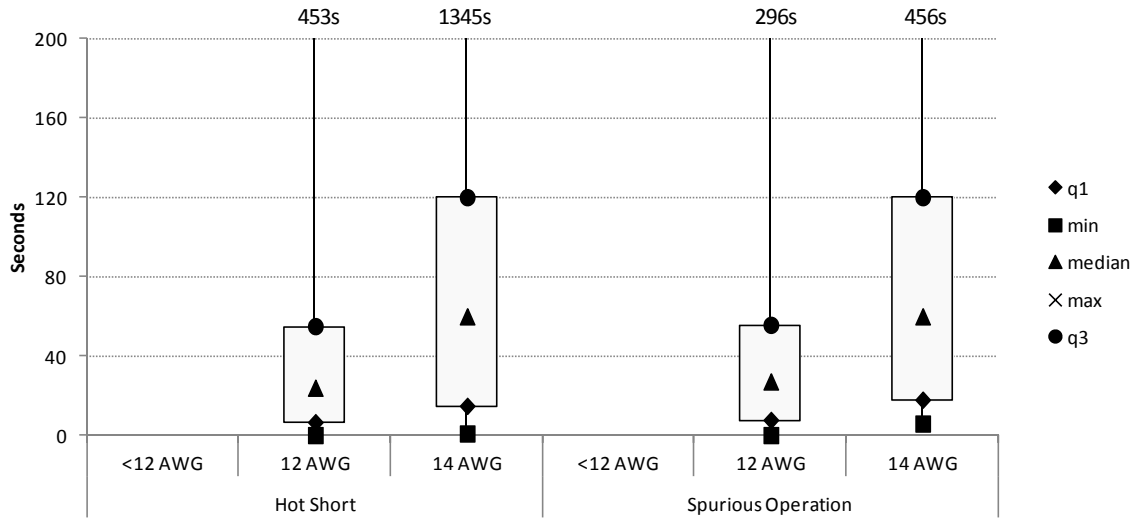
Hot Short			Spurious Operation		
	<12 AWG	12 AWG	14 AWG	<12 AWG	12 AWG	14 AWG
q1	-	7	15	-	8	18
min	-	1	1	-	1	6
median	-	24	60	-	27	60
max	-	453	1345	-	296	456
q3	-	55	120	-	56	120
mean	-	52	115	-	49	94

**Figure 2-29. Conductor size box plot, duration, AC tests**

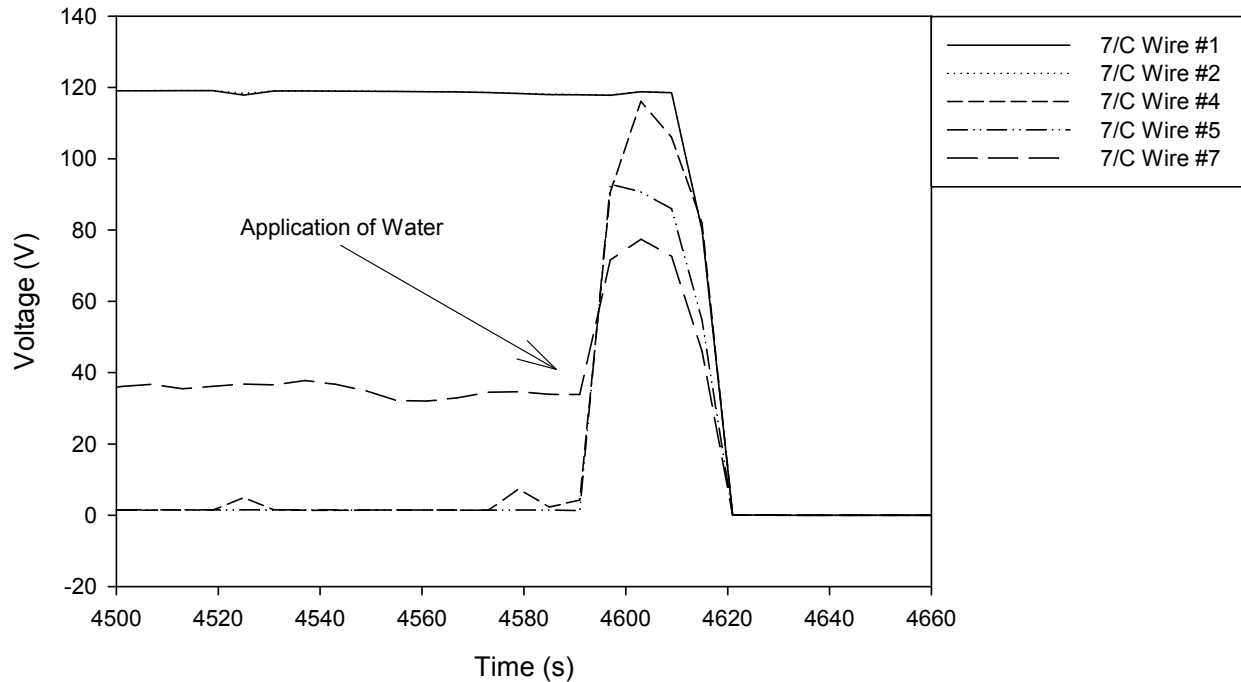
Water spray was observed to cause spurious operations in only one NEI/EPRI test, Test 3. In this case, a spurious operation did coincide with water spray, and persisted for approximately 24 seconds before a fuse clear occurred. This test cable was located at the center of the top layer of a two-layer cable fill test. Figure 2-30 provides a voltage plot of test circuit 3 for NEI/EPRI Test #3, showing the spurious operation on the target conductor, Wire #4 but only hot shorts on non-spurious operation target Wire #5 and Wire #7.

**Figure 2-30. NEI/EPRI test 3 voltage plot - water spray**

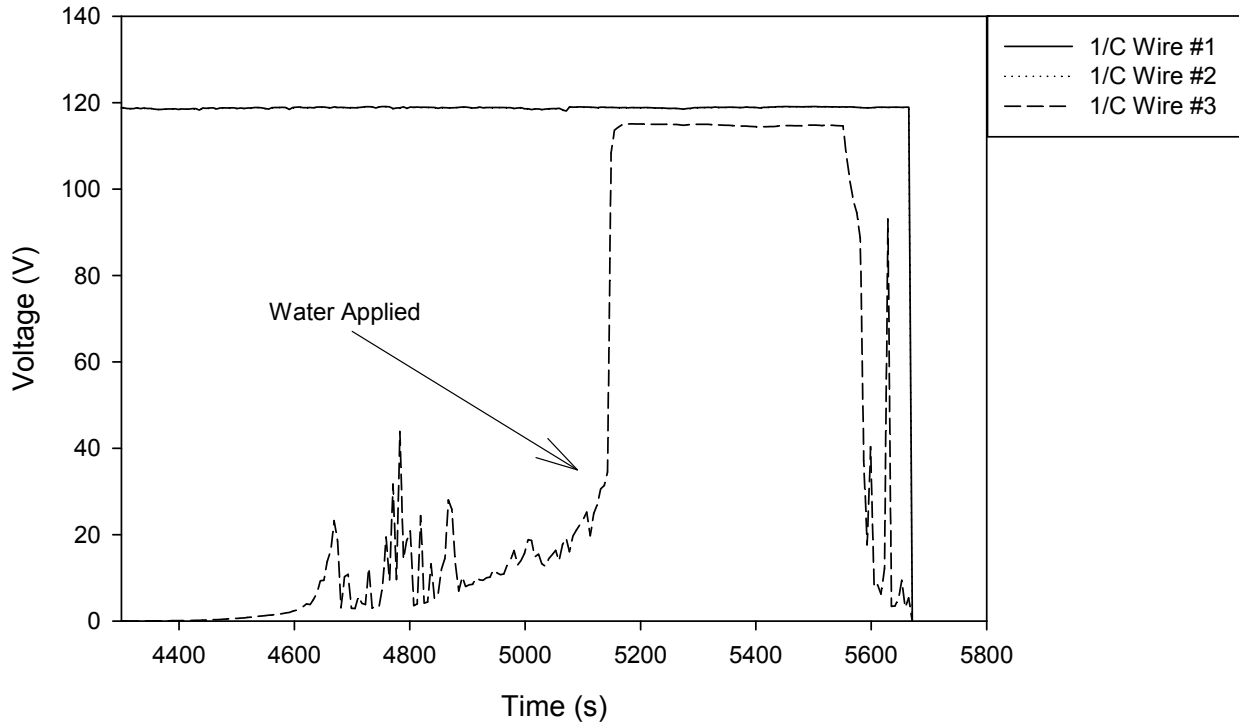
In Test 10 of the EPRI program, water spray was applied during an ongoing spurious operation. The application of water terminated the spurious operation (cleared for 42 seconds), followed by a brief operation of a target conductor (6 seconds), followed by a fuse clear failure. These electrical interactions are shown in Figure 2-31. In two other tests, water spray showed marginal effects on the cable electrical response. In one case, an induced voltage had built upon the spare conductor. When water spray was initiated, the induced voltage was rapidly lost. In the other case, very minimal current spikes (~0.05 amps) were observed in the 1/C cables, coincident with water application. The reader is encouraged to refer to the EPRI test report for more information.

**Figure 2-31. NEI/EPRI test 10 voltage response following water spray**

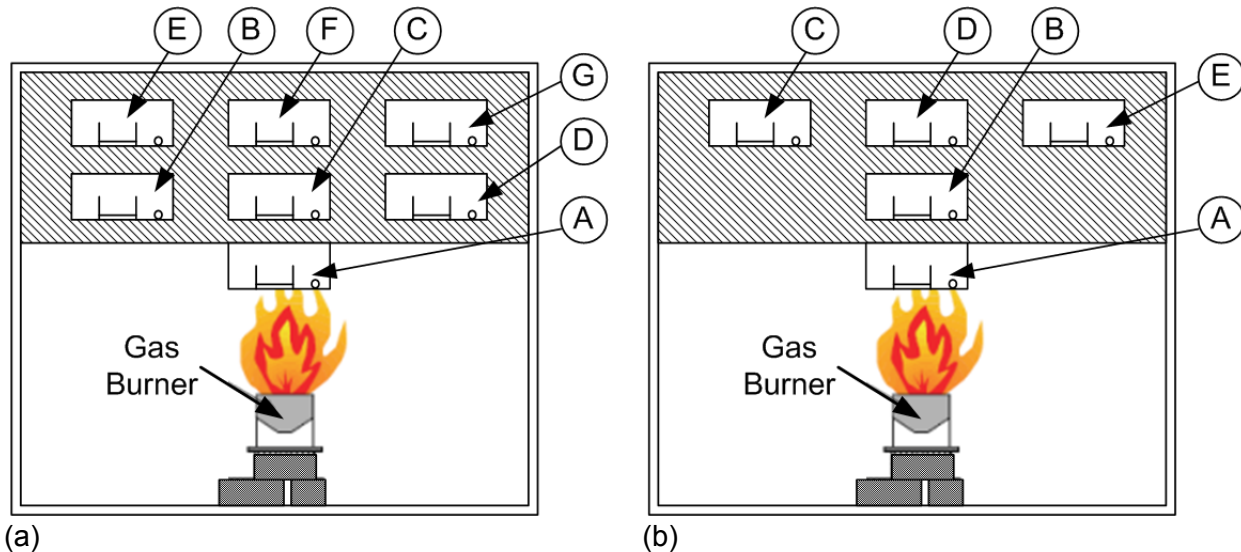
same physical location at the same time (i.e., concurrence). The data was also processed to account for the electrical and mechanical interlocks that would typically be used in NPP applications, but were not used during testing. For instance, the MOV starters have two active targets that, if energized by a fire-induced hot short, would be classified as hot-short induced spurious operations by the testing protocol. In reality, however, only one MOV contactor can be energized at a time. Thus, the data was post-processed to represent circuit response in NPP applications where the interlocks would be used.

**Figure 2-32. (a) CAROLFIRE and (b) DESIREE-FIRE intermediate-scale exposure location designation**

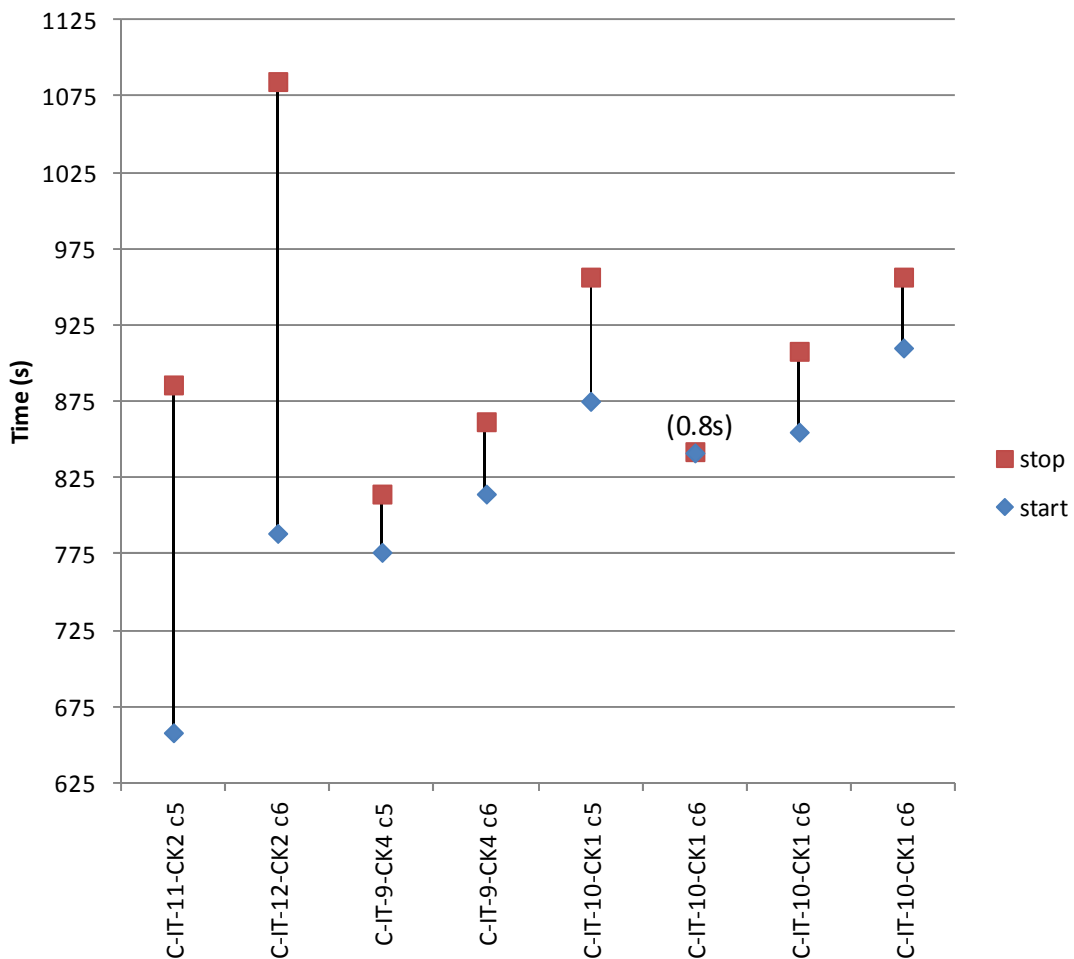
The other instance in which concurrent hot shorting was identified in this analysis was in the upper hot gas layer exposure locations (CAROLFIRE location G/E, DESIREE-FIRE location C/E). In these locations the data represents 20 test cables. Of these 20 cases, 12 spurious operations occurred, with 14 instances of concurrence. The only set of concurrences included four cables, of which three were of the same construction (PE/PVC) and the other was PVC/PVC. All were of the thermoplastic polymer variety. Figure 2-35 presents a plot of the hot short-induced spurious operation durations, and Table 2-32 provides a listing of the circuits involved in spurious operation concurrences and associated durations. The durations of these concurrences are longer than those in Location A, likely due to the difference in thermal exposure conditions.

Figure 2-35. Concurrent hot shorts - upper hot gas layer - 4 cables

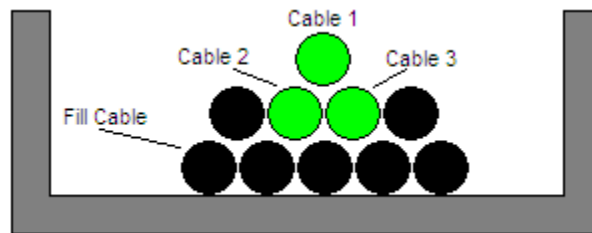
Figure 3-1 provides an illustration of how the cables were oriented within a cable tray for the inter-cable tests during the NEI/EPRI program. Cables 1-3 were monitored for electrical response, with cables 1 and 3 containing both energized source conductors and target conductors, while cable 2 only contained target conductors. The target conductors were connected to burden resistors to simulate a load. The black cables in Figure 3-1 represent fill cables that were not monitored for electrical response, but were used as a buffer between the electrically monitored cables and the metallic cable tray. These fill cables likely reduced the likelihood of an energized source coming in contact with the ground plane and causing a fuse clear failure.

**Figure 3-1. NEI/EPRI inter-cable test tray fill**

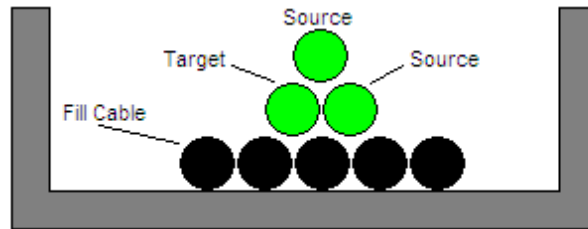
The CAROLFIRE inter-cable test set-up was slightly different in that all of the conductors in two multi-conductor cables were energized as sources and a third multi-conductor cable had all of its conductors connected to a motor starter contactor, a target. Thus, the CAROLFIRE circuit could detect inter-cable interactions, but was unable to recognize when conductors internal to the multi-conductor cables had failed. The CAROLFIRE inter-cable test set-up is shown in Figure 3-2.

**Figure 3-2. CAROLFIRE inter-cable test tray fill**

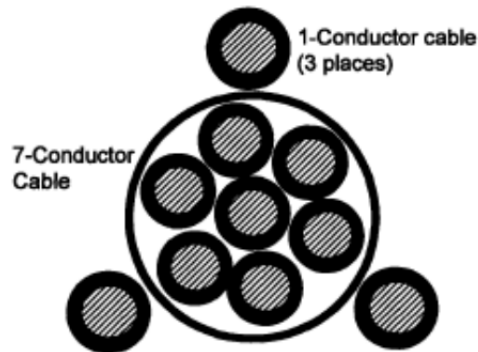
increase the likelihood of inter-cable interactions because of the lack of jacket and the use of cable ties to keep the single conductors in close proximity to the 7/C cable.

**Figure 3-3. NEI/EPRI cable configuration**

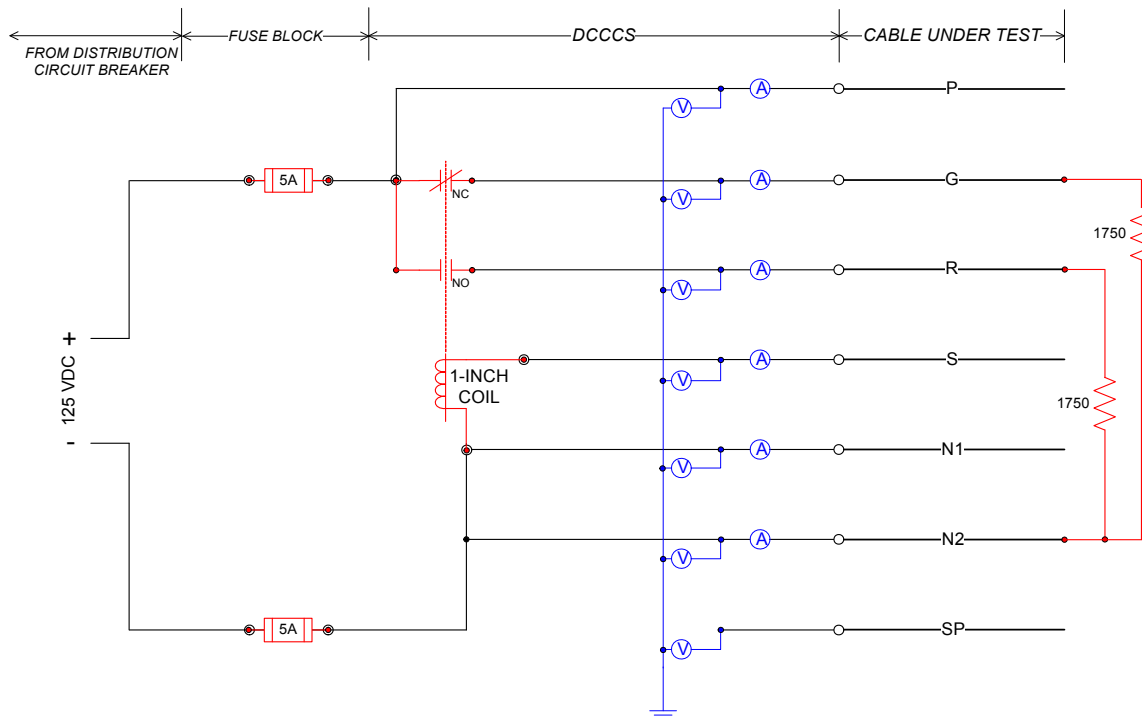
For the 1-inch valve circuit, conductor S was the hot short (HS)/spurious operation (SA) target, and conductors G and R were the HS targets for the penlight tests. For intermediate-scale tests, conductor S was the HS/SA target, and conductors G and R were not used for fuse status. The SP conductor was a non-energized target that could either short to the positive or negative sides of the circuit for all tests. The other conductors were used to determine whether a fuse had blown. Once the positive or negative fuse had blown, the durations for the HS and/or HS/SA were assumed to be complete.

**Figure 4-1. Line drawing of the DC-SIM panel layout for a 1-inch coil circuit**

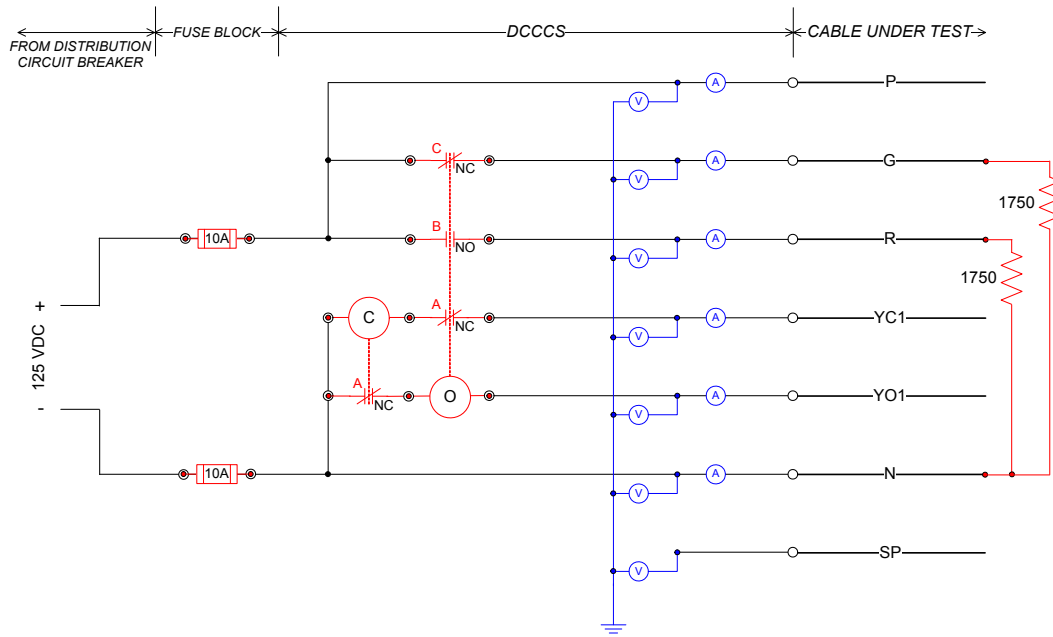
The MOV circuit that was tested is shown below in Figure 4-3. As seen in the figure, there are seven conductors that were monitored during the test. Those seven conductors' electrical measurement data was analyzed based on the information displayed in Table 4-4 for all tests. Each test had two MOV circuits designated as MOV1 and MOV2. Conductors YO1 and YC1 for MOV1 were HS/SA and HS targets. With MOV1, there were mechanical interlocks that caused YC1 to lock out if YO1 was engaged; thus, if YO1 had an HS/SA while YC1 got an HS, YC1 would not engage. Conductors G and R were HS targets. The SP conductor was a non-energized target that could short to either the positive or the negative side of the circuit for all tests. The other conductors were used to determine whether a fuse had blown. Once the positive or negative fuse had blown, the durations for the HS and/or HS/SA were assumed to be complete.

Figure 4-3. Line drawing for DC MOV circuit

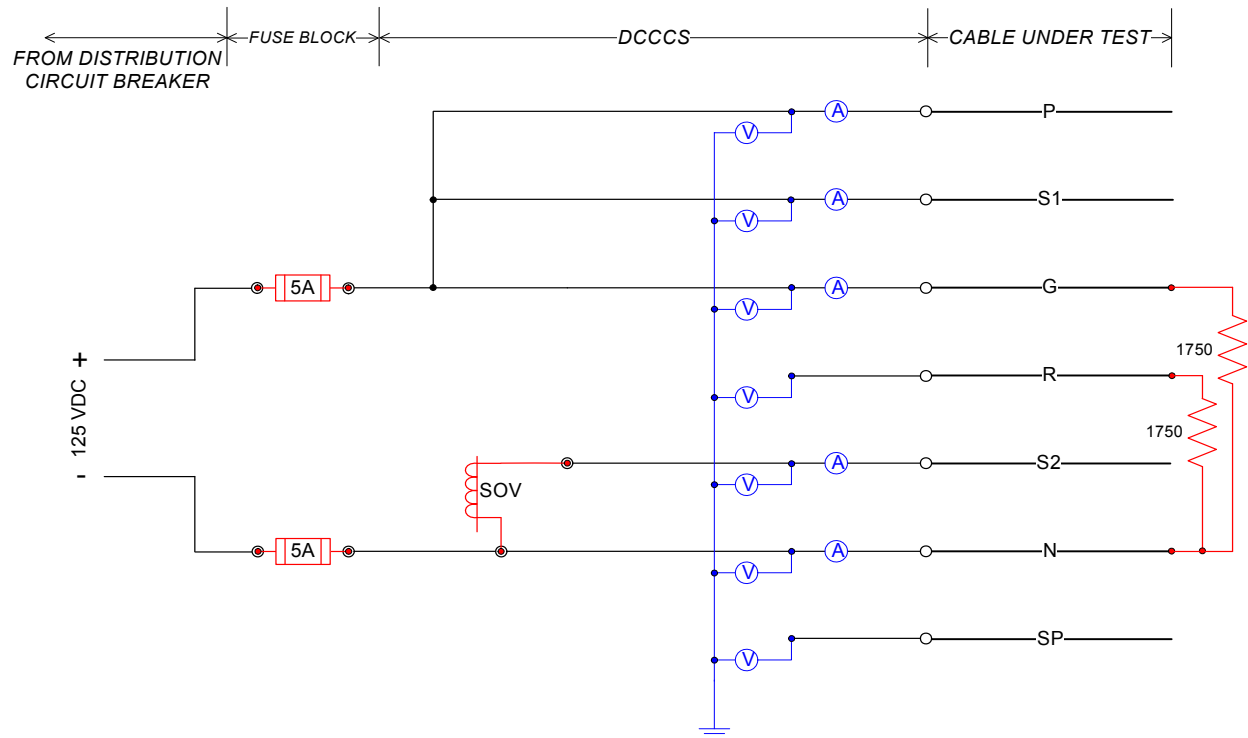
The SOV circuit that was tested is shown below in Figure 4-4. As seen in the figure, there are seven conductors that were monitored during the test. Those seven conductors' electrical measurement data was analyzed based on the information displayed in Table 4-5 for all tests. For this circuit conductor, S2 was the HS/SA target, and conductor R was an HS target for all tests. The SP conductor was a non-energized target that could short to either the positive or the negative side of the circuit for all tests. The other conductors were used to determine whether a fuse had blown. Once the positive or negative fuse had blown, the durations for the HS and/or HS/SA were assumed to be complete.

Figure 4-4. Line drawing for DC SOV circuit

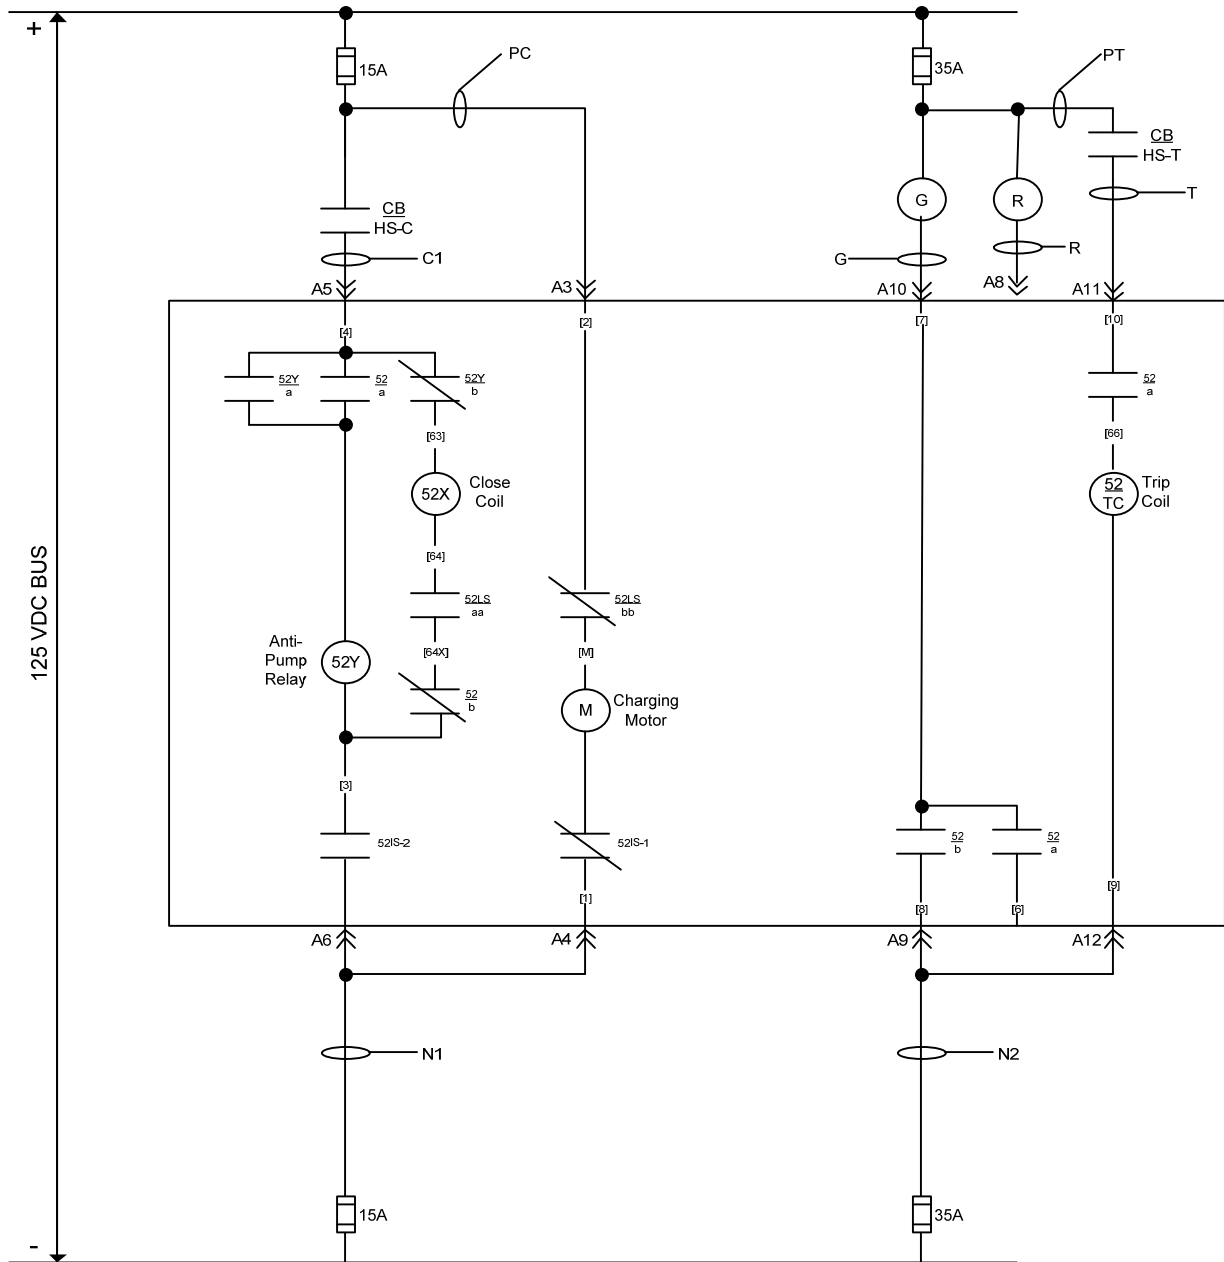
There were two different medium-voltage circuit breakers (SWGR) circuits used during DESIREE testing. As mentioned in the report, there was a problem with the first breaker during intermediate-scale Test #8. The first SWGR circuit is displayed in Figure 4-5, with the instrumentation's data analysis displayed in Table 4-6. The internal manufacturer wired this SWGR in reverse, which is depicted in Figure 4-5. The wiring did not affect the functionality of the SWGR, the only difference being that the red light was not energized. Table 4-6 has a different set-up than the tables for the previous circuits analyzed. The SWGR circuits were more complex to analyze, resulting in the different format. Conductors G, T, and C1 were hot short targets, while T and C1 were used to determine whether the breaker had tripped or closed (HS/SA target). The duration for the HS/SA was never more than one time step. Conductor R was treated as a energized spare. The two SP conductors were non-energized targets that could short to either the positive or the negative side of the circuit for all tests. The other conductors were used to determine whether a fuse had blown. Once the positive or negative fuse had blown, the durations for the HS and/or HS/SA were assumed to be complete. The second SWGR circuit is displayed in Figure 4-6, with the instrumentation's data analysis displayed in Table 4-7. The only difference with this SWGR in terms of the data analysis logic was that R was an HS target and not an energized spare. It is also noted in Table 4-6 and Table 4-7 that there were two cables tested for each SWGR test. One cable was connected to the close circuit, and the other was connected to the trip circuit. The conductors associated with each are identified in the tables.

Figure 4-5. Line drawing for DC SWGR 1 circuit

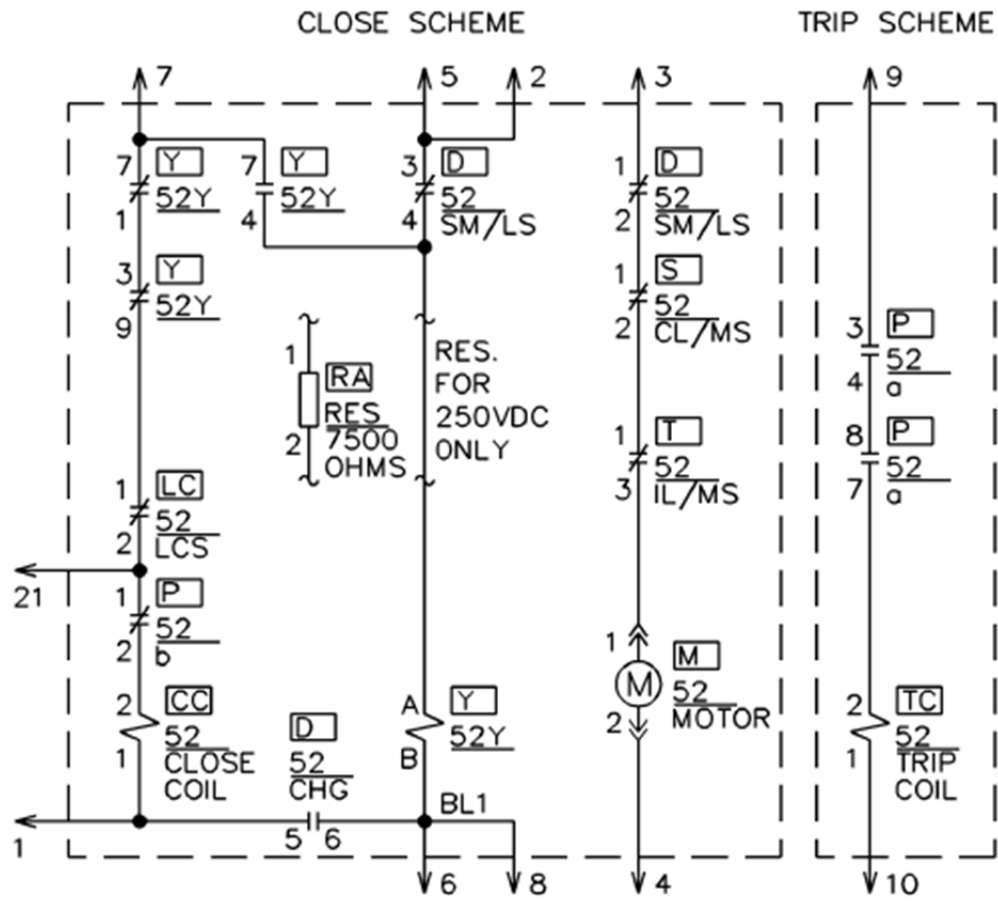
Figure 4-6. Line drawing for DC SWGR 2 circuit

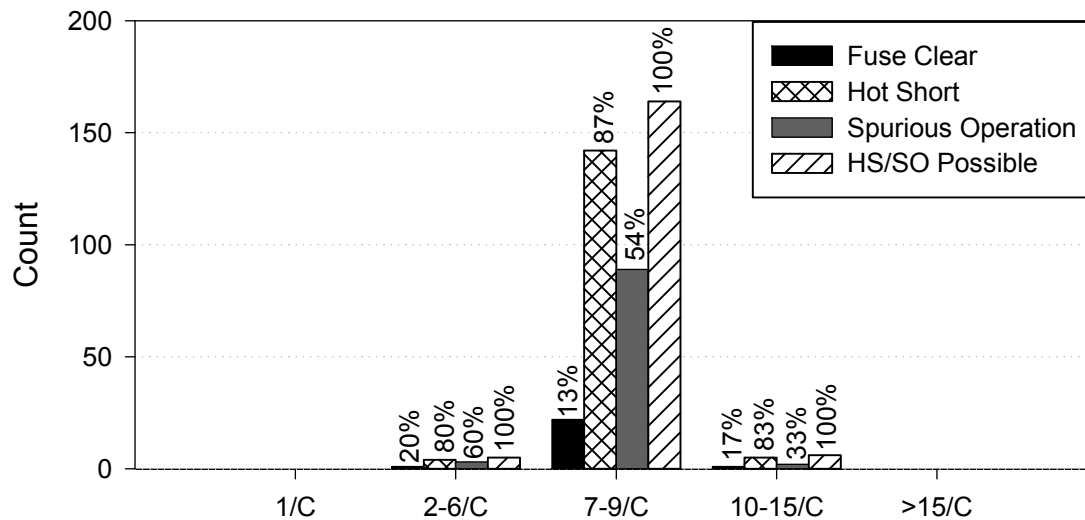
Global Approach	1/C	2-6/C	7-9/C	10-15/C	>15/C
Fuse Clear	-	1	22	1	-
Hot Short	-	4	142	5	-
Spurious Operation	-	3	89	2	-
HS/SO Possible	-	5	164	6	-

**Figure 4-7. Conductor count column plot, global approach, DC tests**

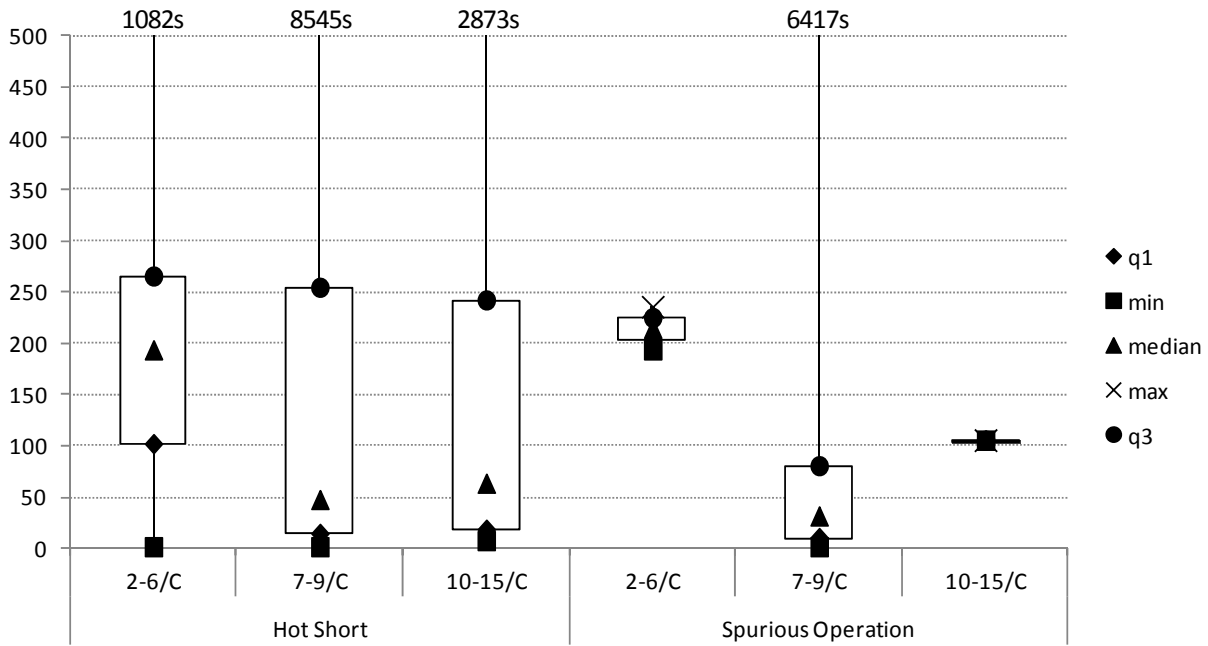
Hot Short					Spurious Operation				
	1/C	2-6/C	7-9/C	10-15/C	>15/C	1/C	2-6/C	7-9/C	10-15/C	>15/C
q1	-	101.5	14	18	-	-	203.5	10	105	-
min	-	1	1	7	-	-	193	1	105	-
median	-	193	47	63	-	-	214	31	105	-
max	-	1082	8545	2873	-	-	235	6417	105	-
q3	-	265	254	242	-	-	224	80	105	-
mean	-	302	409	471	-	-	214	195	105	-

**Figure 4-8. Conductor count box plot, duration, DC tests**

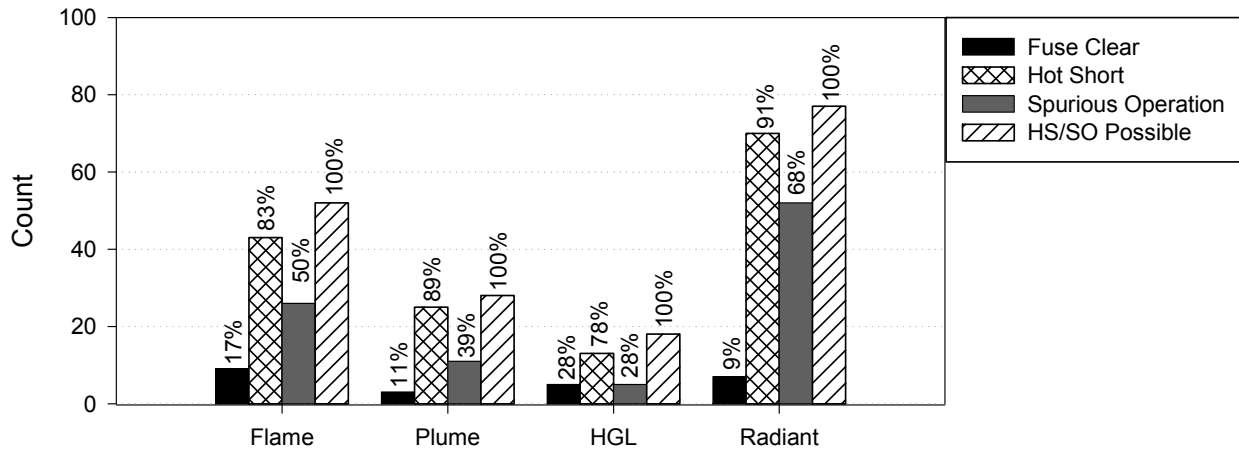
Global Approach	Flame	Plume	HGL	Radiant
Fuse Clear	9	3	5	7
Hot Short	43	25	13	70
Spurious Operation	26	11	5	52
HS/SO Possible	52	28	18	77

**Figure 4-9. Thermal exposure conditions column plot, global approach, DC tests**

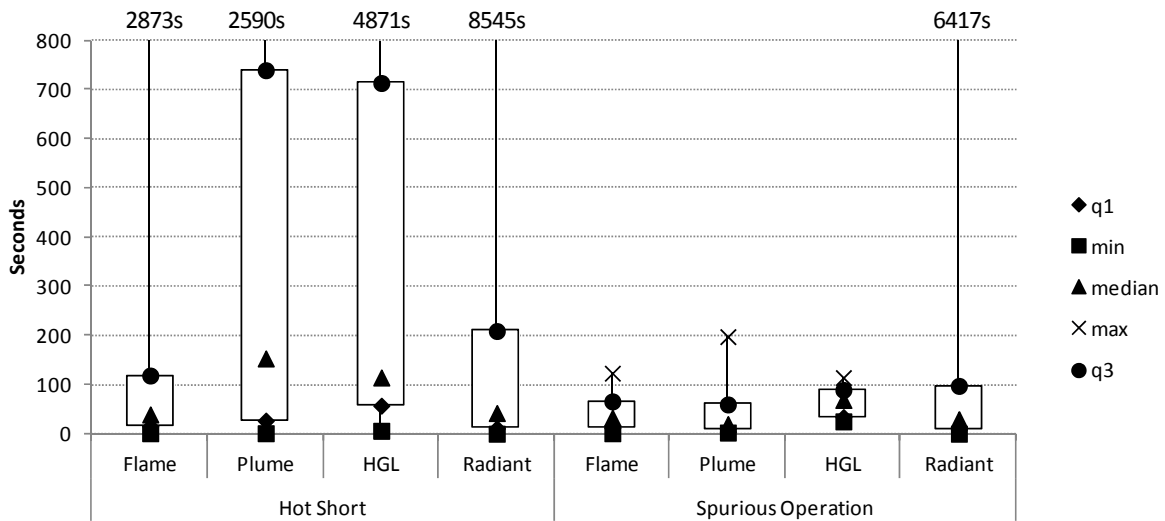
Hot Short				Spurious Operation			
	Flame	Plume	HGL	Radiant	Flame	Plume	HGL	Radiant
q1	16.4	27.5	57.95	12	13	10.7	34.8	10
min	2	2	7	1	3	3.4	26	1
median	40	154	115	43	34	20.6	70	31
max	2873	2590	4871	8545	124	198.4	115	6417
q3	119.2	740	714	210	66.7	60.5	90.0	98.3
mean	61.6	468.7	587.8	428.4	45.1	146.6	111.9	301.0

**Figure 4-10. Thermal exposure conditions box plot, duration, DC tests**

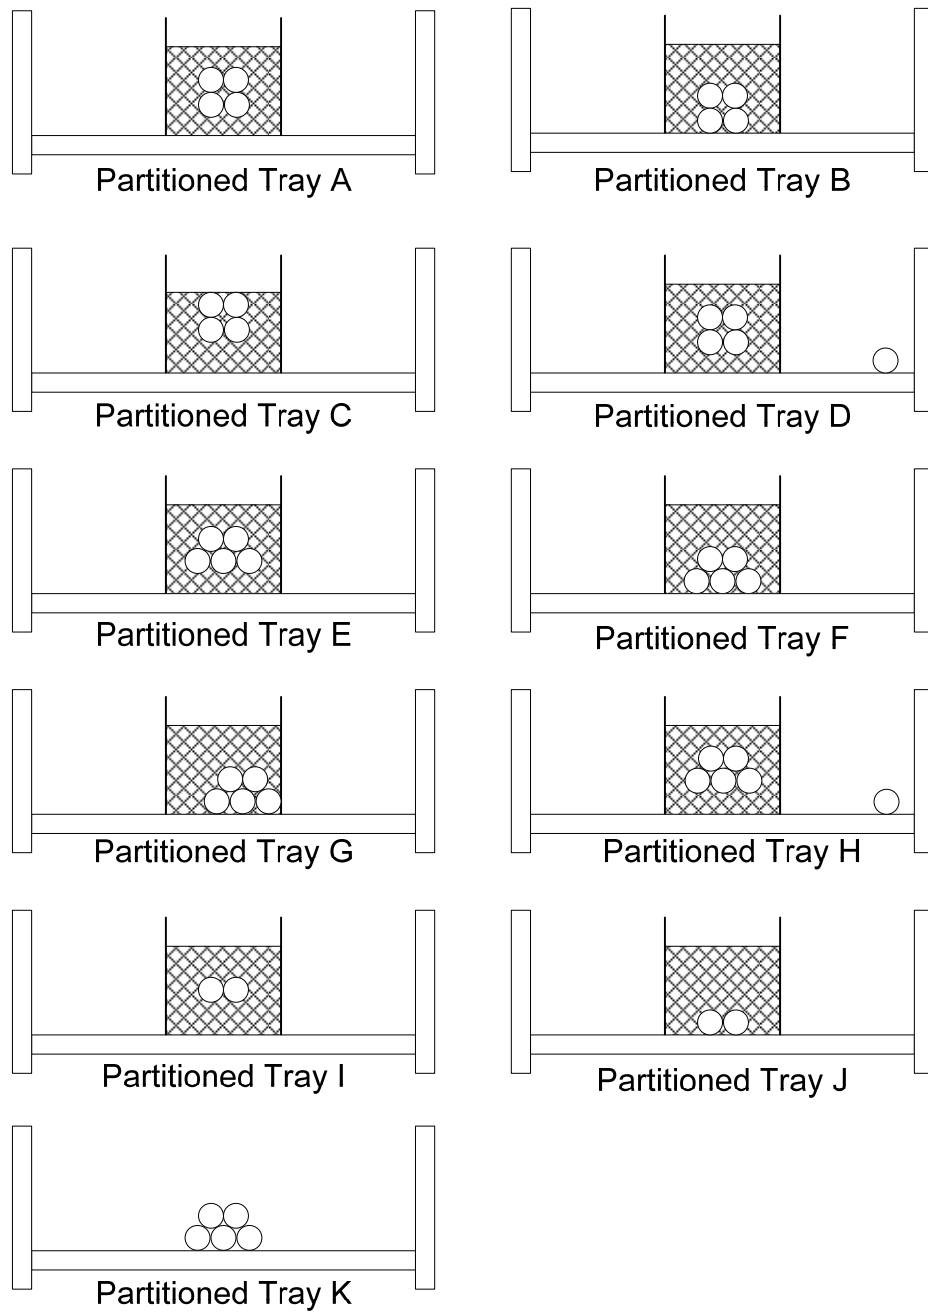
**Figure 4-15. Circuit cable orientation for partitioned trays**

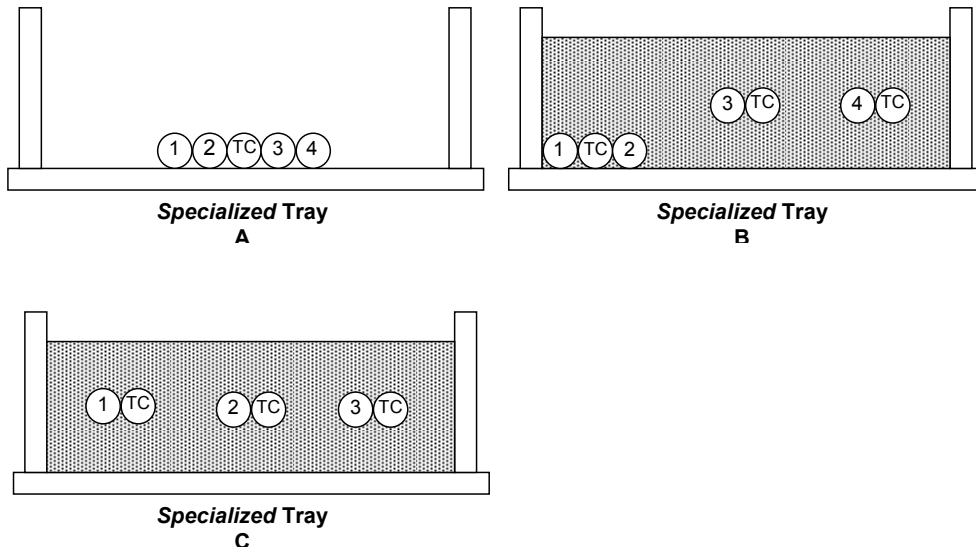
**Figure 4-16. Circuit cable orientation for specialized trays**

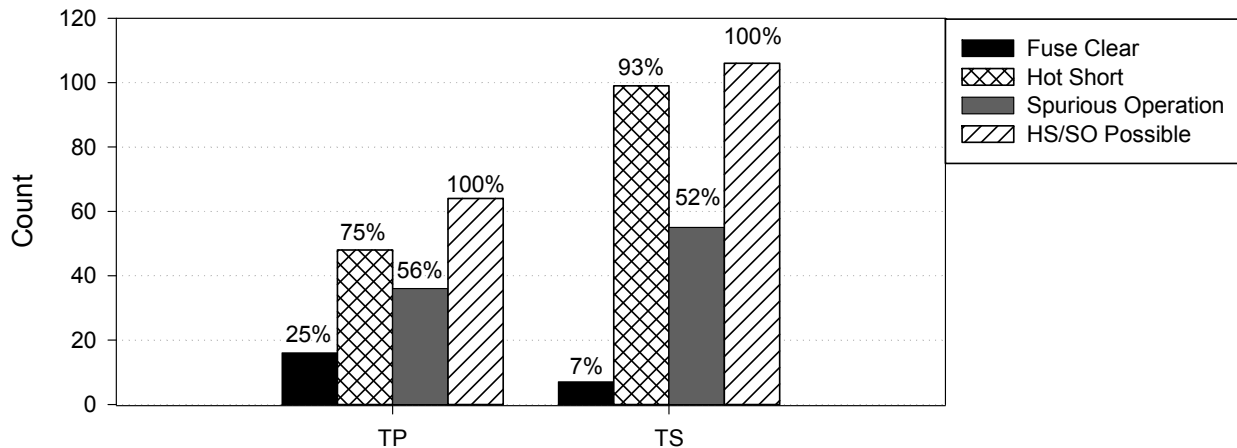
Global Approach	TP	TS
Fuse Clear	16	7
Hot Short	48	99
Spurious Operation	36	55
HS/SO Possible	64	106

**Figure 4-19. Insulation type column plot, global approach, DC tests**
