# **Electrical Cable Test Results and Analysis During Fire Exposure (ELECTRA-FIRE)**

**A Consolidation of Three Major  
Fire-Induced Circuit and Cable  
Failure Experiments Performed  
Between 2001 and 2011**

Final Report

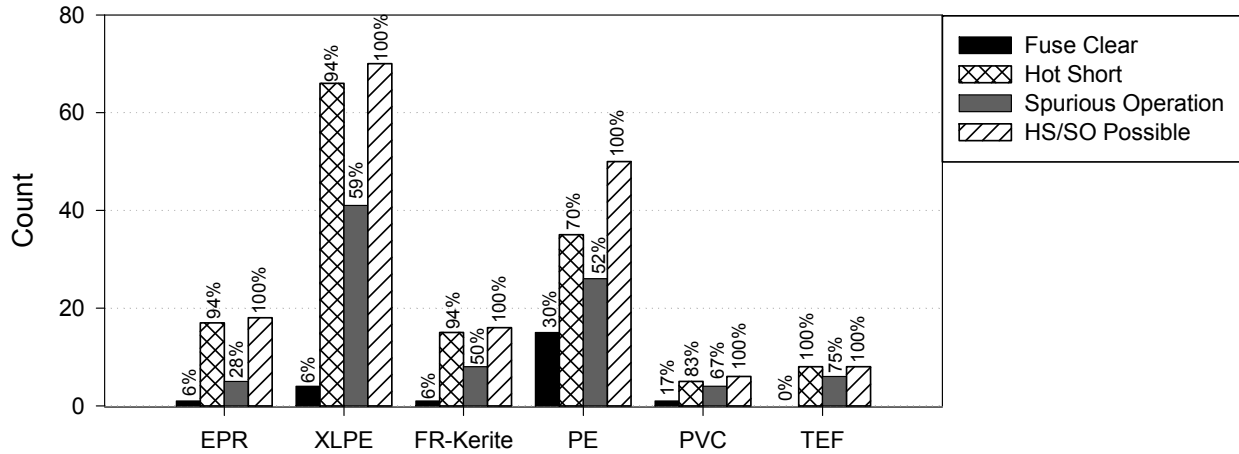
Global Approach	TS			TP		
	EPR	XLPE	FR-Kerite	PE	PVC	TEF
Fuse Clear	1	4	1	15	1	0
Hot Short	17	66	15	35	5	8
Spurious Operation	5	41	8	26	4	6
HS/SO Possible	18	70	16	50	6	8

**Figure 4-21. Insulation material column plot, global approach, DC tests**

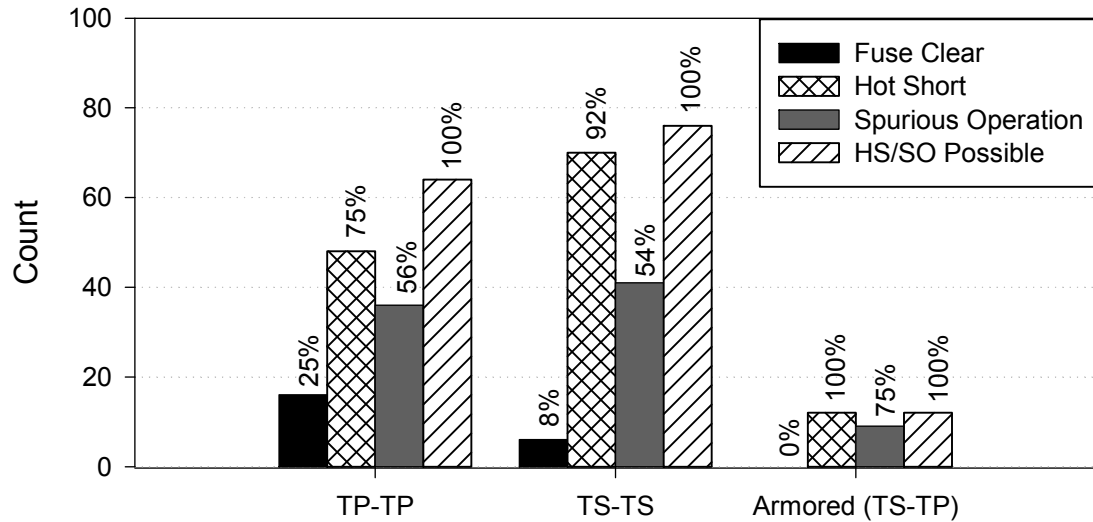
Global Approach	TP-TP	TS-TS	Armored (TS-TP)
Fuse Clear	16	6	0
Hot Short	48	70	12
Spurious Operation	36	41	9
HS/SA Possible	64	76	12

**Figure 4-23. Insulation-jacket type column plot, global approach, DC tests**

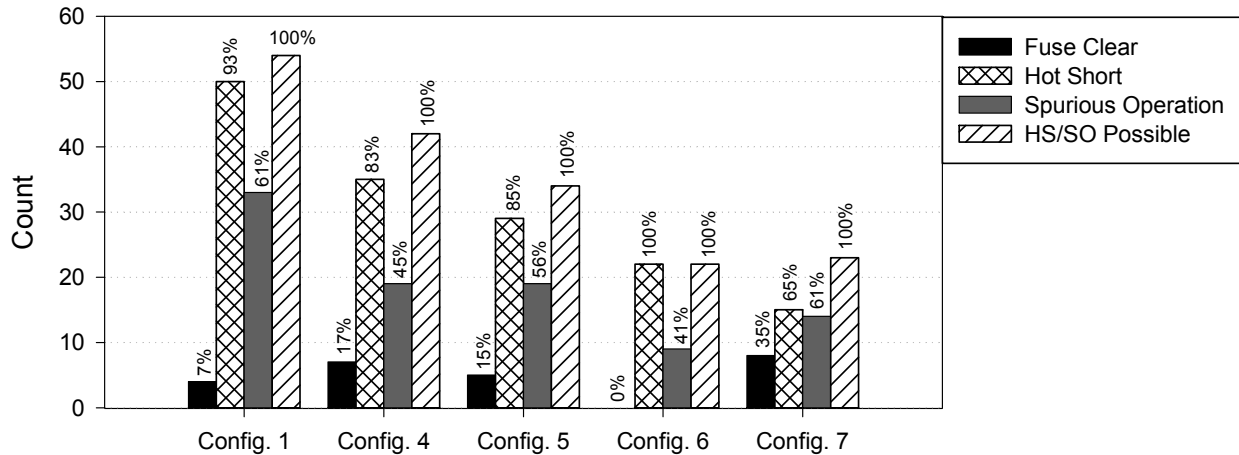
Global Approach	Config. 1	Config. 4	Config. 5	Config. 6	Config. 7
Fuse Clear	4	7	5	0	8
Hot Short	50	35	29	22	15
Spurious Operation	33	19	19	9	14
HS/SO Possible	54	42	34	22	23

**Figure 4-25. Wiring configuration column plot, global approach, DC tests**

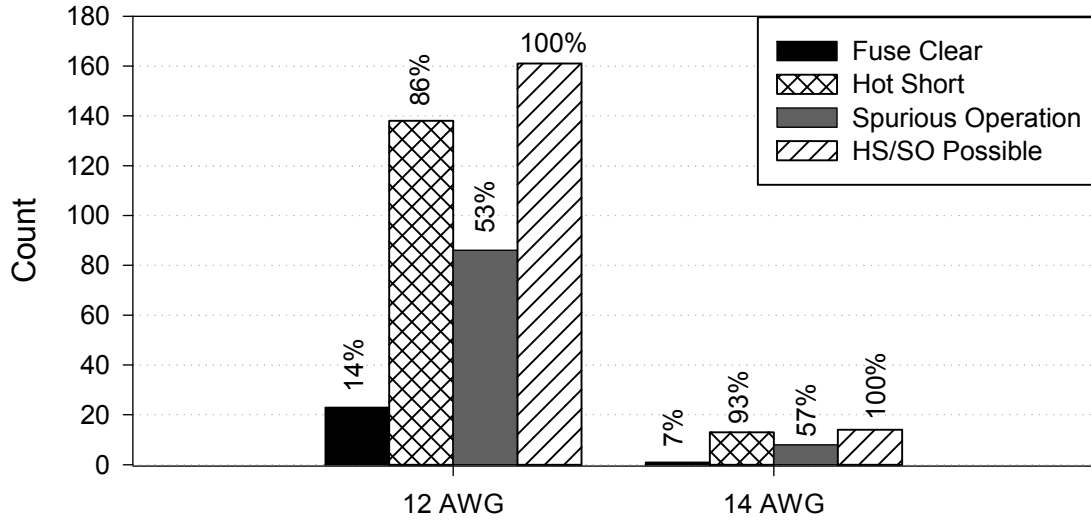
Global Approach	12 AWG	14 AWG
Fuse Clear	23	1
Hot Short	138	13
Spurious Operation	86	8
HS/SA Possible	161	14

**Figure 4-27. Conductor size column plot, global approach, DC tests**

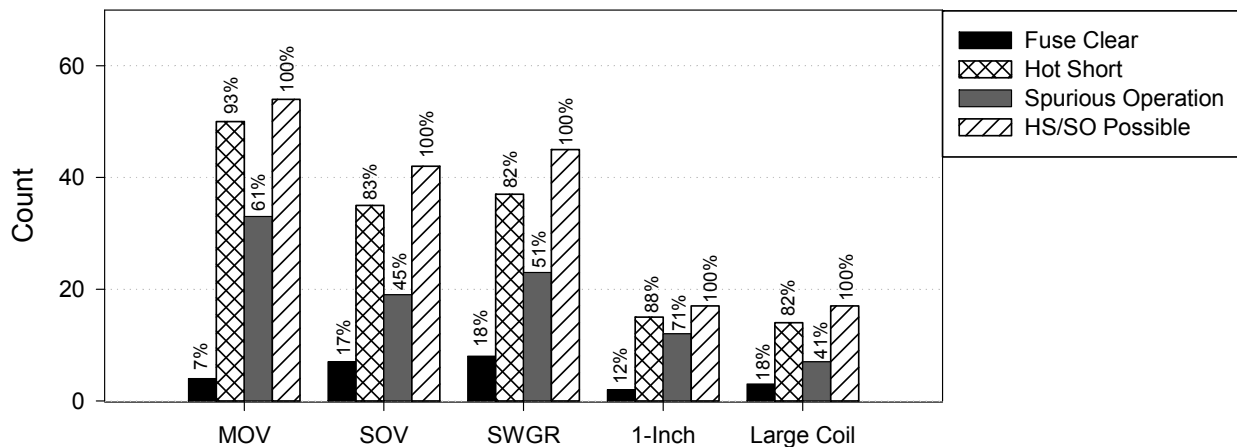
Global Approach	MOV	SOV	SWGR	1-inch	Large Coil
Fuse Clear	4	7	8	2	3
Hot Short	50	35	37	15	14
Spurious Operation	33	19	23	12	7
HS/SO Possible	54	42	45	17	17

**Figure 4-29. Circuit type column plot, global approach, DC tests**

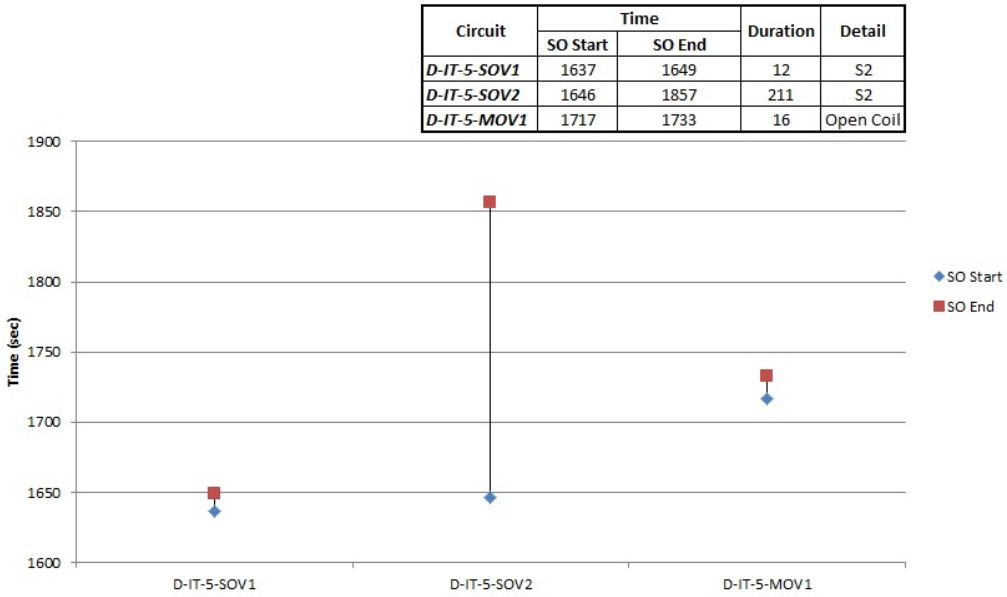
**Figure 4-35. Time plot of concurrent hot shorts for DESIREE-FIRE intermediate-scale test 5**

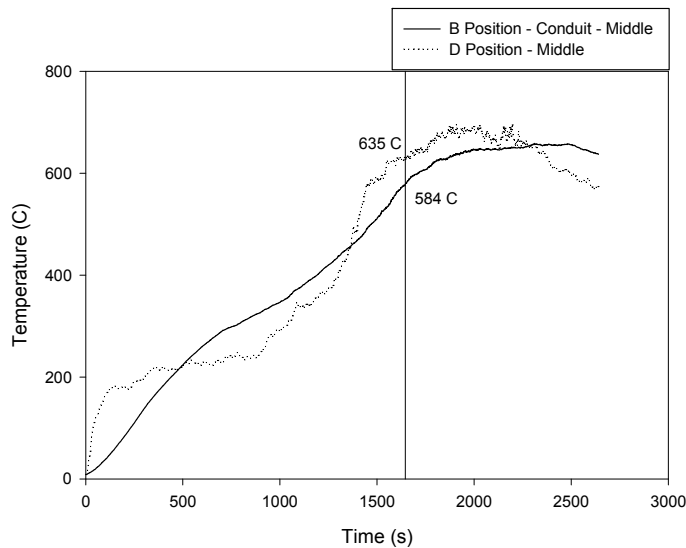
**Figure 4-36. Plot of intermediate-scale test 5 for MOV and SOV cable locations**

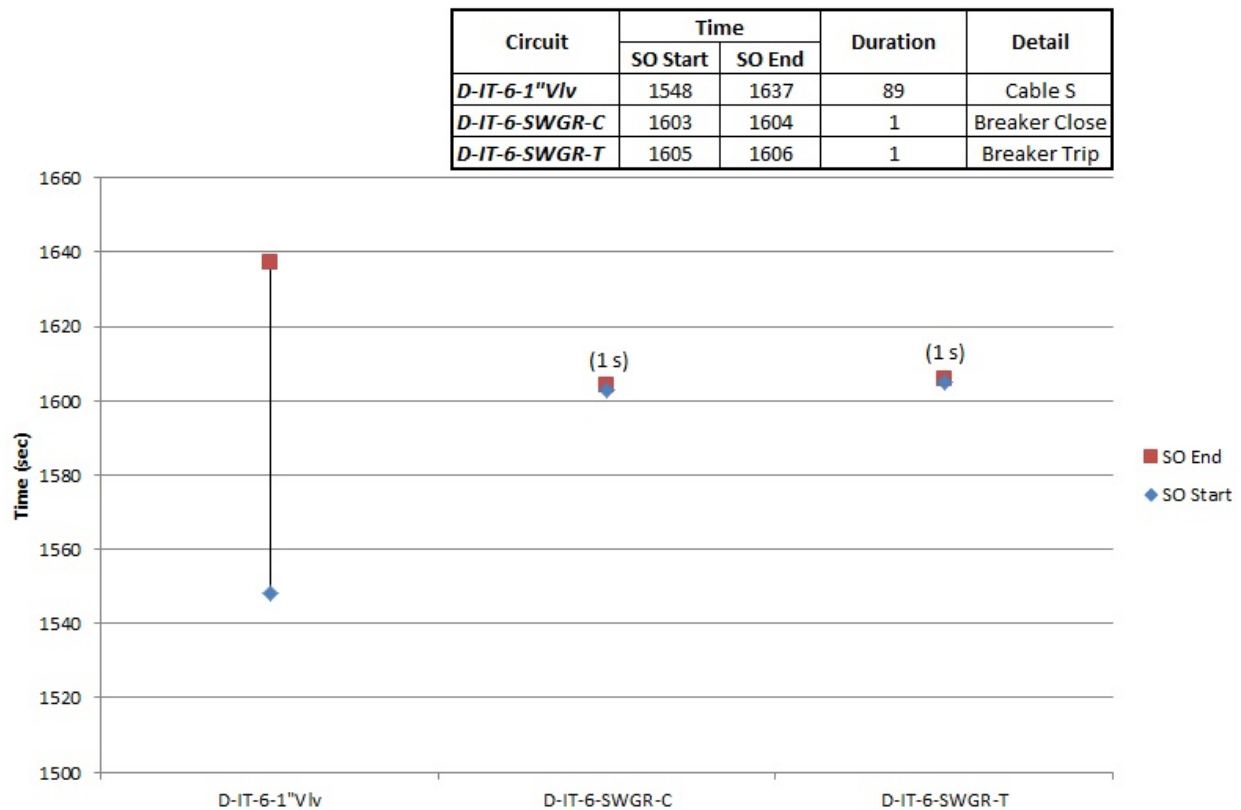
**Figure 4-37. Concurrent hot shorts - test 6**

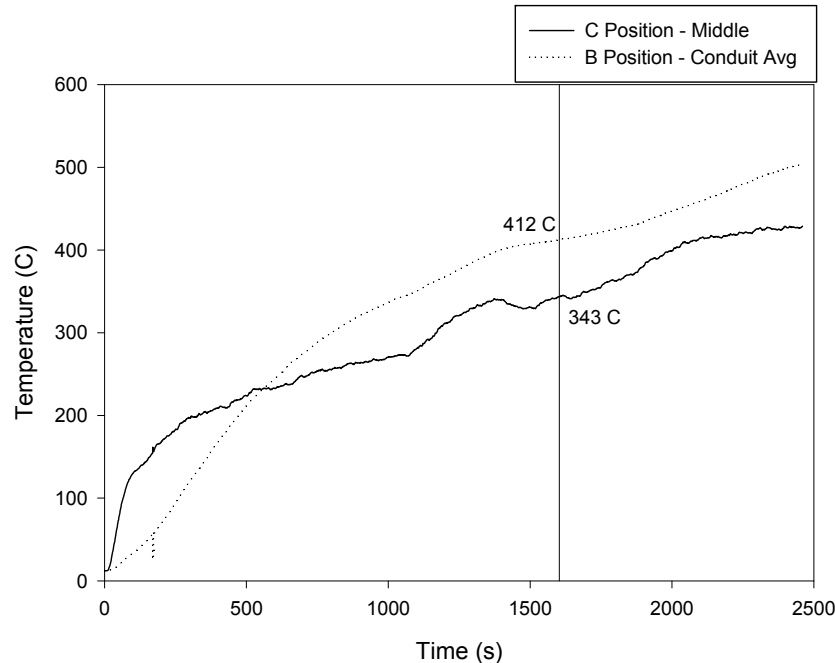
**Figure 4-38. Plot of intermediate-scale test 6 for 1-inch valve and switchgear cable locations**

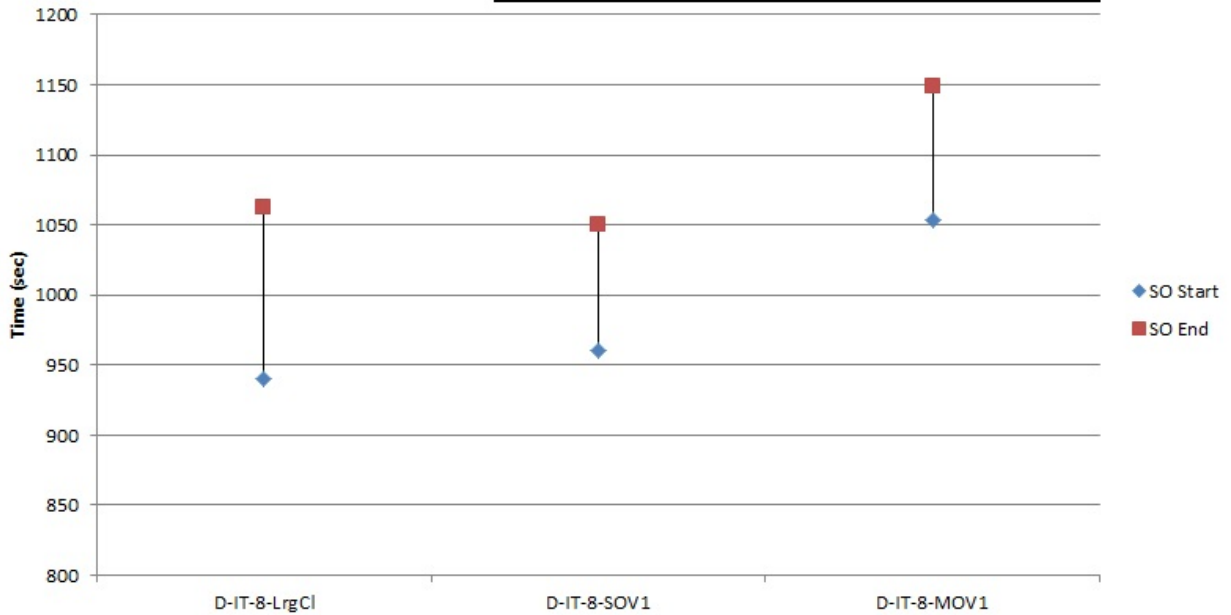
**Figure 4-39. Concurrent hot shorts - test 8**

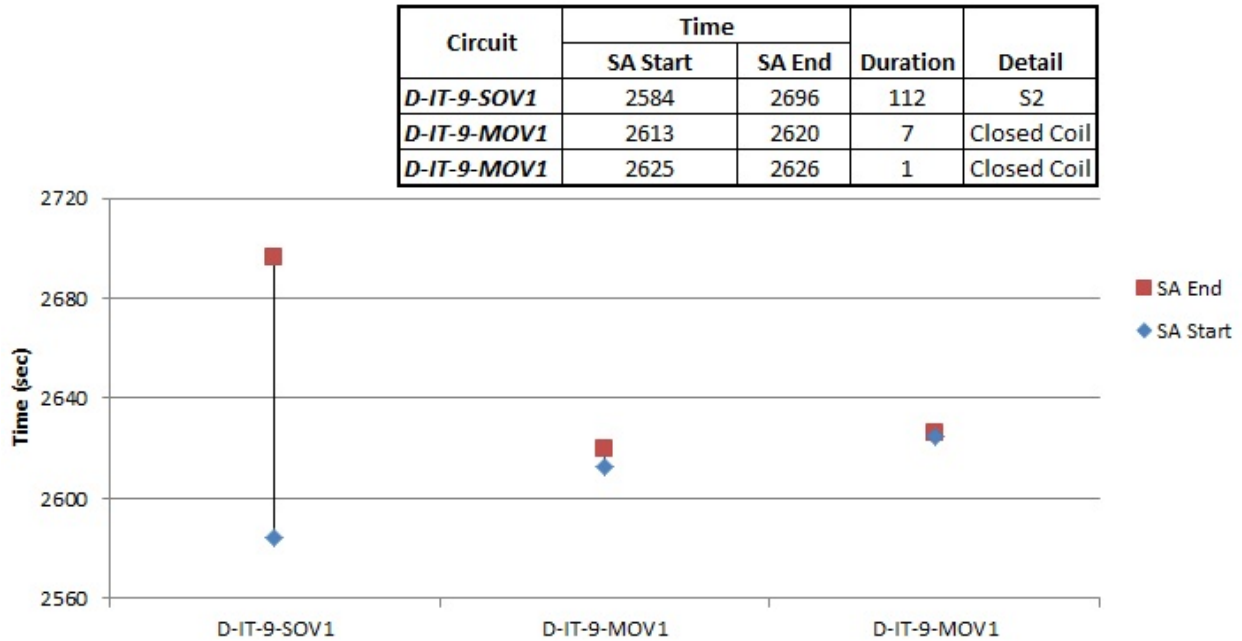
**Figure 4-40. Concurrent hot shorts - test 9**

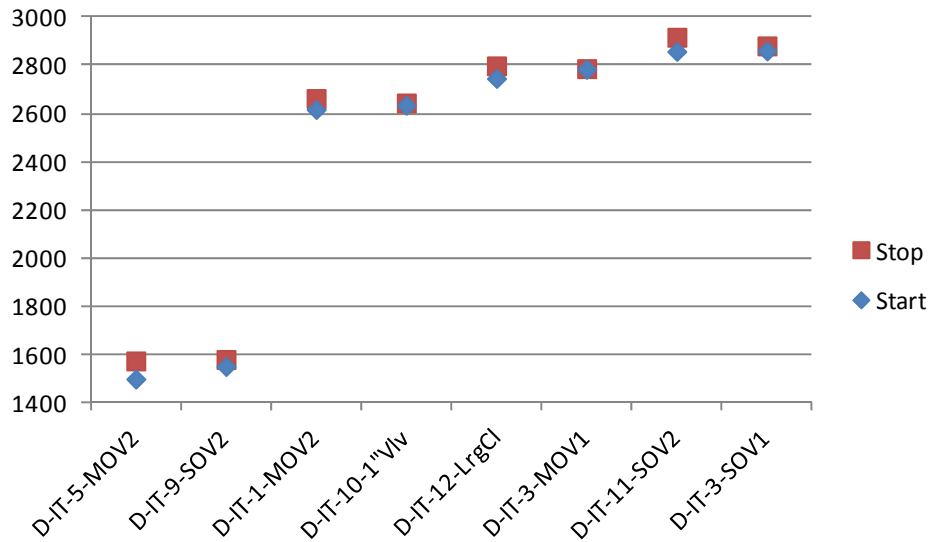
**Figure 4-42. Time plot of concurrent spurious operations for DESIREE-FIRE among all test circuits in Location D**

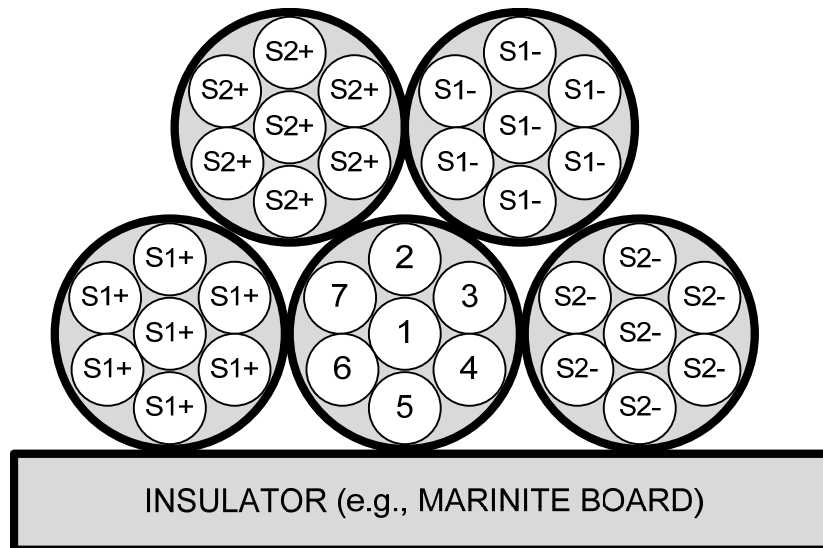
**Figure 5-1. DESIREE-FIRE inter-cable configuration**

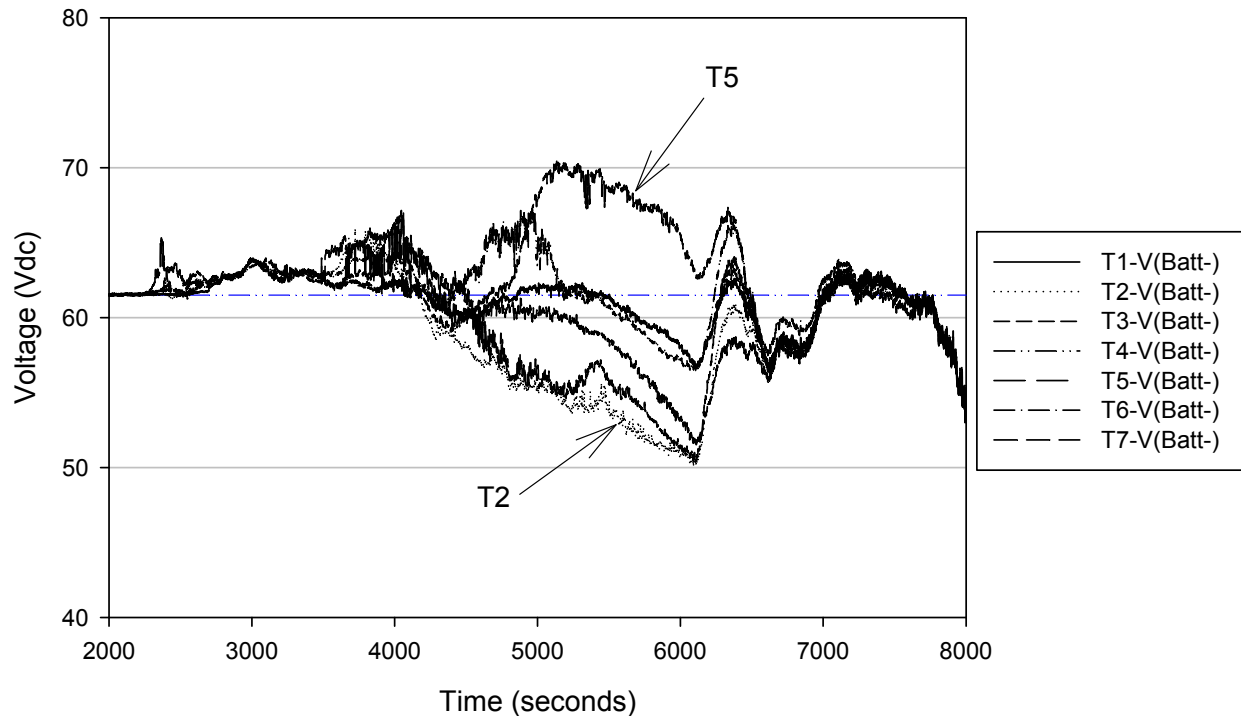
**Figure 5-2. DESIREE-FIRE inter-cable test results penlight test 47**

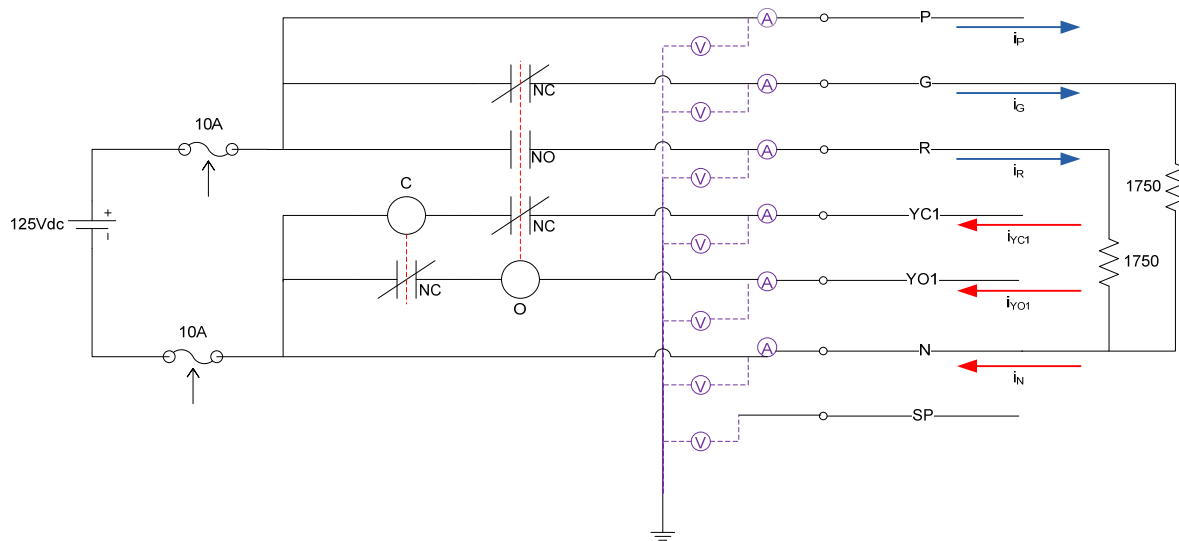
**Figure 5-3. DC MOV schematic showing current summation used in identifying inter-cable shorting behavior**

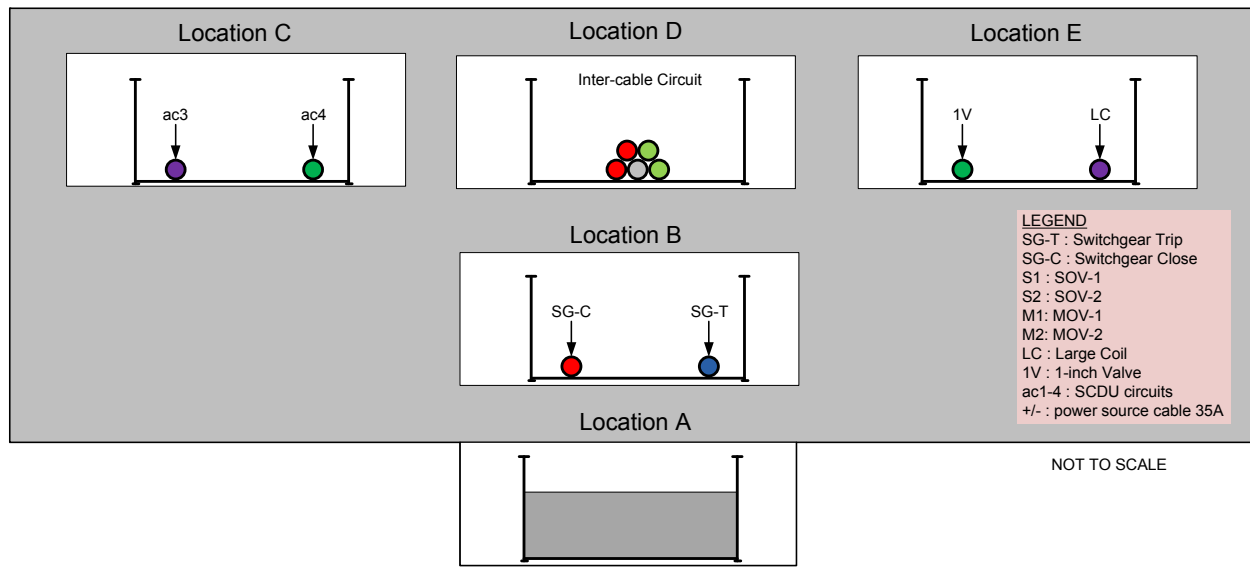
**Figure 5-5. Intermediate-scale test preliminary 1 cable loading configuration**

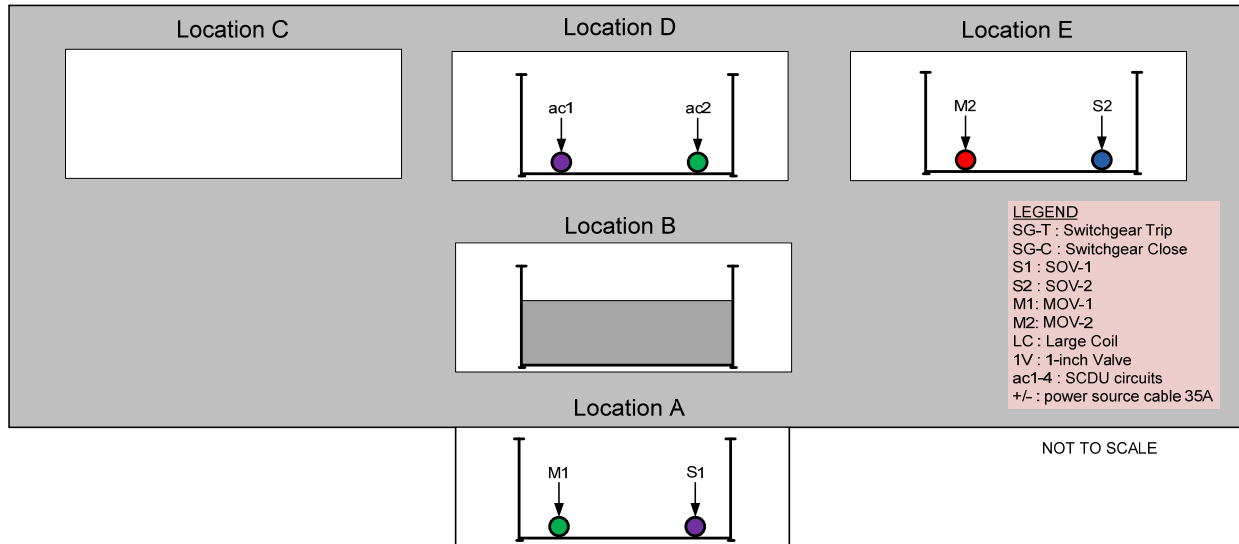
Figure 5-6. Intermediate-scale test preliminary 2 cable loading configuration

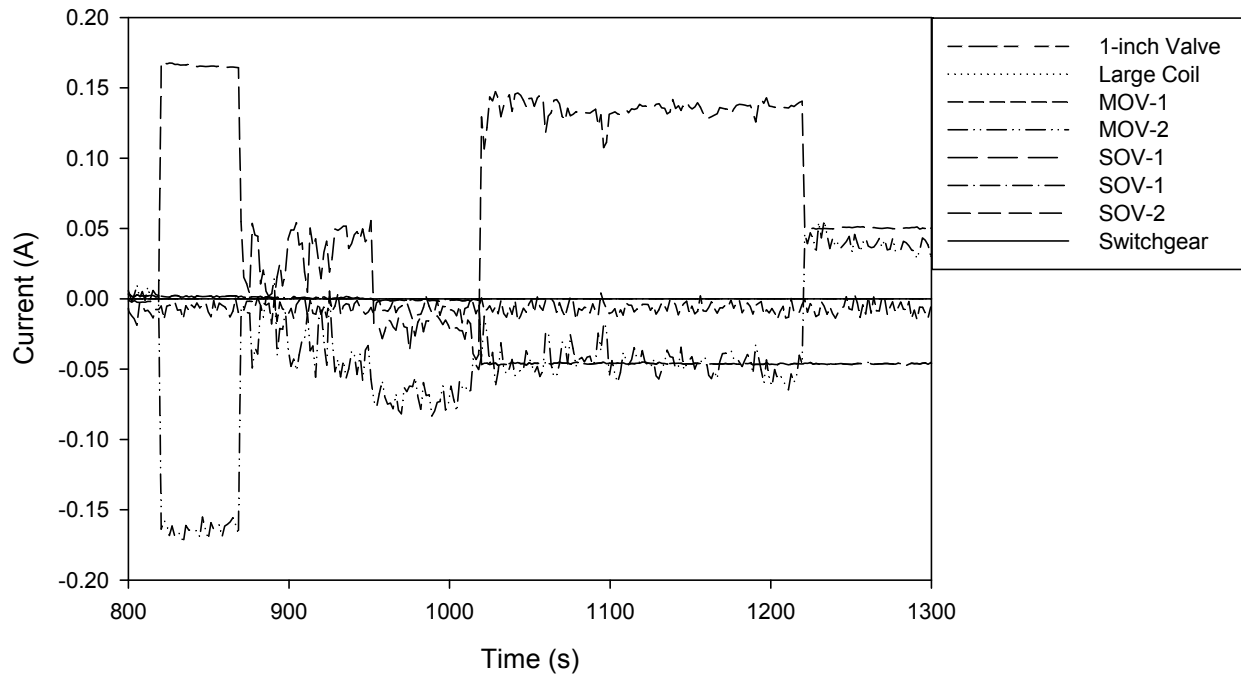
**Figure 5-7. Intermediate-scale test preliminary 2 – inter-cable shorting between SOV-2 and MOV-2**

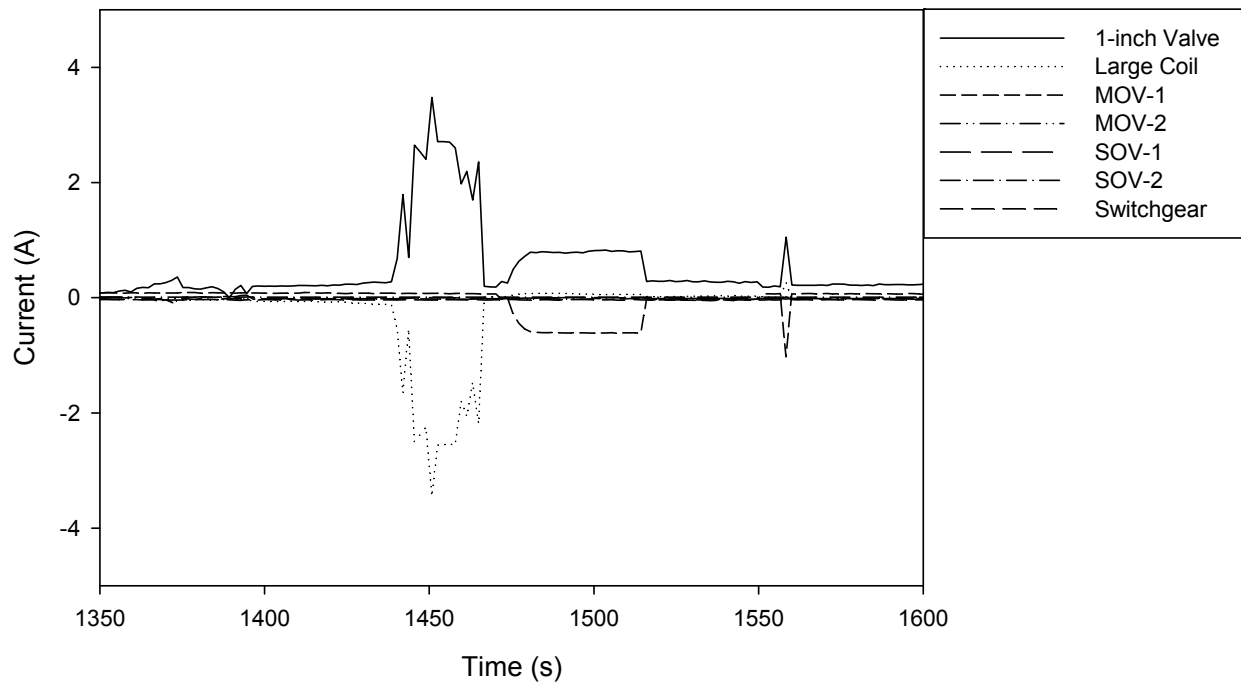
**Figure 5-9. Outstanding current hot shorting for intermediate-scale test 1 between 1-inch valve, large coil, and MOV-1 circuits**

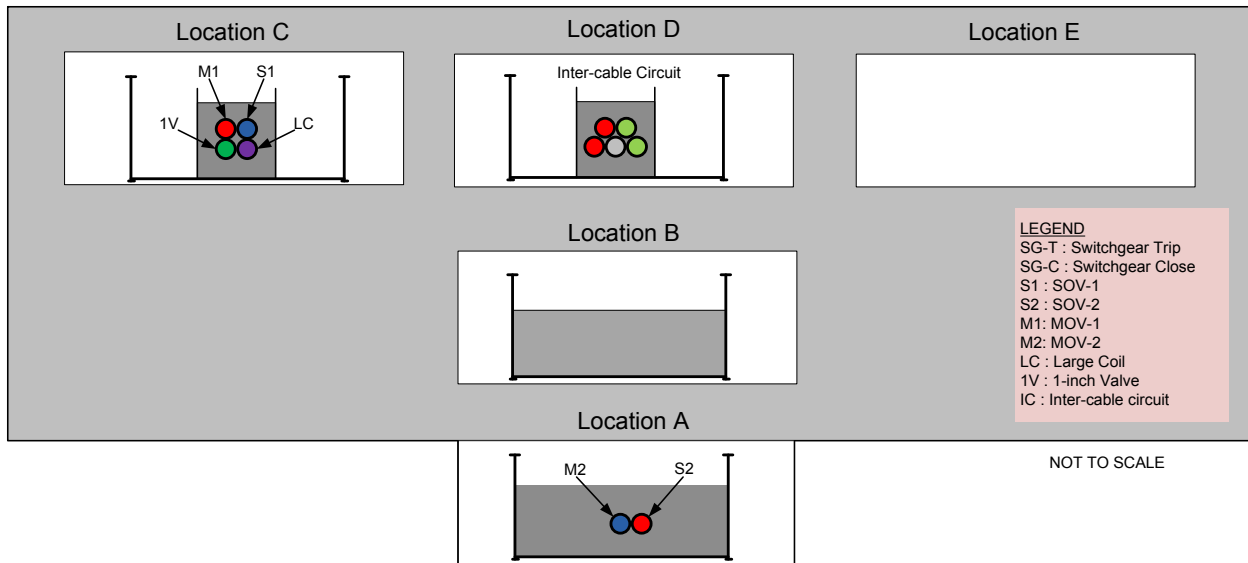
Figure 5-10. Intermediate-scale test 2 cable loading

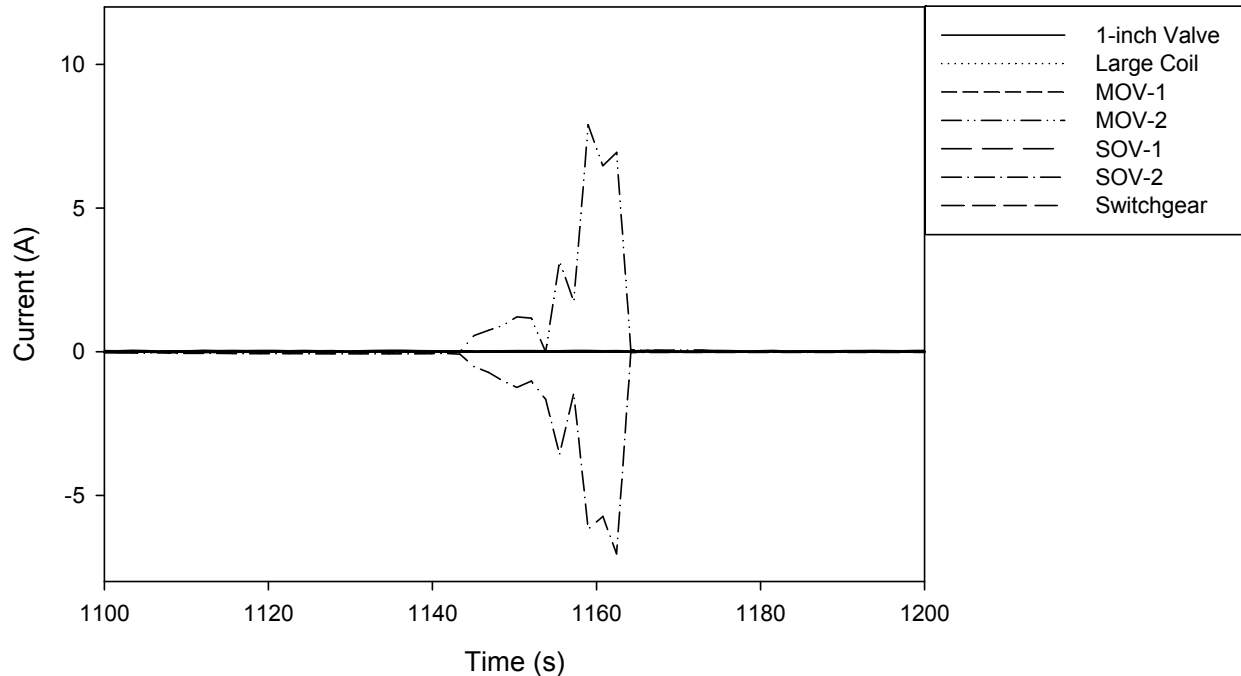
**Figure 5-11. Outstanding current shorting in intermediate-scale test 2, between SOV-2 and MOV-2**

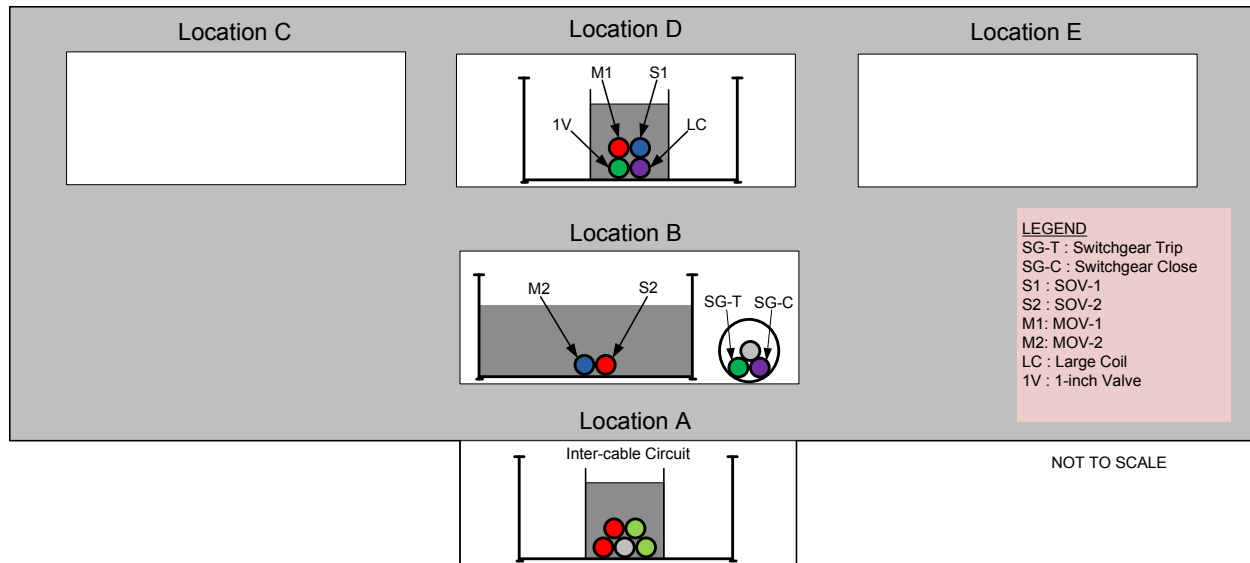
Figure 5-12. Intermediate-scale test 3 cable loading

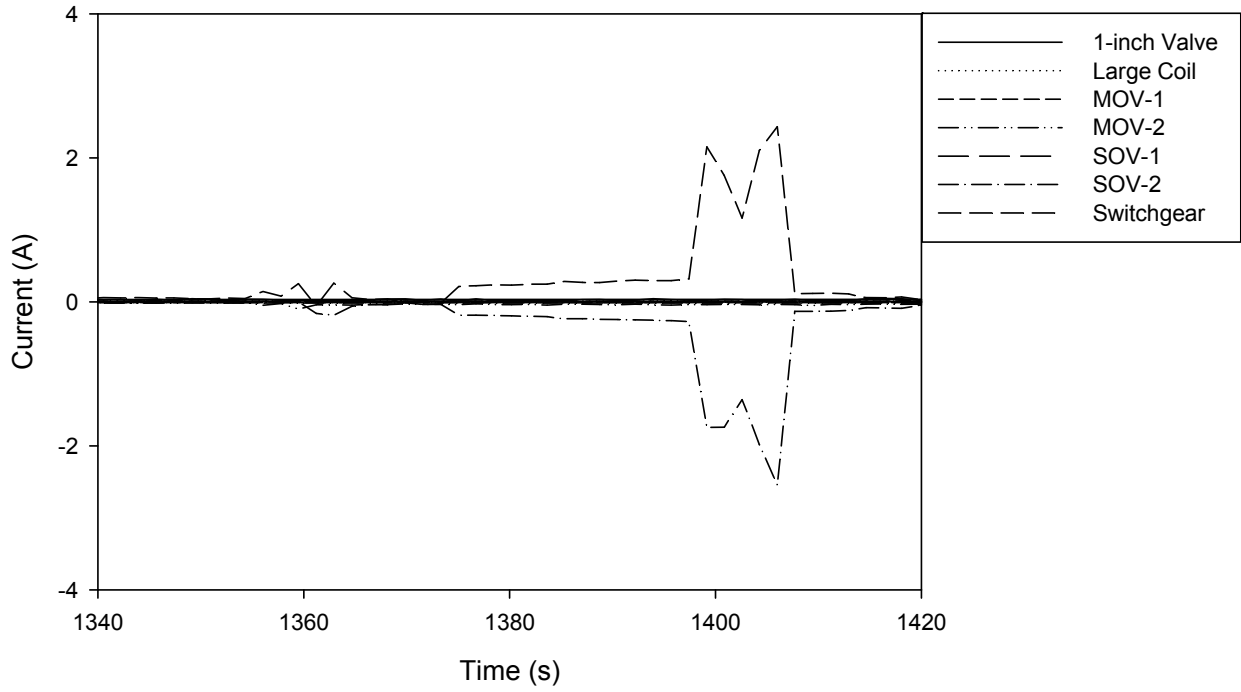
**Figure 5-13. Outstanding current shorting in intermediate-scale test 3, between SOV-2 and SWGR-T**

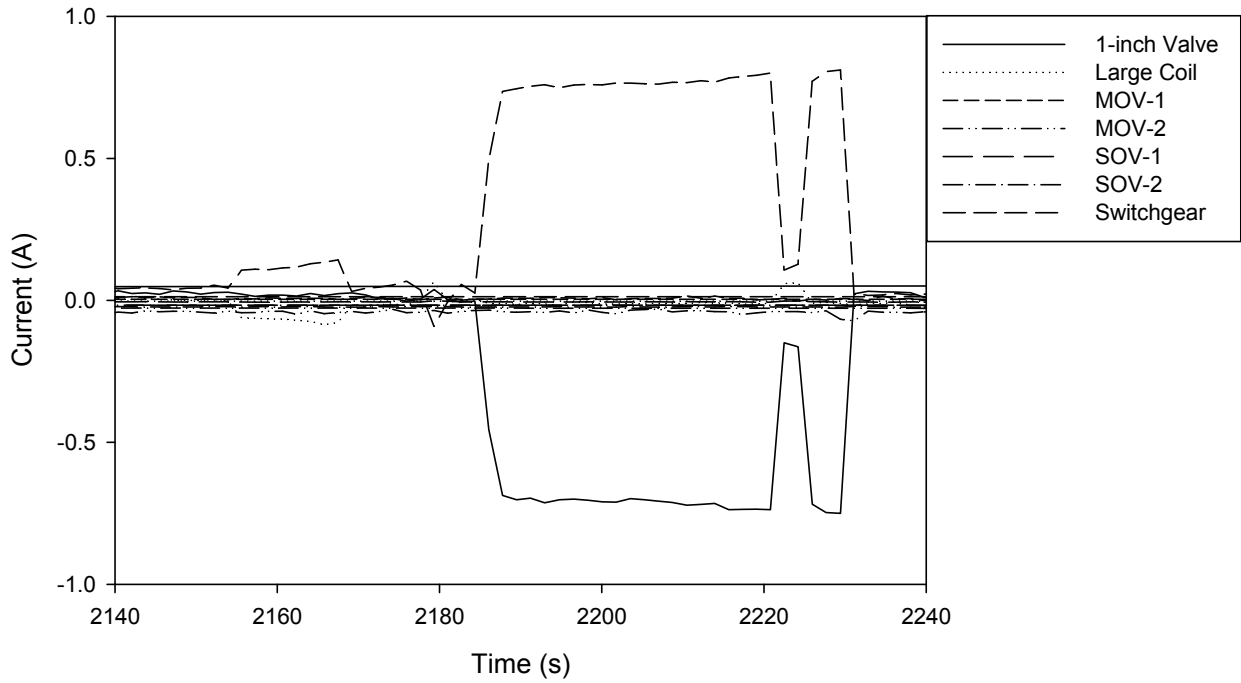
**Figure 5-14. Outstanding current shorting in intermediate-scale test 3, between 1 inch valve and SWGR-T**

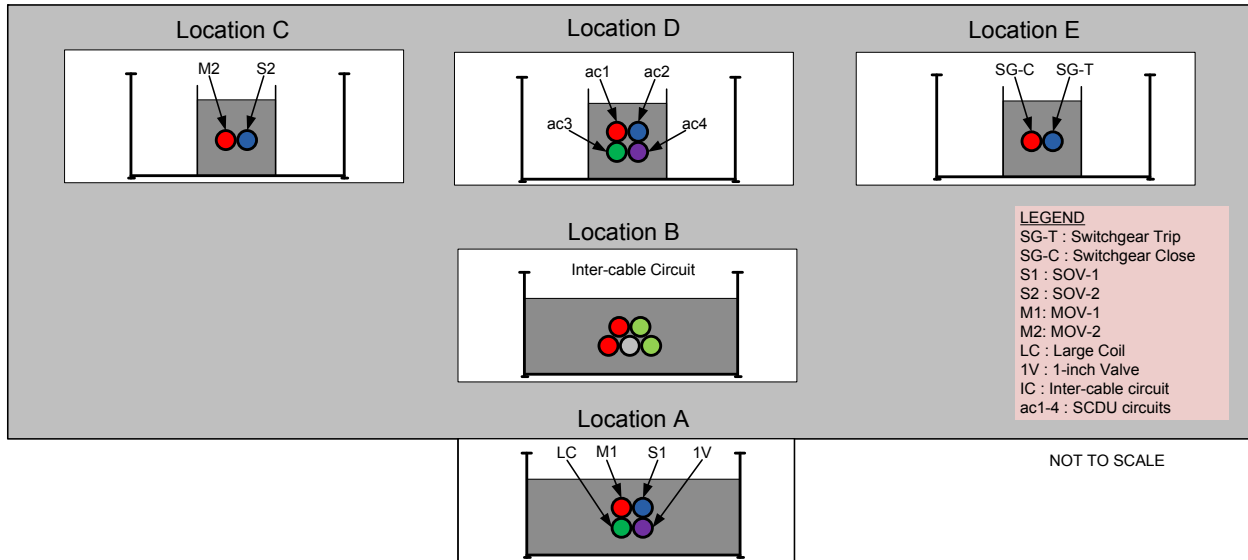
Figure 5-15. Intermediate-scale test 4 cable loading

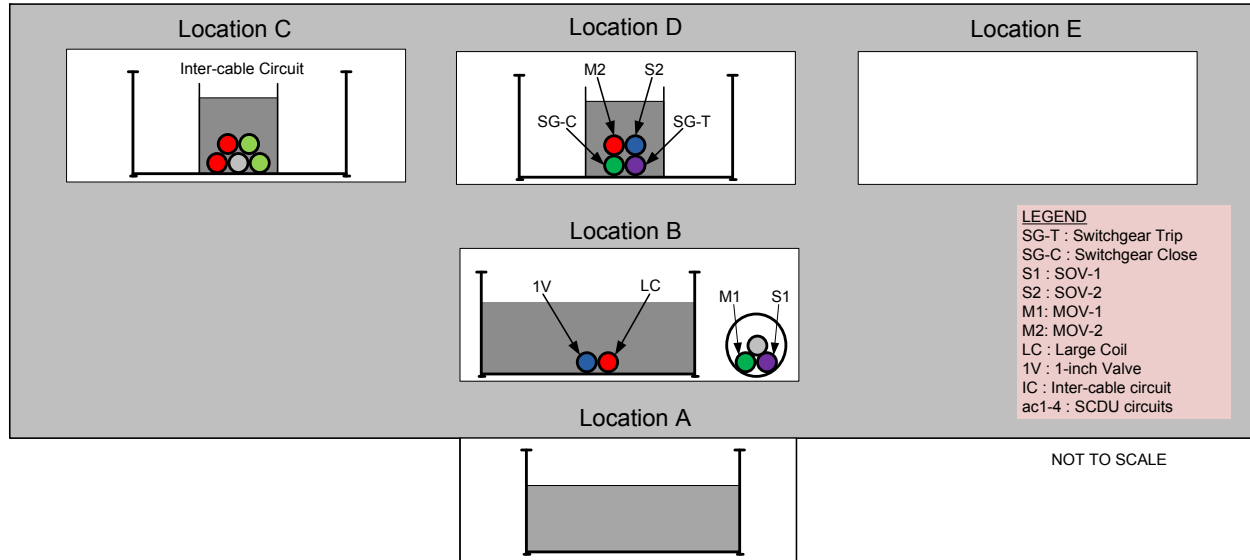
Figure 5-16. Intermediate-scale test 5 cable loading

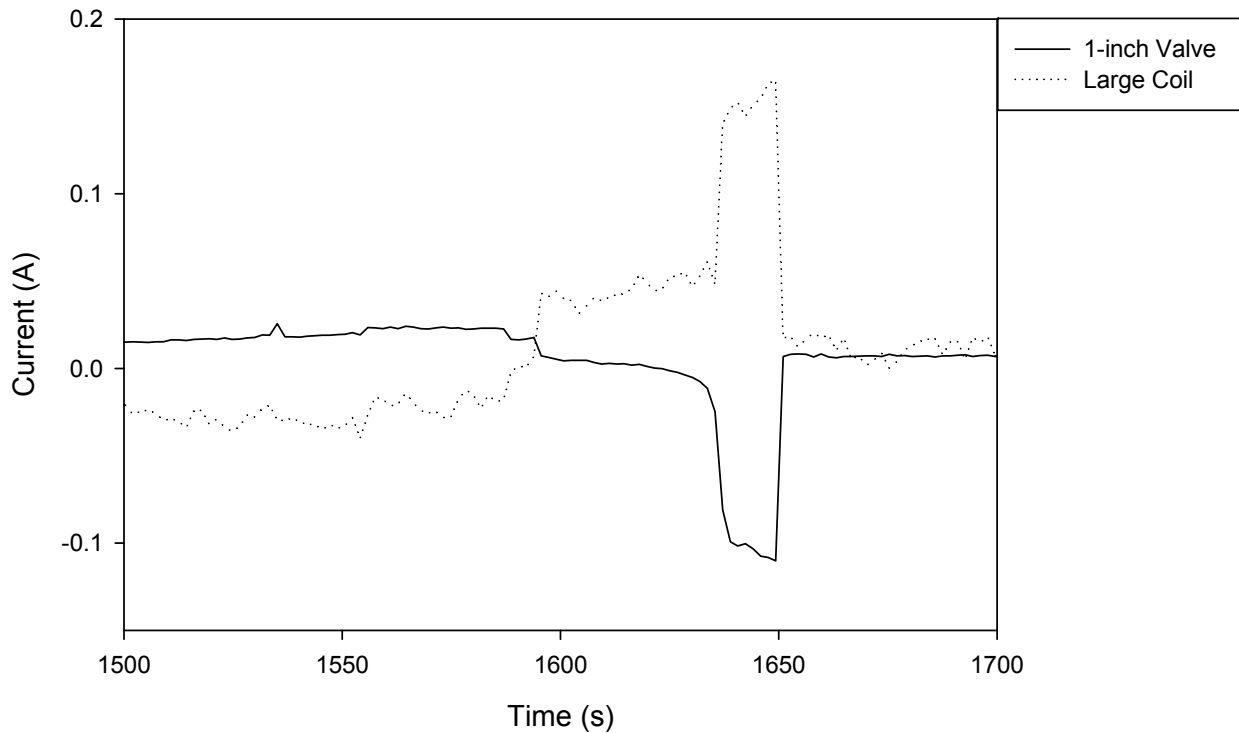
**Figure 5-17. Outstanding current shorting in intermediate-scale test 5, between SOV-1 and SWGR-T**

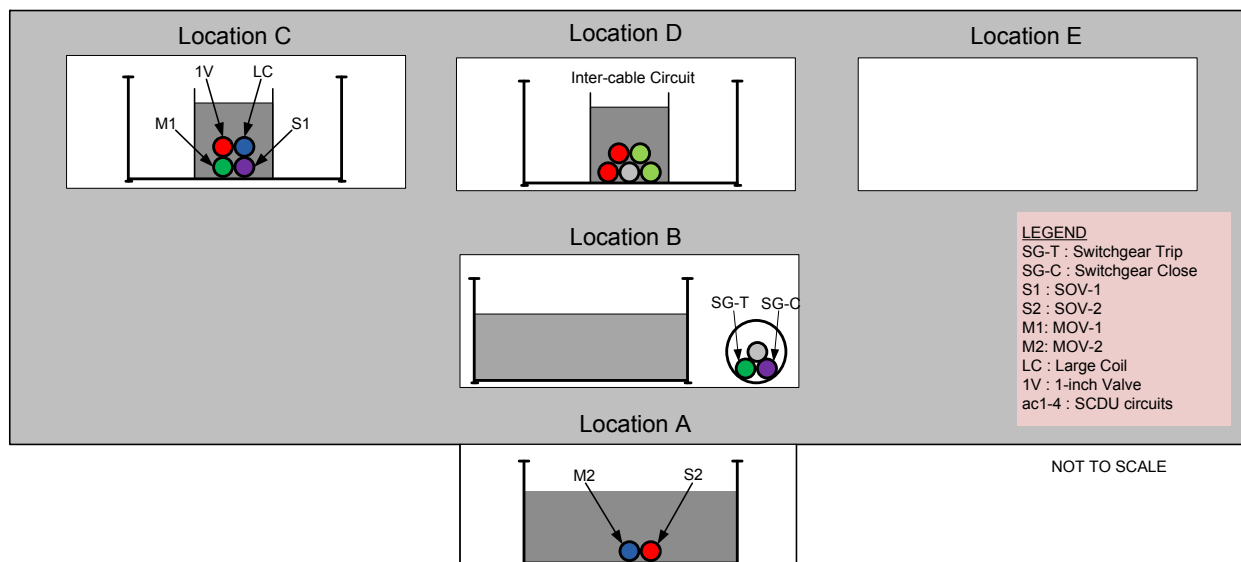
Figure 5-18. Intermediate-scale test 6 cable loading

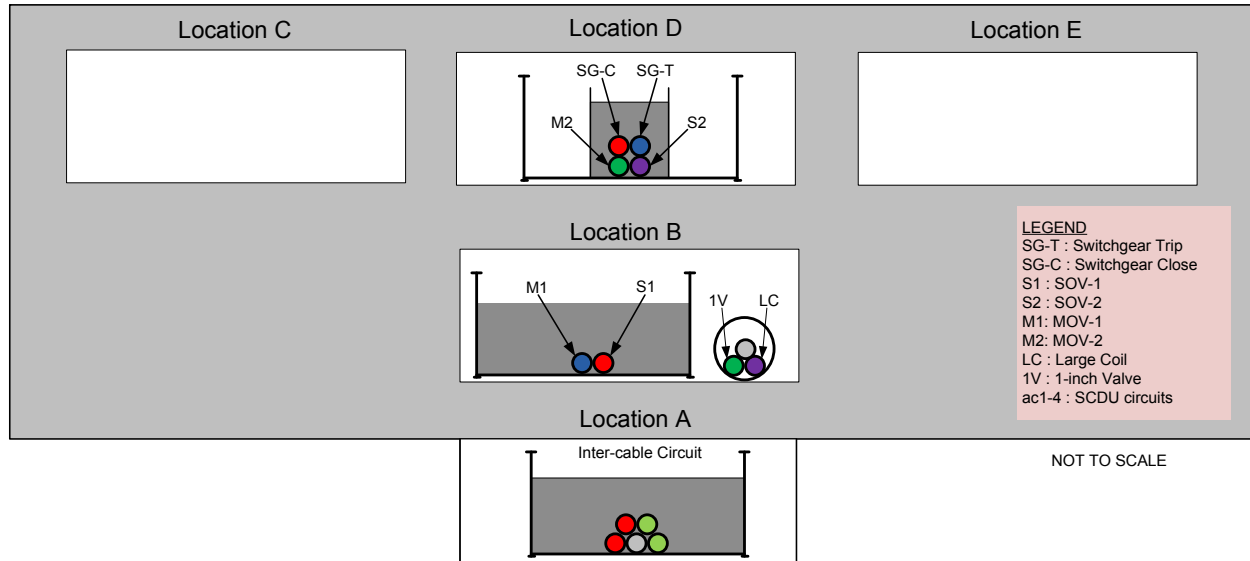
**Figure 5-19. Intermediate-scale test 7 cable loading**

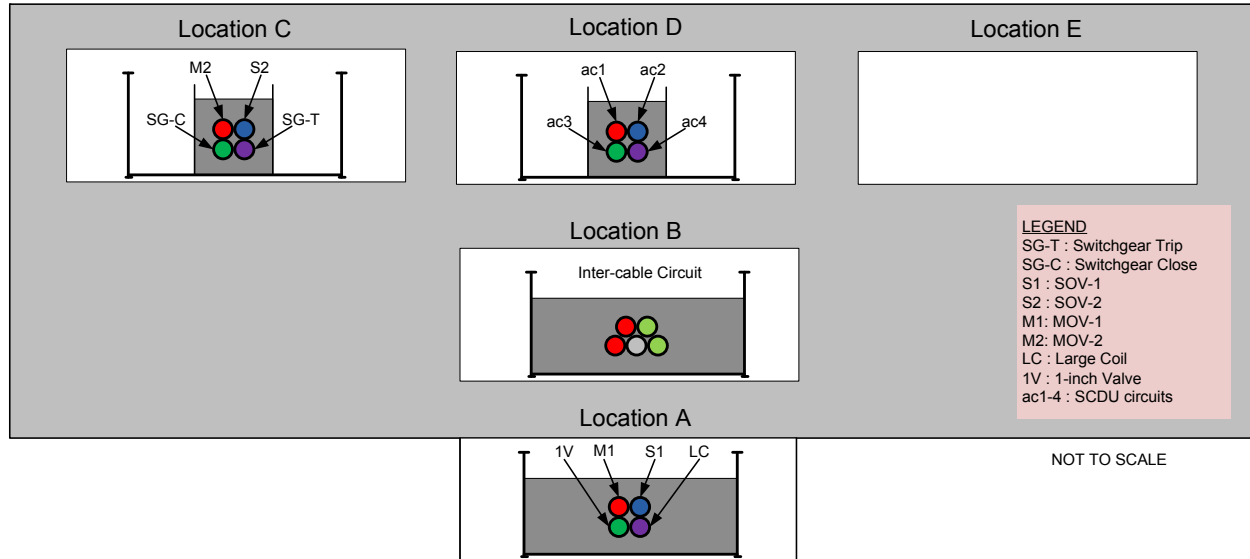
Figure 5-20. Intermediate-scale test 8 cable loading

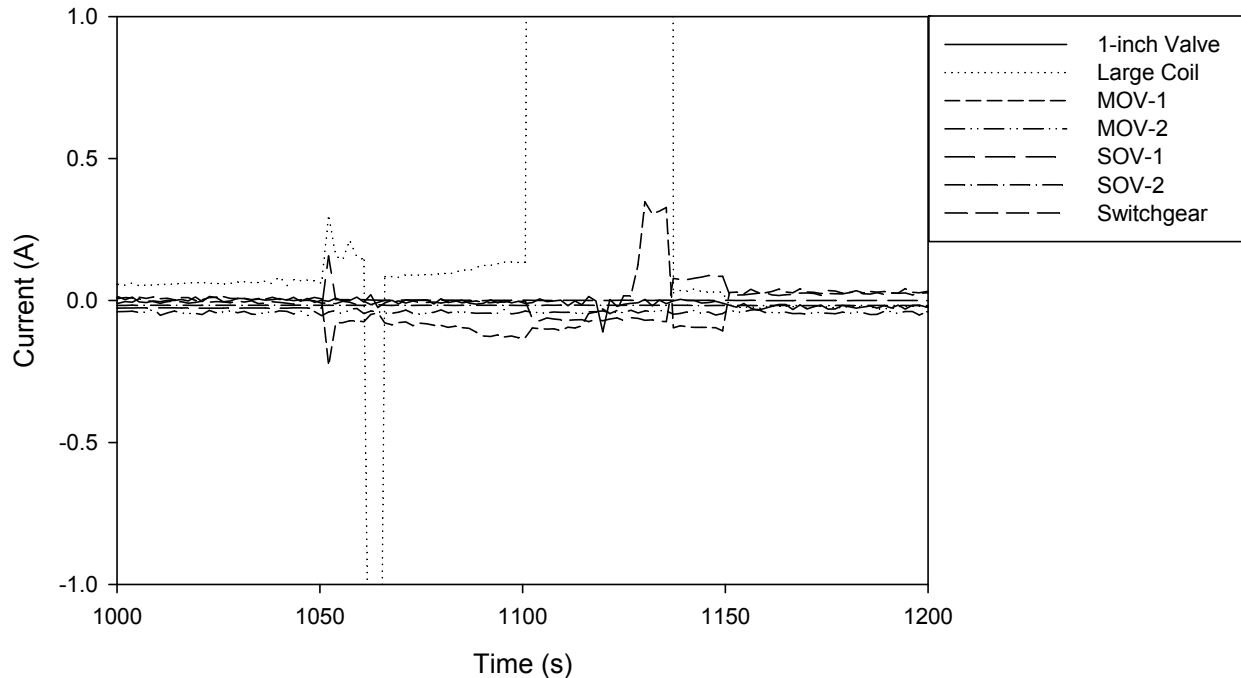
**Figure 5-21. Outstanding current shorting in intermediate-scale test 8, between MOV-1 and Lg Coil**

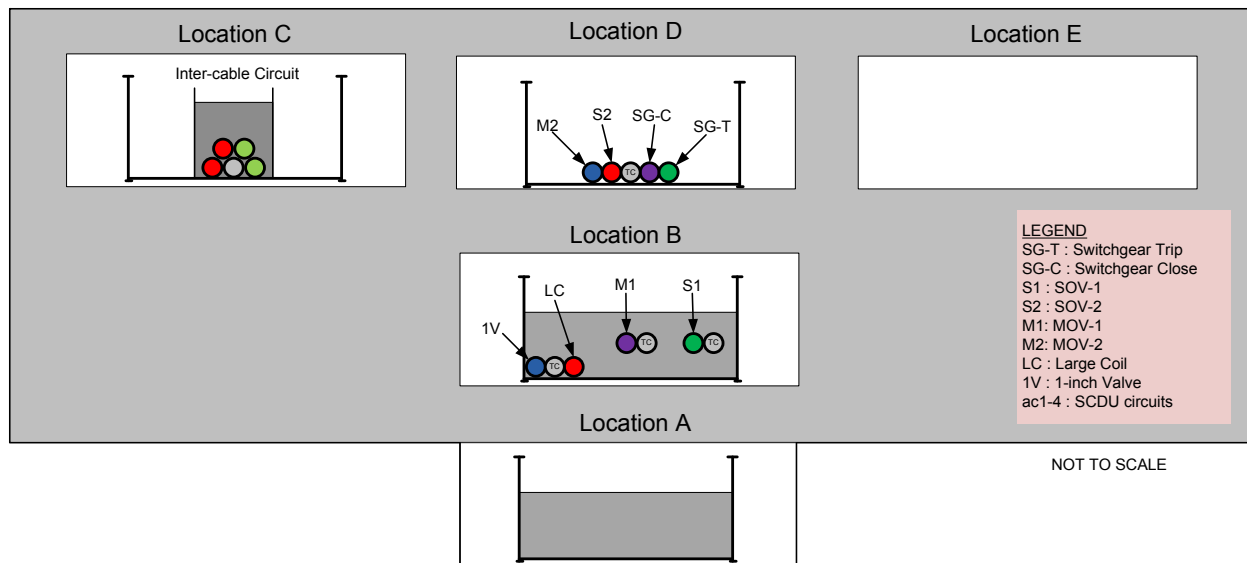
Figure 5-22. Intermediate-scale test 9 cable loading
