# **Electrical Cable Test Results and Analysis During Fire Exposure (ELECTRA-FIRE)**

**A Consolidation of Three Major  
Fire-Induced Circuit and Cable  
Failure Experiments Performed  
Between 2001 and 2011**

Final Report

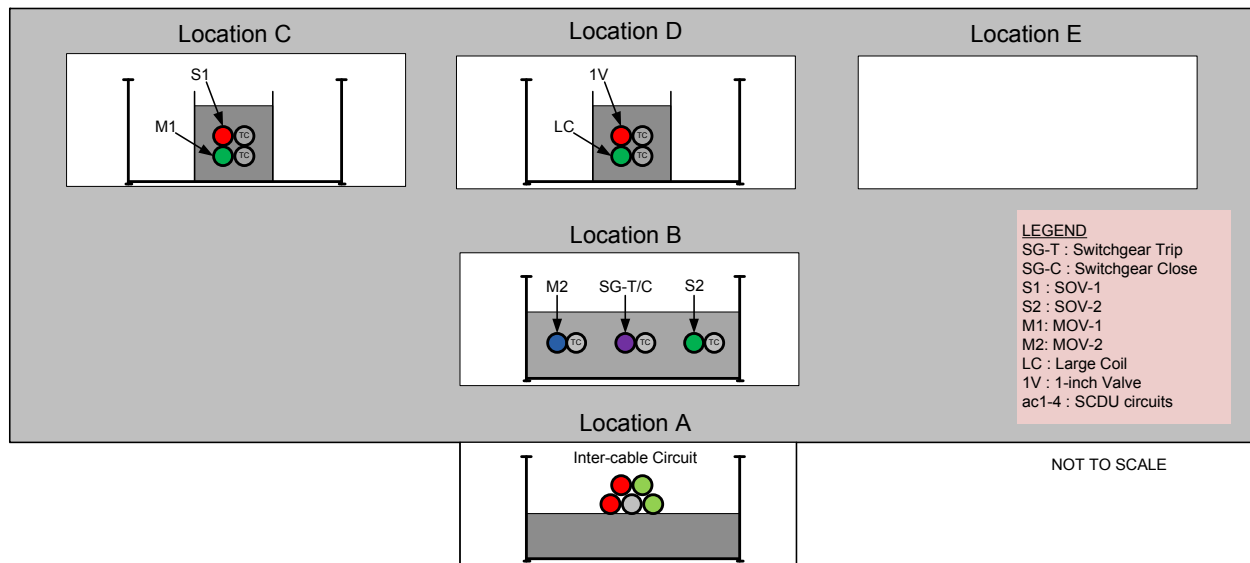
Figure 5-23. Intermediate-scale test 10 cable loading

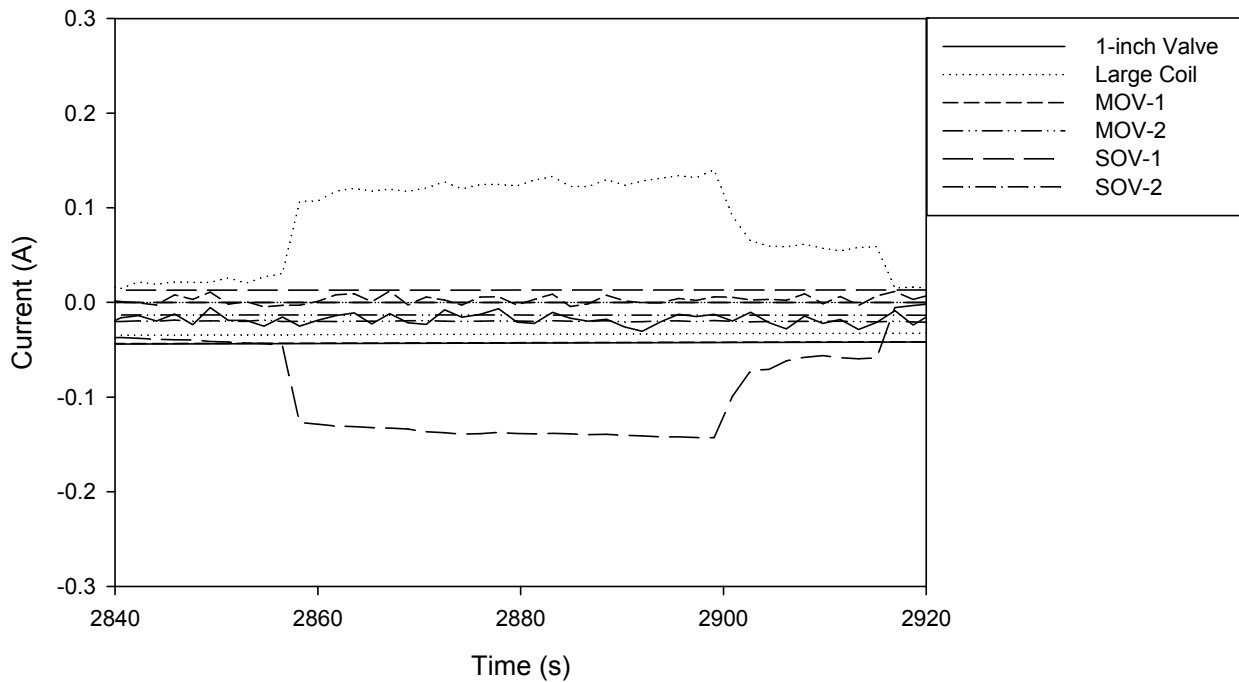
**Figure 5-25. Intermediate-scale test 11 current summation**

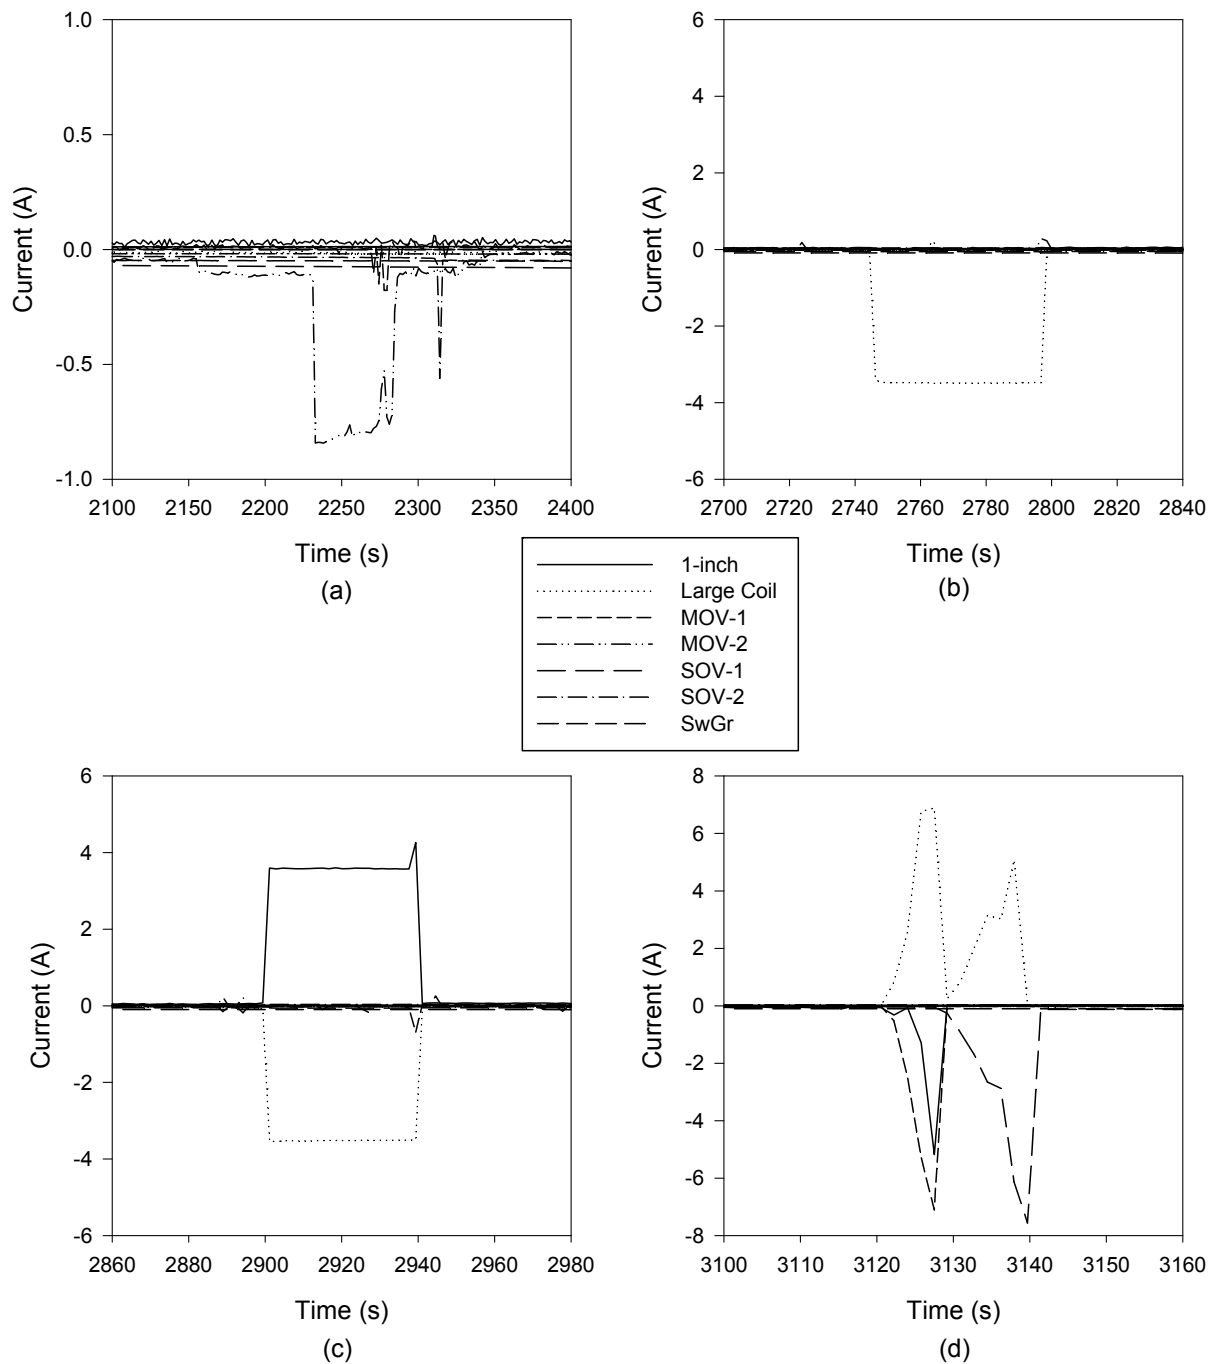
**Figure 5-27. Intermediate-scale test 12 current summation plot**

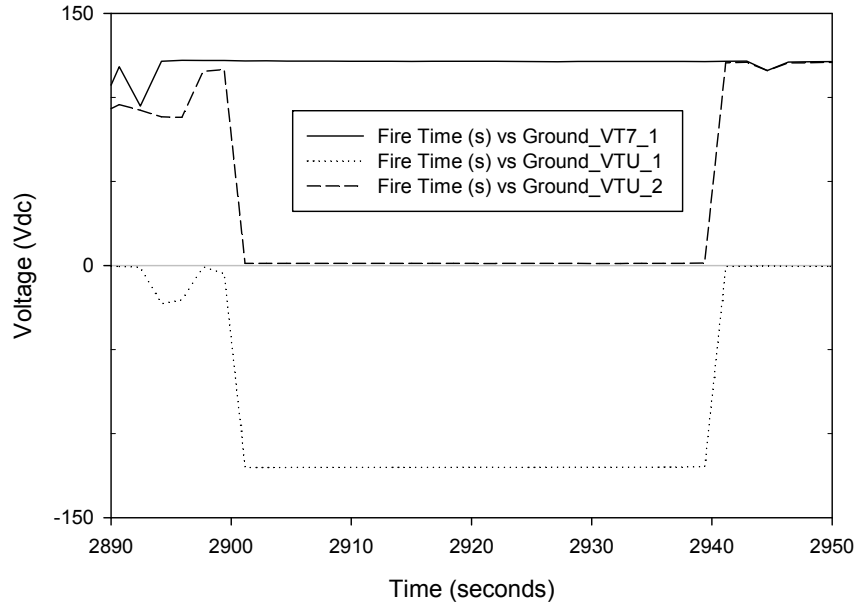
**Figure 5-28. Ground fault detection voltage response for second large coil SO**

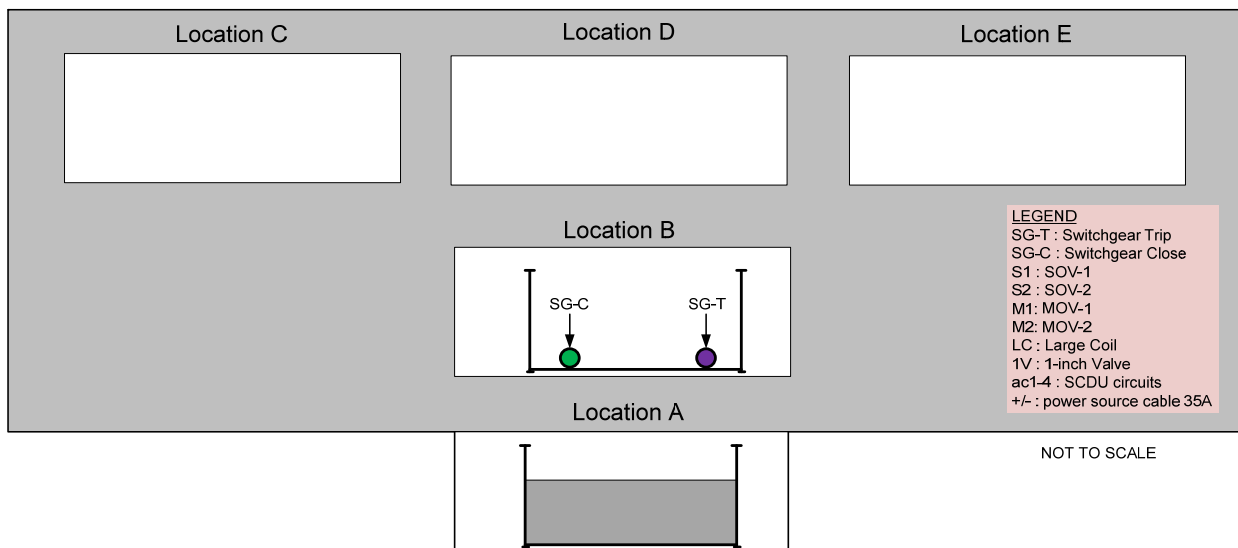
**Figure 5-29. Intermediate-scale test contingency A cable loading configuration**

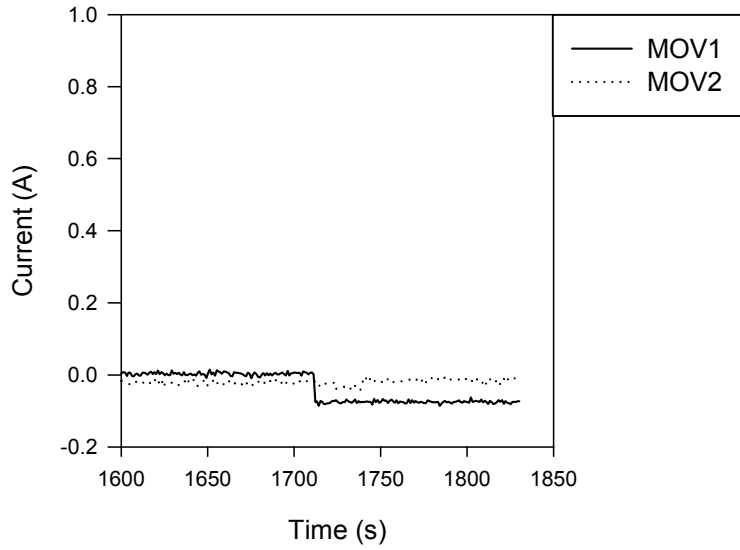
**Figure A-13. Outstanding current shorting in Penlight MOV Test #37**

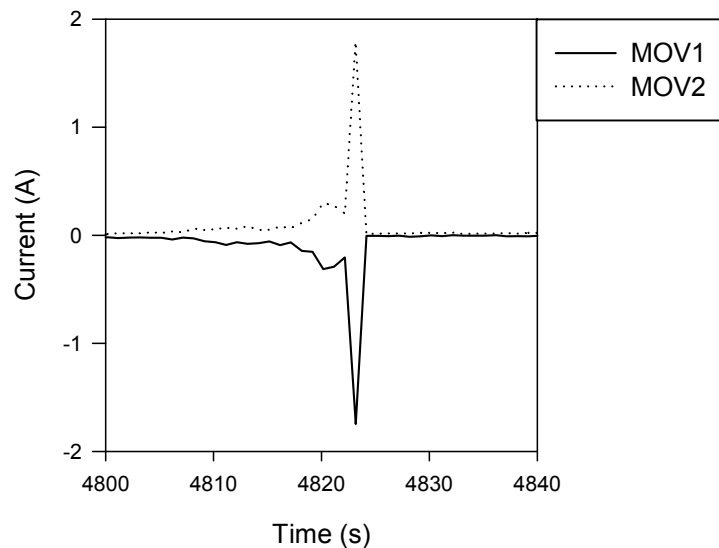
**Figure A-19. Outstanding current shorting in Penlight MOV Test #49**

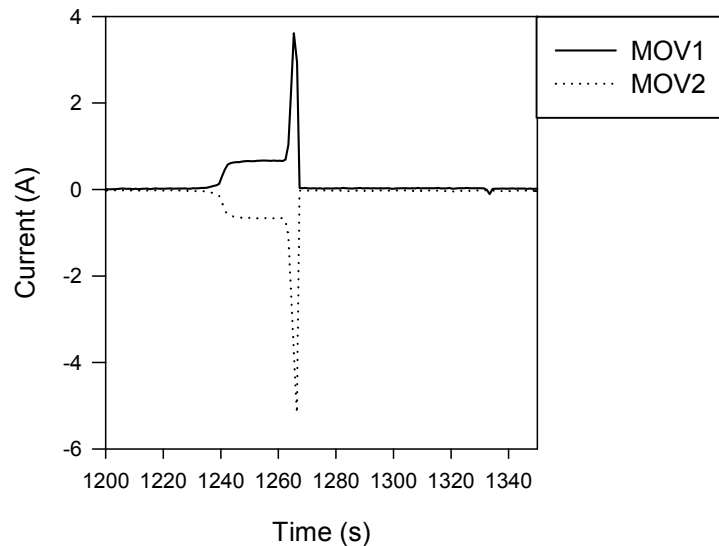
**Figure A-22. Outstanding current shorting in Penlight MOV Test #50**

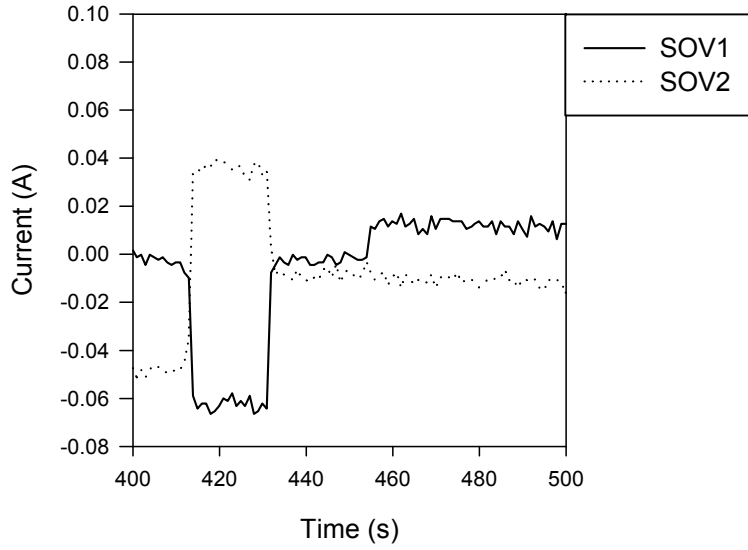
**Figure A-34. Outstanding current shorting in Penlight SOV Test #31**

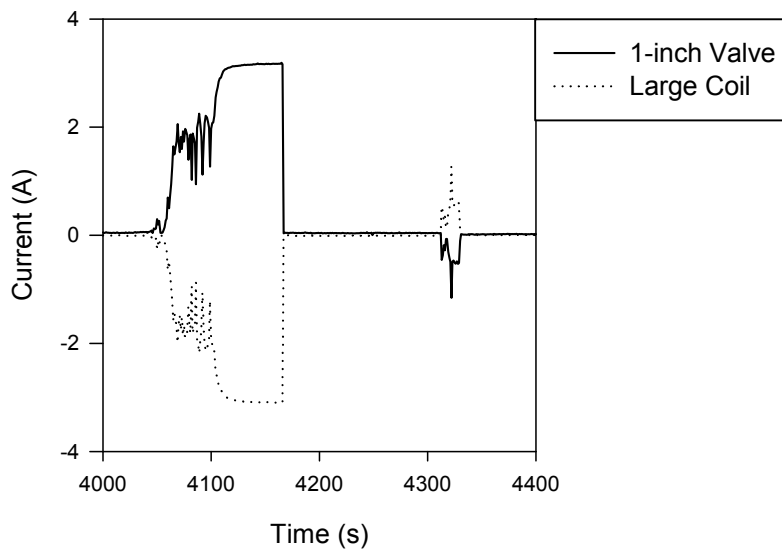
**Figure A-40. Outstanding current shorting in Penlight 1-inch valve and large Coil Test #40**
