Subject: Corrected 2020 Annual Radiological Environmental Operating Report
River Bend Station – Unit 1
Renewed Operating License No. NPF-47
Docket No. 50-458

Plant: River Bend Station	Page 1 of 44
	YEAR: 2020
Document Number: RBG-48093	
Annual Radiological Environmental Operating Report

Annual Radiological Environmental Operating Report

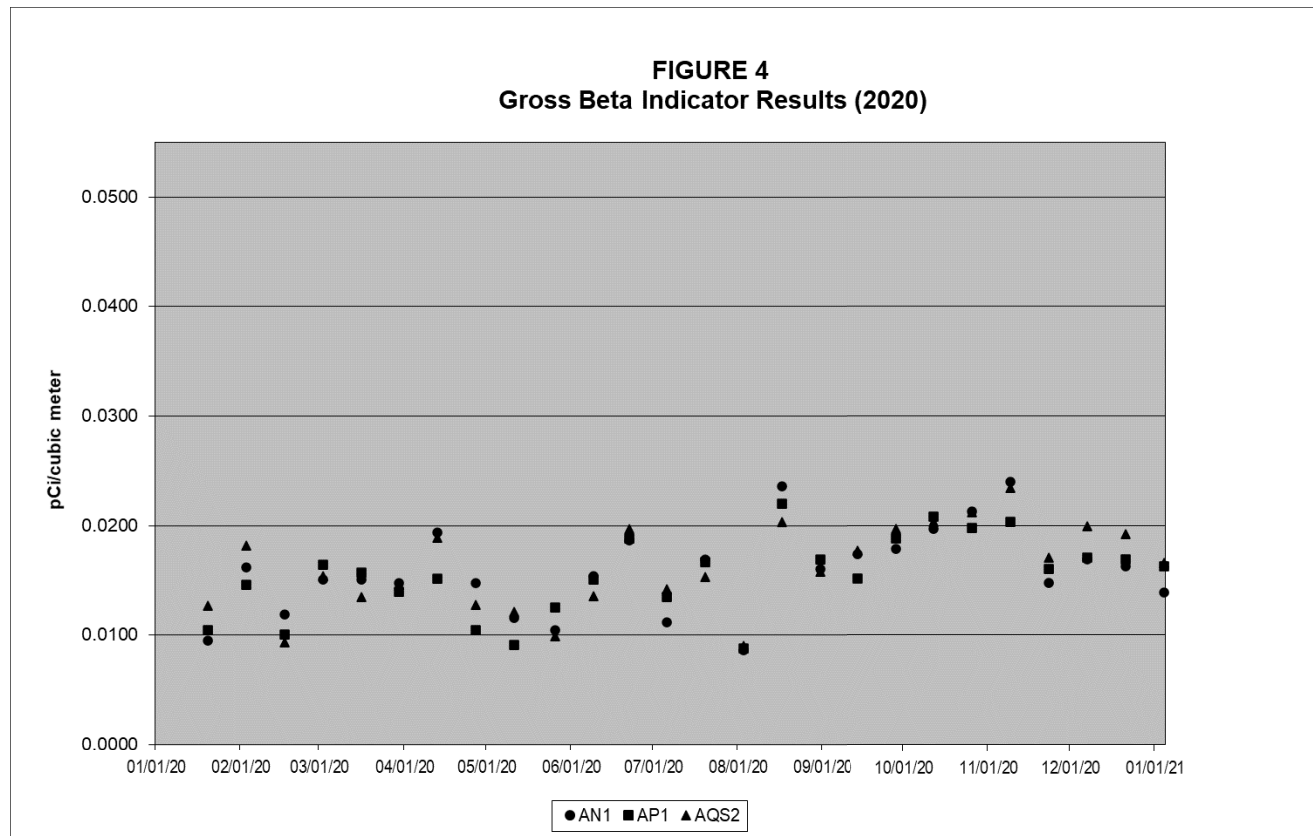
Figure 4: Gross Beta Indicator Results (2020).....17

In 2020 there were no samples above the LLD for I-131. Indicator gross beta air particulate results for 2020 were comparable to results obtained from 2010-2019 of the operational REMP. Also, the 2020 gross beta annual average was less than the average for preoperational levels. Results are reported as annual average picocuries per cubic meter (pCi/m³).

Gross beta activity is attributed to naturally occurring radionuclides. Table 6, which include gross beta concentrations and provide a comparison of the indicator and control means and ranges emphasizes the consistent trends seen in this pathway to support the presence of naturally occurring activity. Therefore, it can be concluded that the airborne pathway continues to be unaffected by River Bend Station operations.

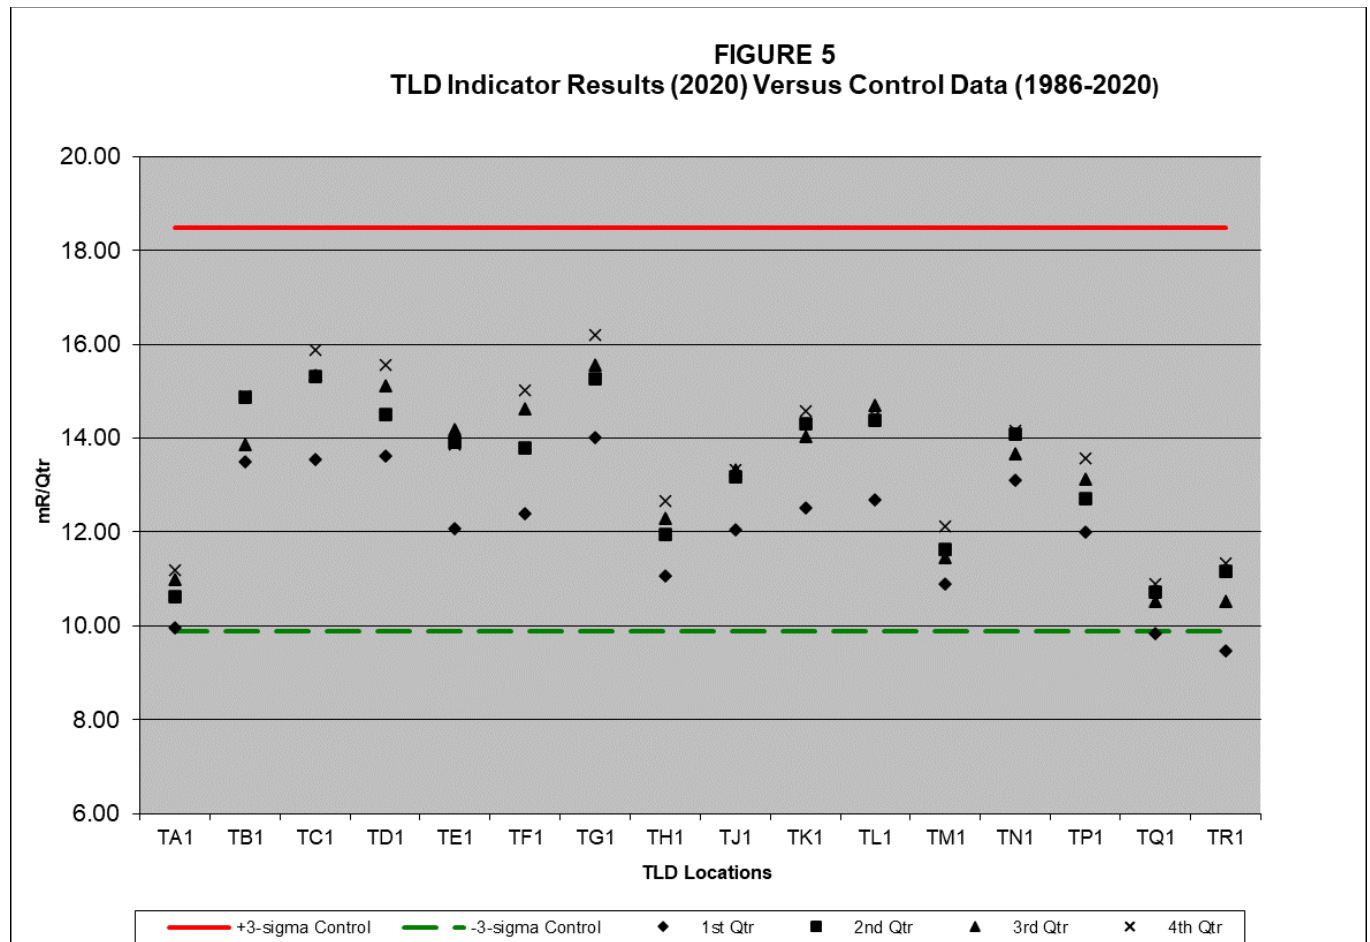
Figure 5: TLD Indicator Results (2020) Versus Control Data (1986-2020).....18

River Bend Station reports measured dose as net exposure (field reading less transit reading) normalized to 90 days and relies on comparison of the indicator locations to the control as a measure of plant impact. River Bend Station's comparison of the indicator and special interest area TLD results to the control, as seen in Table 6, identified no noticeable trend that would indicate that the ambient radiation levels are being affected by plant operations. In addition, the indicator value of 13.1 millirem (mrem) shown in the TLD radiation dose comparison graph below shows the 2020 concentration is comparable to historic results. Overall, River Bend Station concluded that the ambient radiation levels are not being affected by plant operations.
