# Dry Cask Storage Characterization Project—Phase 1: CASTOR V/21 Cask Opening and Examination

Idaho National Engineering and Environmental Laboratory

U.S. Nuclear Regulatory Commission  
Office of Nuclear Regulatory Research  
Washington, DC 20555-0001

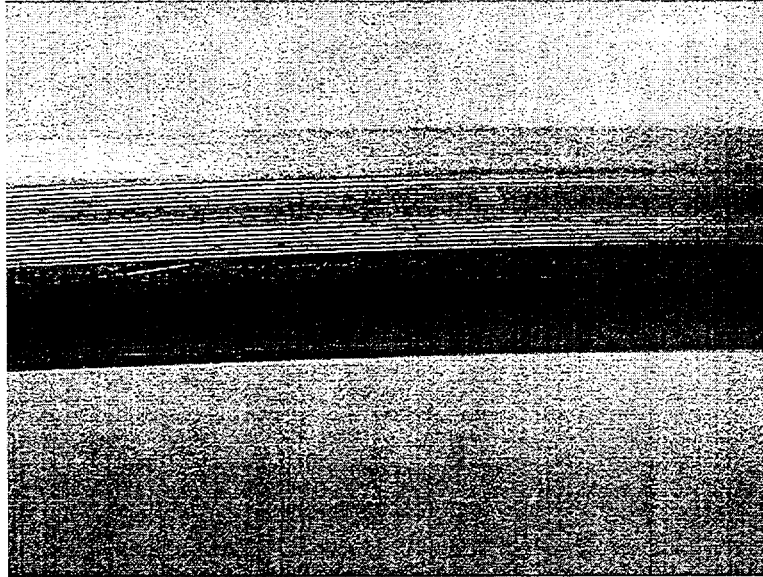
- Several pinpoint indentations, some on sealing surface; typically <0.5 mm dia, probably <0.5 mm deep

Figure 2-11. Primary lid metal O-ring crushed dimensional configuration.

Figures 2-12. Primary lid metal O-ring.

- Several light scratches, a few across the sealing surface; most have metal glint in scratch root, indicating fresh scratches
- No evidence of significant general corrosion, pitting corrosion, stains
- Sealing surface defined by the impression of the machining marks from the seal surface on cask
- No evidence of significant oxidation or spallation of these fine line features
- No deformation of the individual line impressions despite numerous cycles of lid removal/replacement during fuel inspection.
