## SEISMIC WALKDOWN CHECKLIST FORM

Status: Y  N  U Seismic Walkdown Checklist (SWC) SWEL2-008Equipment ID No. 19P-1A Equip. Class 5. Horizontal pumpsEquipment Description: Fuel pool cooling recirc pump ALocation: Bldg. RB Floor El. 326 Room, Area Col 3 line T

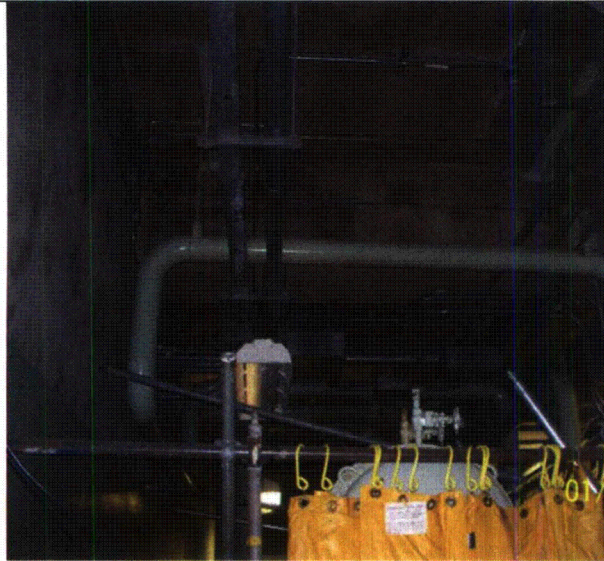
**Note:** 19E-1A with lead shielding around it.  
(The date provided on the bottom right corner  
is not correct the date that the picture was  
taken. Malfunction with camera setting)

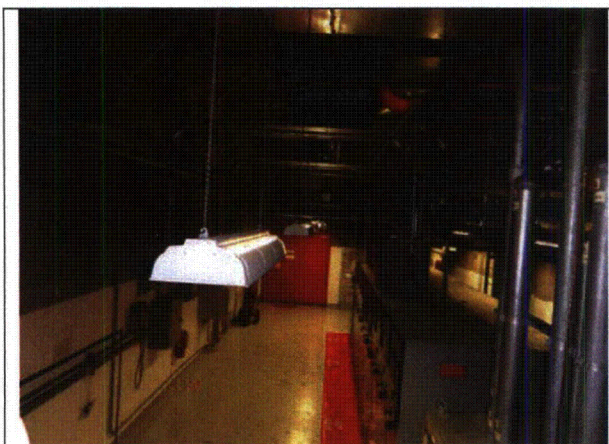
Note: *Light Fixture and MCC's*

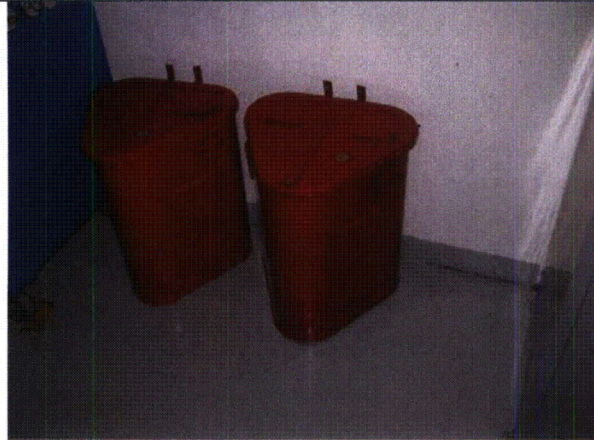
**Note:** *Picture of the clean/dirty rags.*

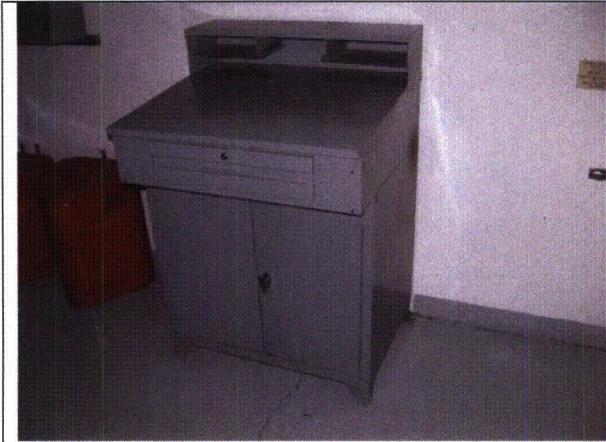
**Note:** *Picture of the work bench.*

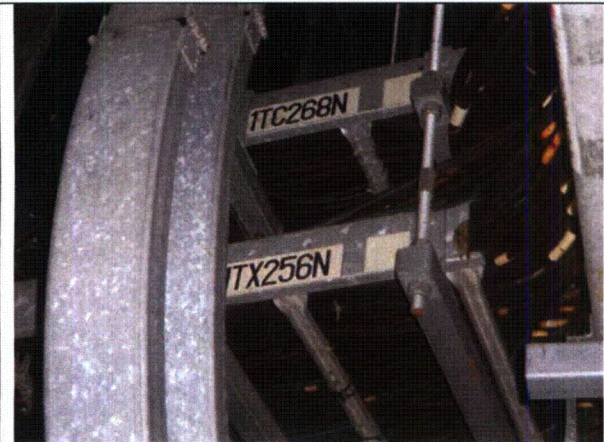
**Note:** *Cable trays*
