Status: Y N U **Seismic Walkdown Checklist (SWC) SWEL1-065**Equipment ID No. F-52B Equip. Class¹ 17 – ENGINE GENERATORSEquipment Description DG2 ENGINE MOUNTED TURBO FILTERLocation: Bldg. RAB Floor El. 369 Room, Area 86Manufacturer, Model, Etc. (optional but recommended) Electro-Motive**Instructions for Completing Checklist**

Seismic Walkdown Checklist (SWC) SWEL1-065

Equipment Description DG2 ENGINE MOUNTED TURBO FILTER

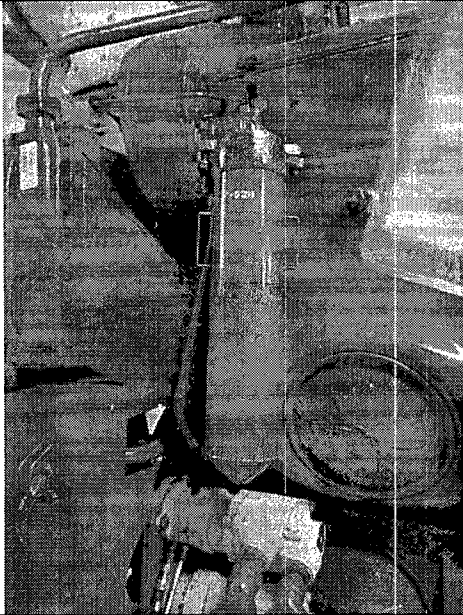
Note: *Component Overview*

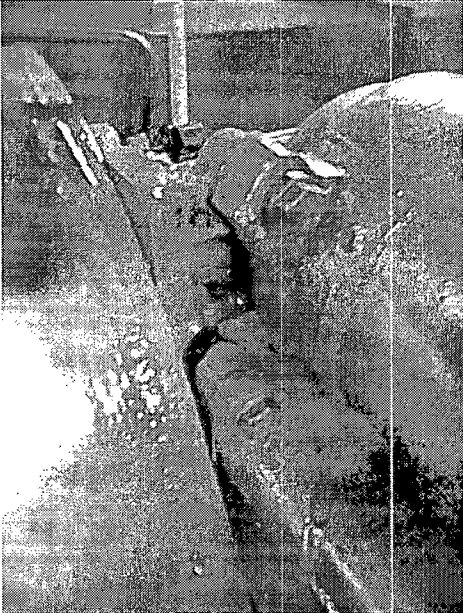
Note: *Component Bolts*

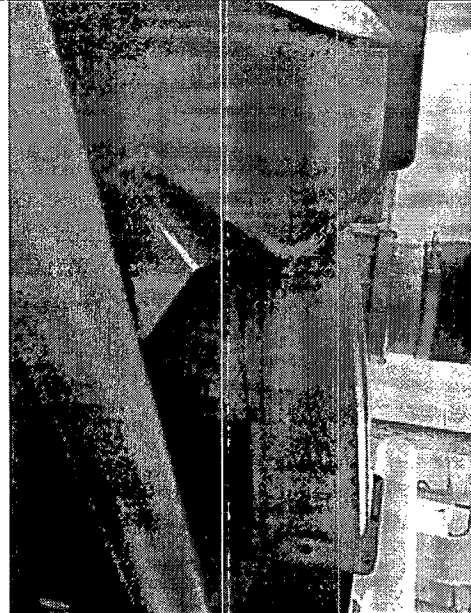
Note: Component Overview

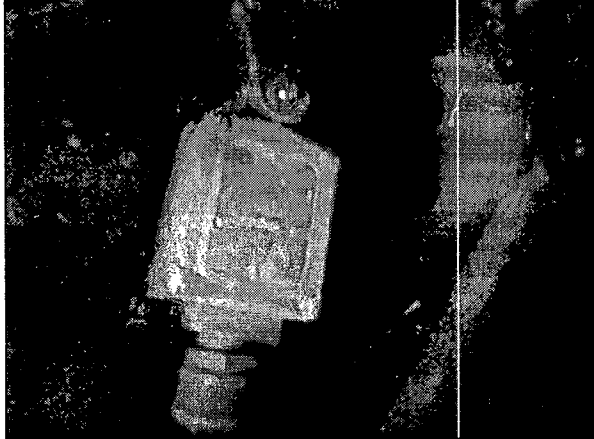
Note: *The manufacturer tag is shown for the overspeed trip switch.*

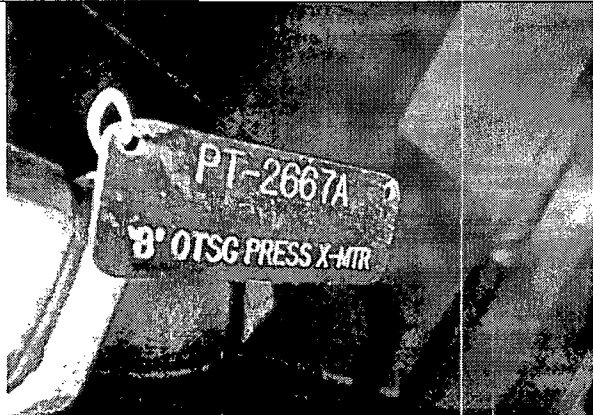
Note: General image of the equipment tag, PT-2667A.

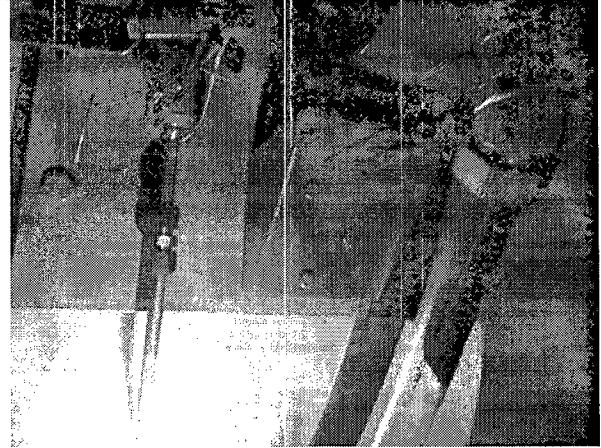
Note: General image of the PT-2667A.

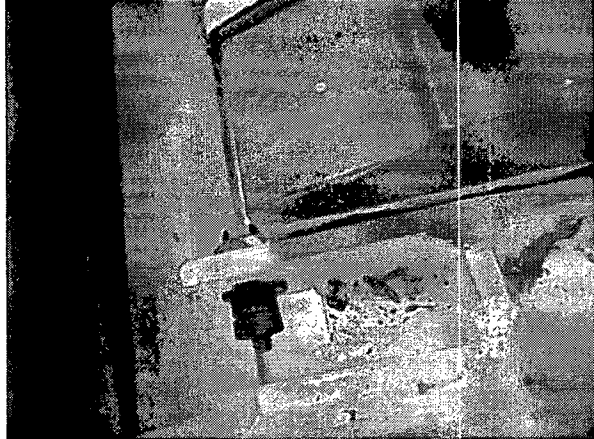
Note: Overhead view of the switch showing the anchor bolt not visible in the previous image.

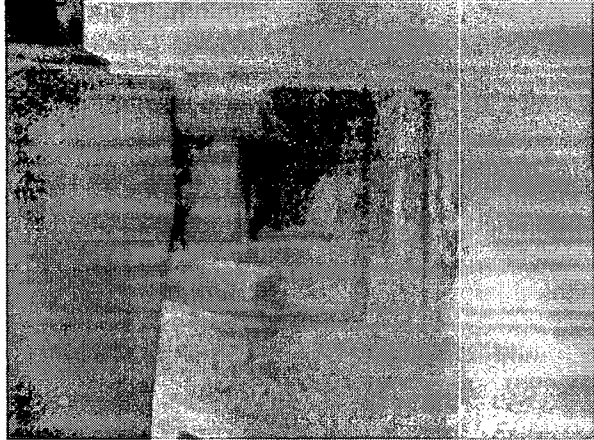
Note: *TS-7904 Temperature Sensor, Uni-Strut Anchorage to Wall.*

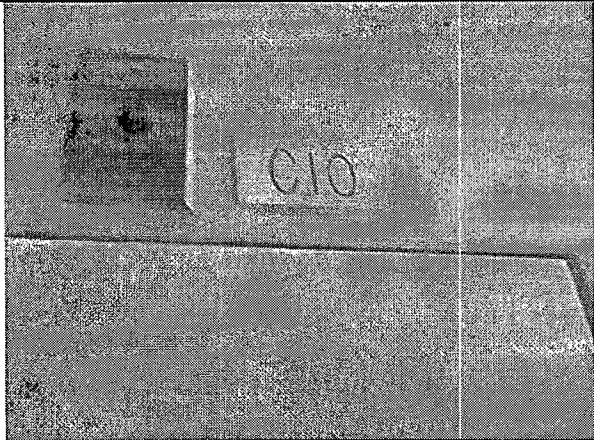
Note: Cabinet C10 tag from the back.

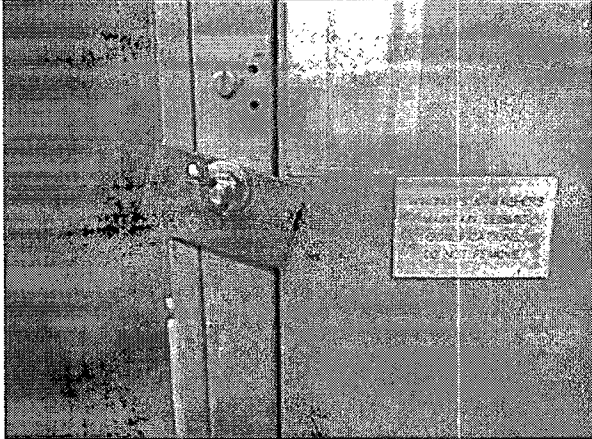
Note: *Wingnut and washer are used to keep the metal plate over the door to keep it from swinging open. As the nameplate reads, this is necessary to maintain seismic qualifications for the cabinet.*

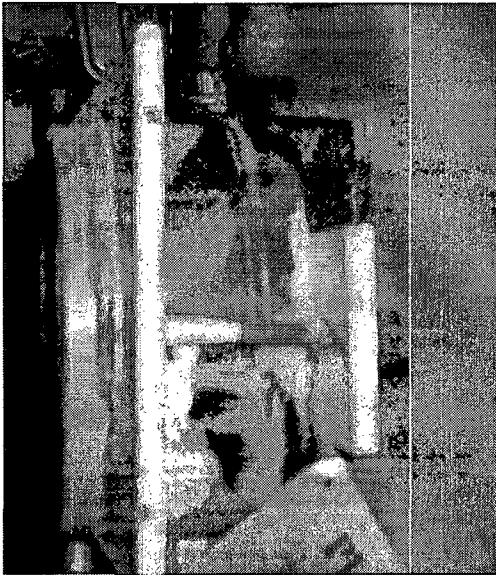
Note: Note that the additional anchors found within the component are free from any signs of corrosion.

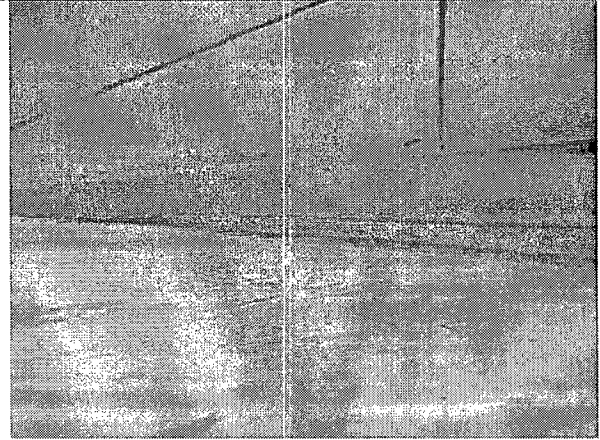
Note: View of the bottom of the cabinet from the outside. Consistent with plant documentation, no anchorage is visible without opening the cabinet.

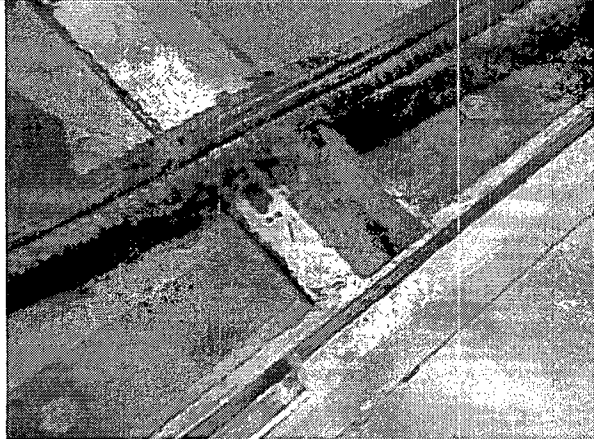
Note: View of a weld to the embedded steel channel, and an anchor bolt for the embedded steel channel.

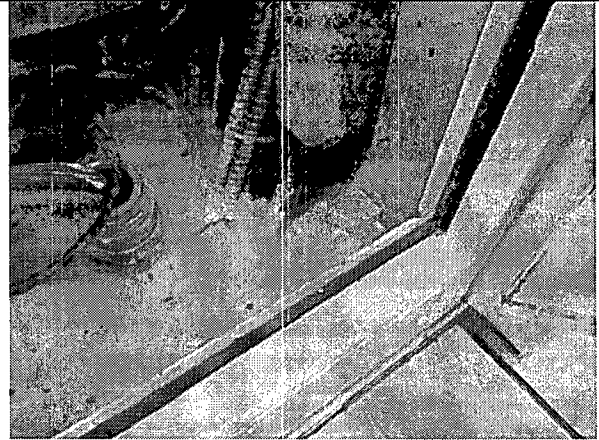
Note: *View inside the bottom of the cabinet with the front door open. Anchorage is not visible.*

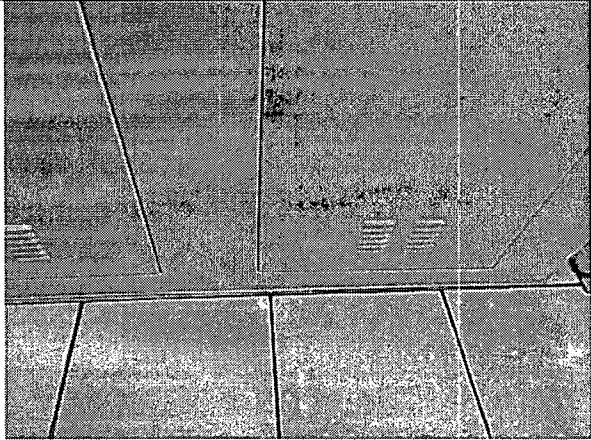
Note: *Shown above are the louvers on the rear doors of cabinet C-26. No anchorage is visible from the rear of the cabinet.*

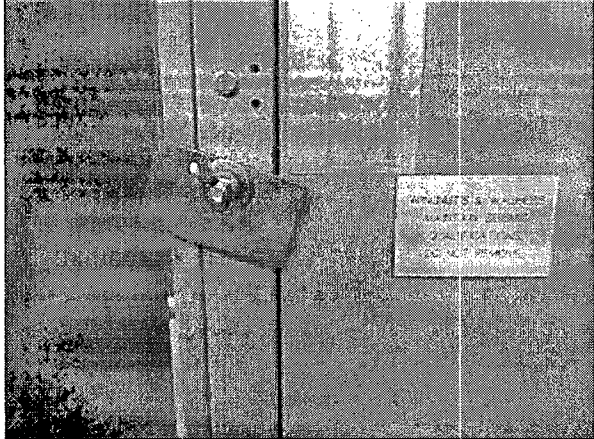
Note: *Wingnut and washer are used to keep the metal plate over the door to keep it from swinging open. As the nameplate reads, this is necessary to maintain seismic qualifications for the cabinet.*

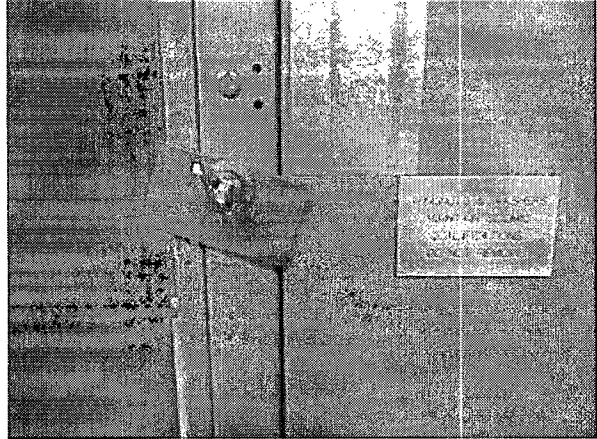
Note: *Wingnut and washer are used to keep the metal plate over the door to keep it from swinging open. As the nameplate reads, this is necessary to maintain seismic qualifications for the cabinet.*

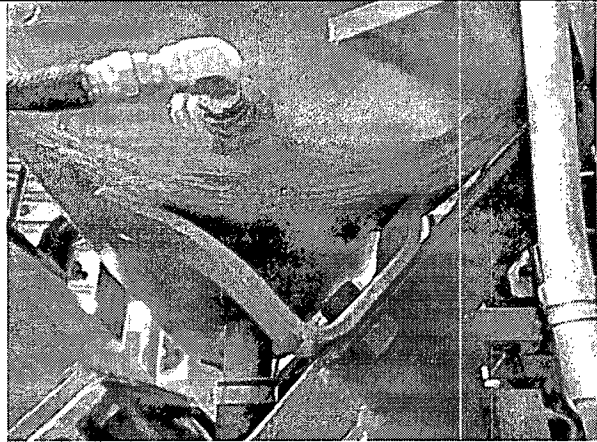
Note: Close-up view of T-78A welded to bracket used to bolt to steel frame on skid. View from North side of skid.

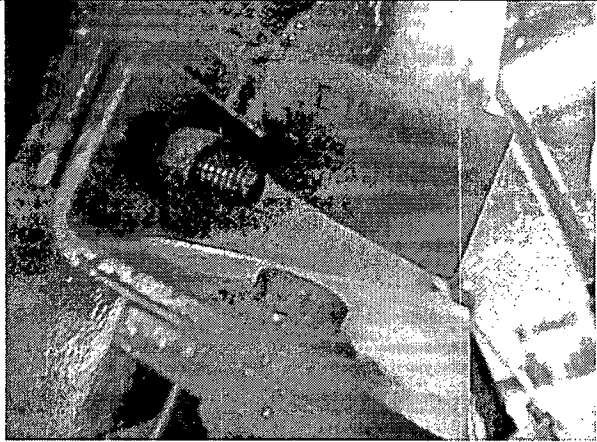
Note: Close-up view of equipment ID tag and bolts anchoring heat exchanger to the steel frame.

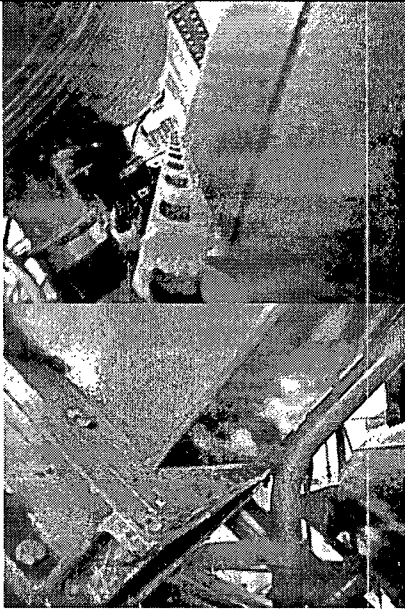
Note: View of anchor bolts along the upper (top) and lower (bottom) edges of the heat exchanger.

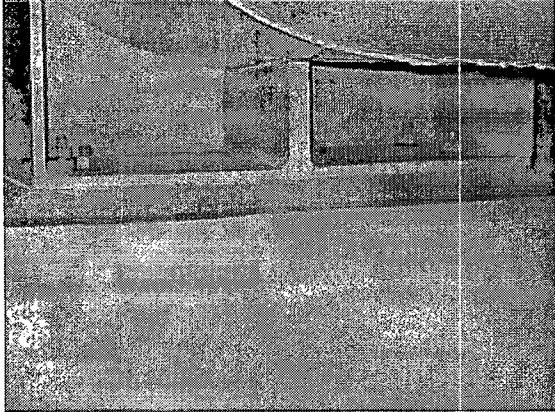
Note: Anchorage

The anchorage found in the system appeared to be in very good conditions. Anchor bolts did not show any signs of oxidation, nor were cracks in the concrete piers detected. No tag ID was found for this component, but it was clear to determine the identity of this equipment item due to its description and large size.

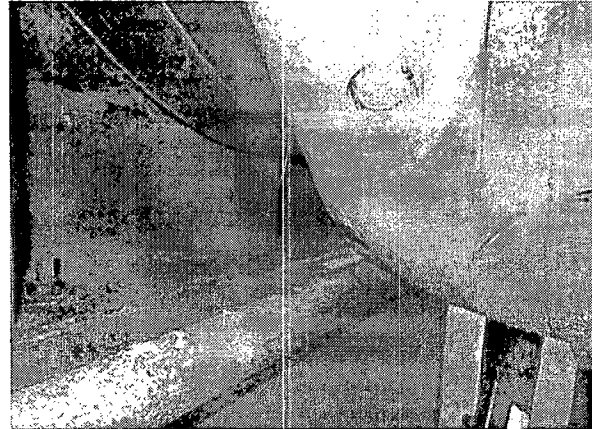
Note: *Anchorage on the other side of the component also appears to be in adequate conditions.*

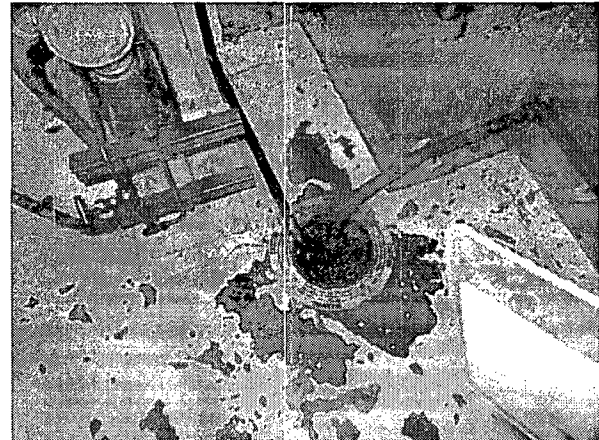
Note: *Drains are present in the area, thus mitigating any seismic hazards that would cause flooding.*

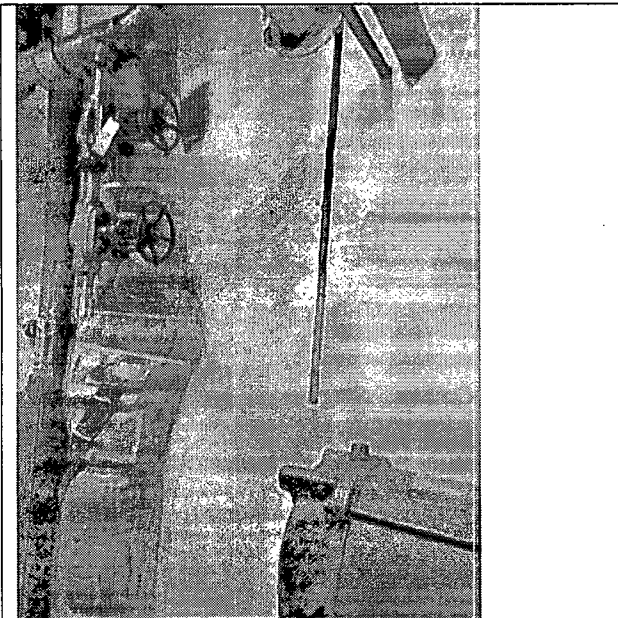
Note: Room 56 insulated pipe with plastic wrap near component CV-1276.

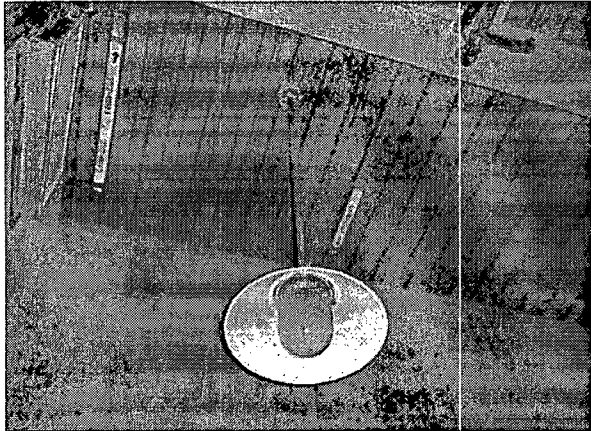
Note: *Lighting appeared to be adequately secured in the area.*

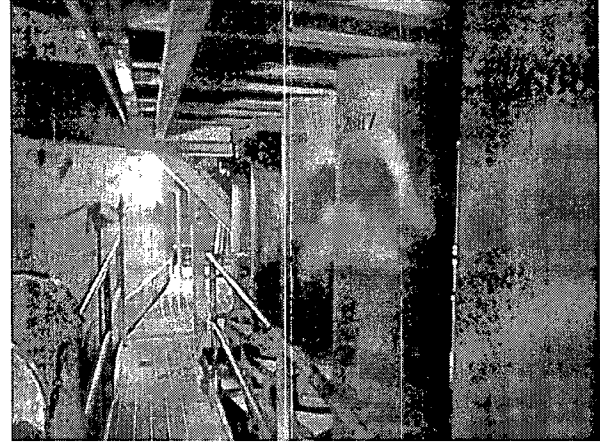
Note: *This is a general image of the area. No housekeeping concerns were observed.*

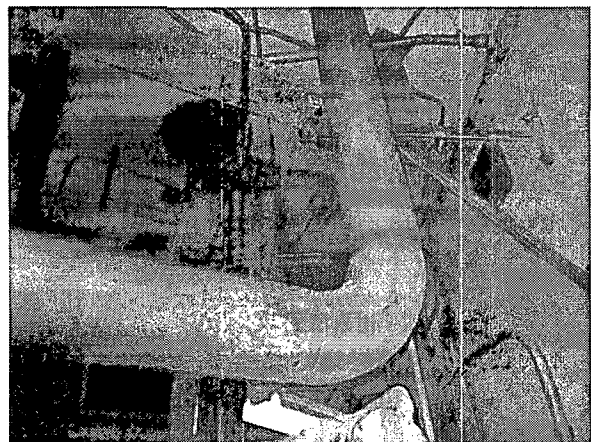
Note: Anchorage in the area has been shown to be in proper conditions. No signs of corrosion and concrete cracking have been found.

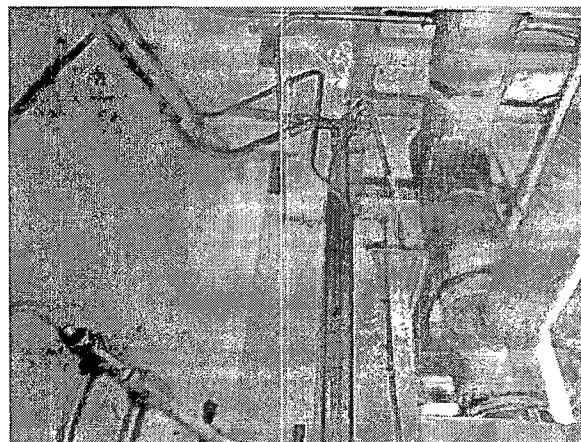
Note: Cables, conduits, and pipe supports in the area are shown to be properly secured.

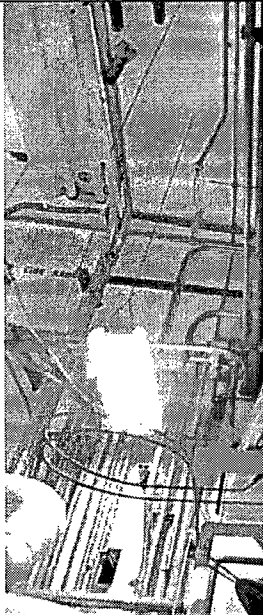
Note: *General image of the area. This room was exceptional in house-keeping practices.*

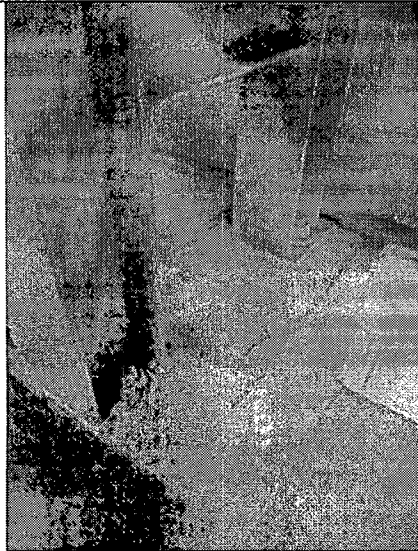
Note: *Observe anchorage in good condition*

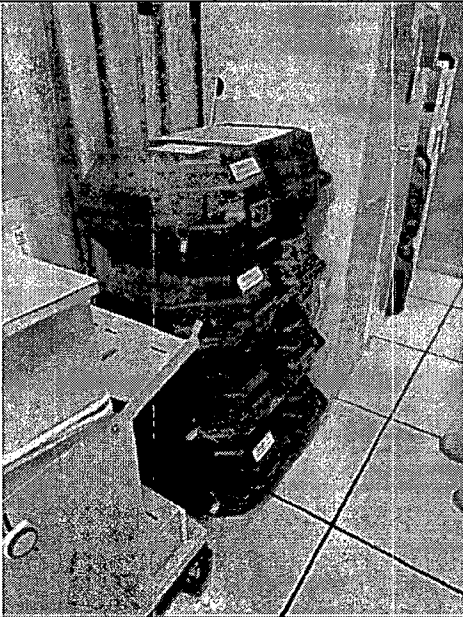
Note: *Picture shows emergency respiratory protection boxes stacked upon each other.*

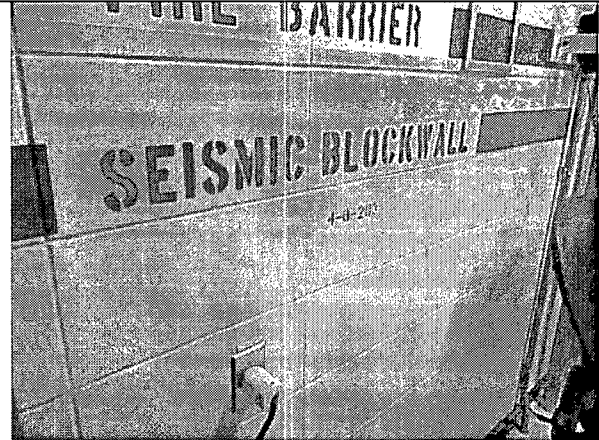
Note: *Photo showing seismic block wall located in the control room.*

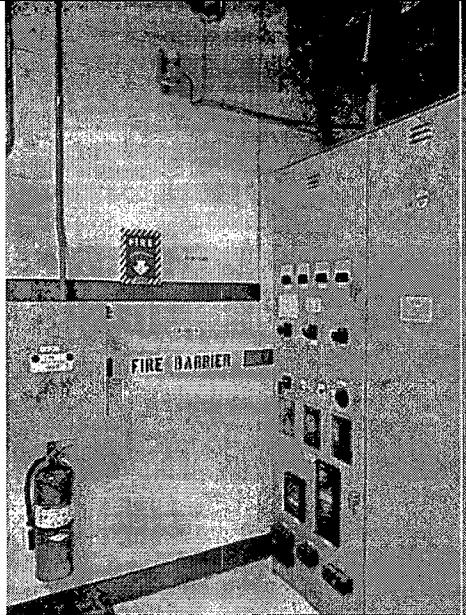
Note: Fire Extinguisher near door and electrical cabinet E-21

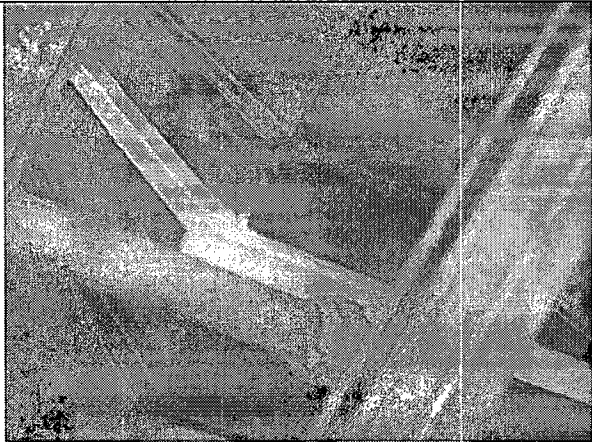
Note: *Overhead ventilation duct with steel support hanger.*

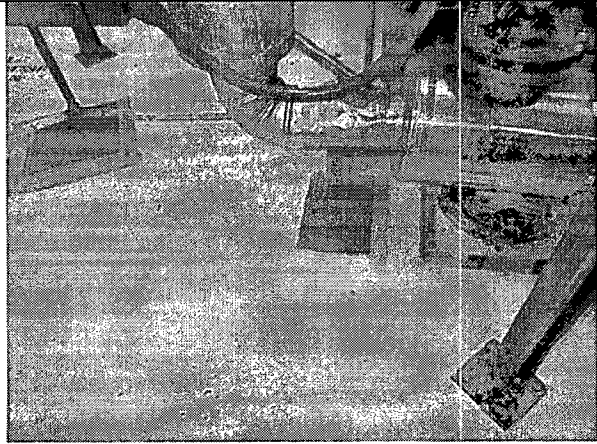
Note: *View of equipment properly anchored to floor.*
