AREA WALK-BY CHECKLIST

Area Walk-By Checklist (AWC) AWC-013

Location: Bldg. SWSTR PIT Floor El. 5'-9" Room, Area¹ Zem Strainer Pit

ATTACHMENT E – POTENTIALLY ADVERSE SEISMIC CONDITIONS

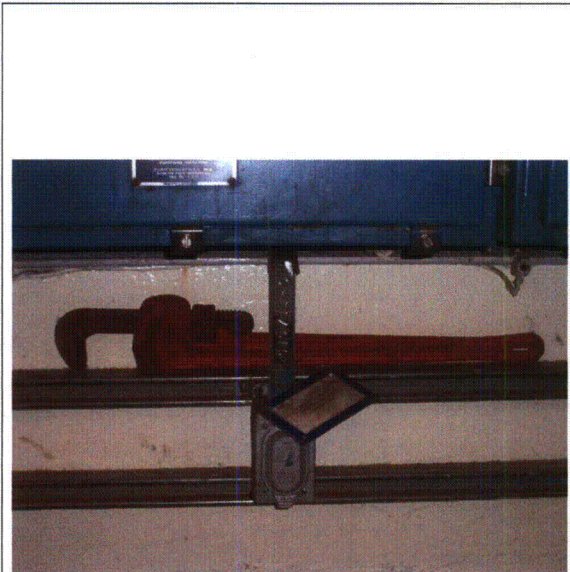
Note: Tools lying around area.

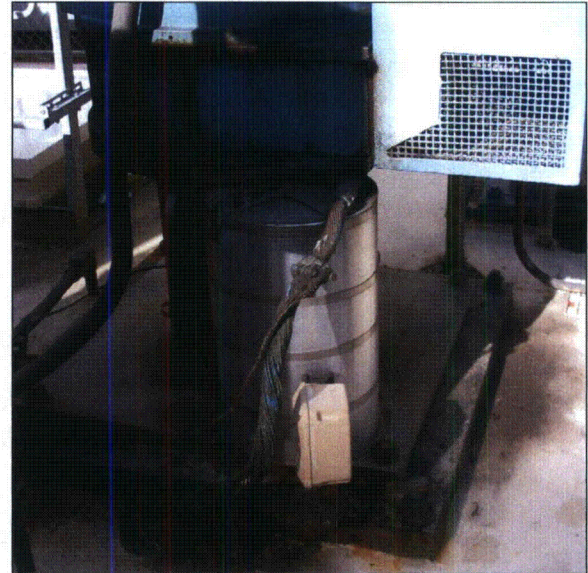
Note: Example of the same pipe connected to identical service water pumps in the area. They are heat traced, insulated, and flashed.

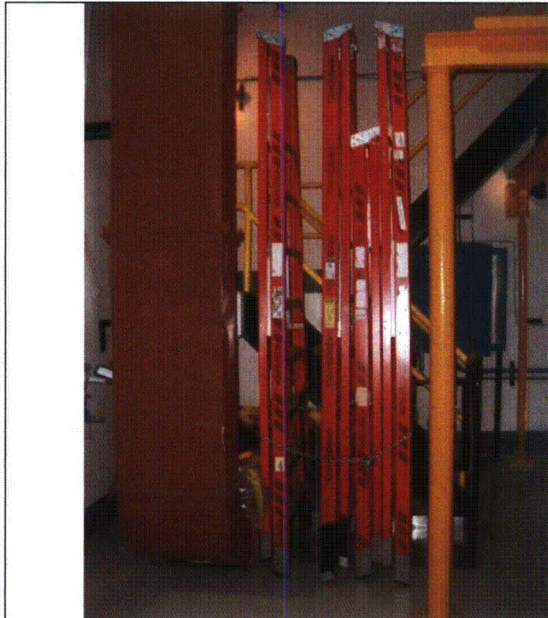
Note: Ladders supported below their center of gravity.

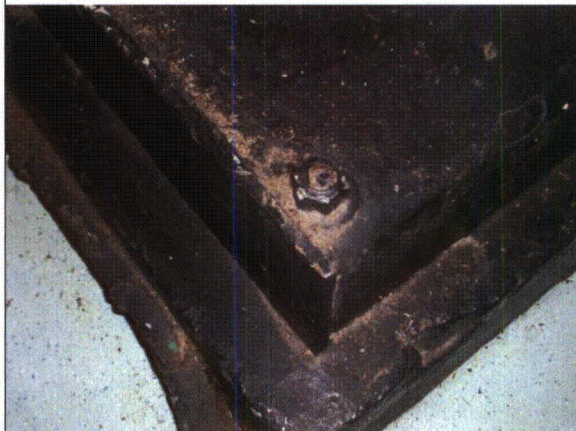
<p>Note: Anchor bolt</p>	<p>Note: View of pump</p>

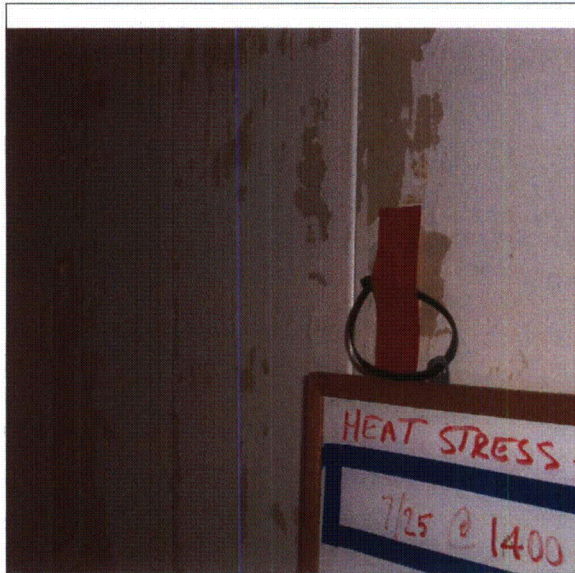
Note: Dry erase board left taped up.

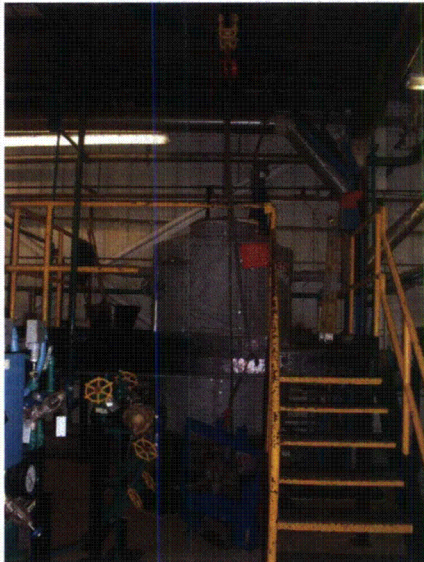
Note: Barrel handling apparatus left hanging on the overhead trolley. CR IP2-2012-06354 issued to track resolution.

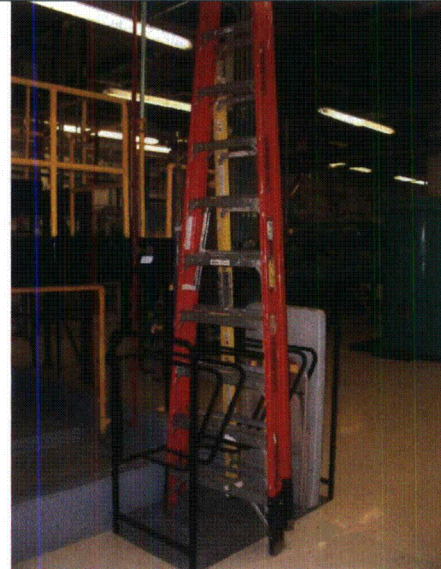
Note: Ladder and other items left unsecured to a ladder rack that is not secured to the floor. CR IP2-2012-06354 issued to track resolution.

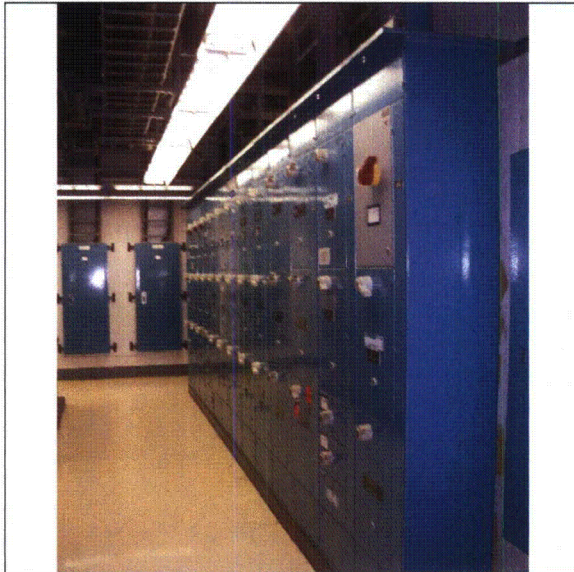
Note: *Picture of one MCC in the room. Other pictures could not be taken in room due to procedural requirement for camera standoff.*

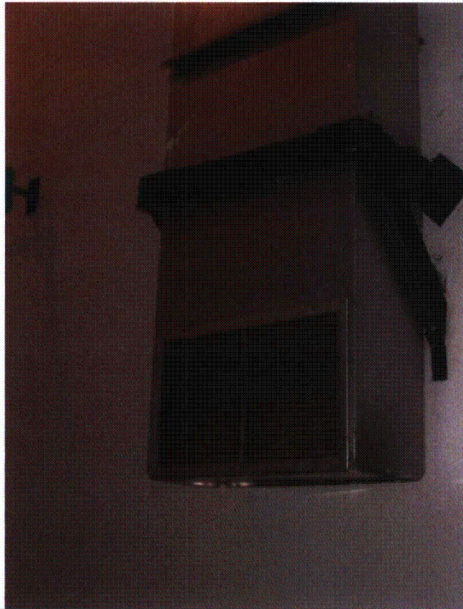
Note: HVAC duct on the wall well secured.

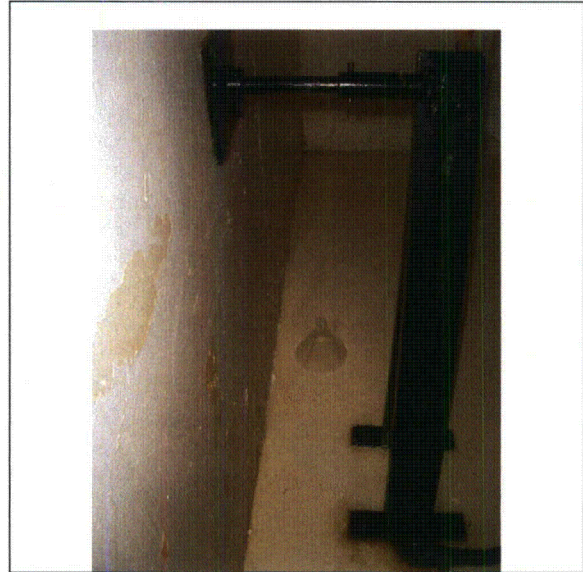
Note: Plastic funnel on the floor

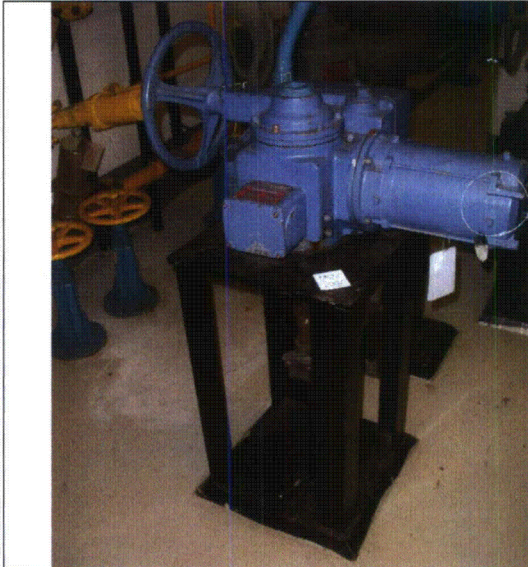
Note: Motor operator for 21RCP Seal Injection Line Isolation valve 250A (SWEL1-038). Valve 250A is located below on EL. 51' connected by reach rod to this motor operator.

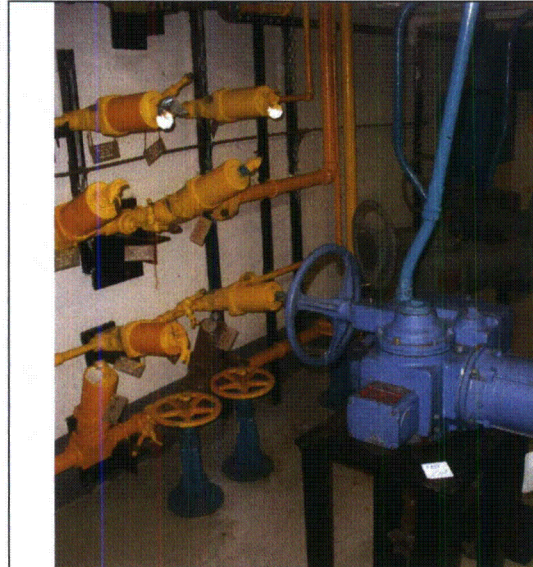
Note: Area around MOV 250A.

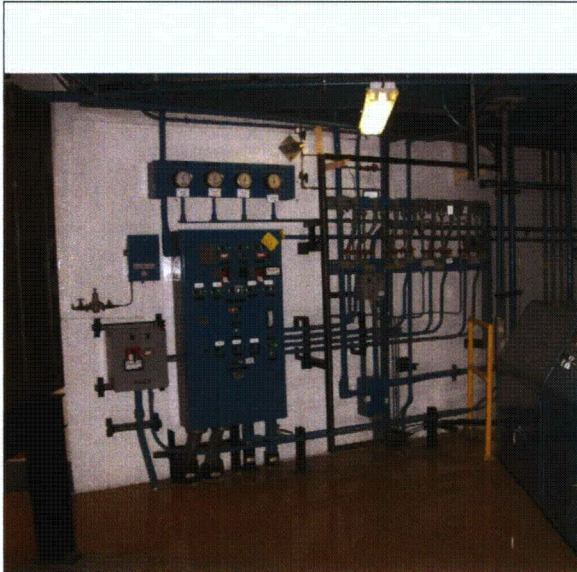
Note: General area of walk down.

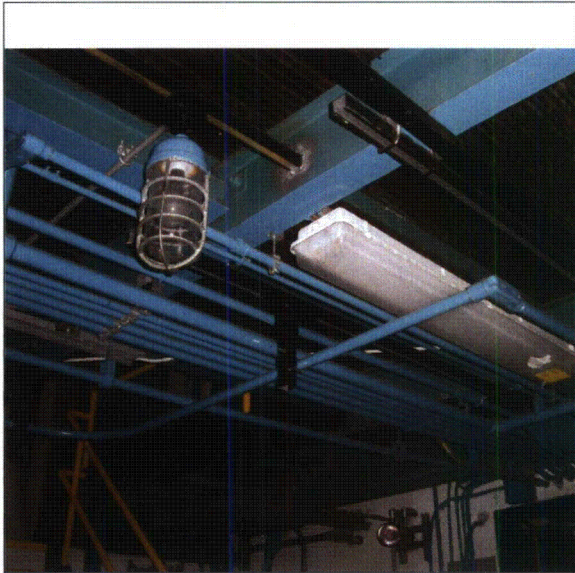
Note: *The two lights that are out in the area.*

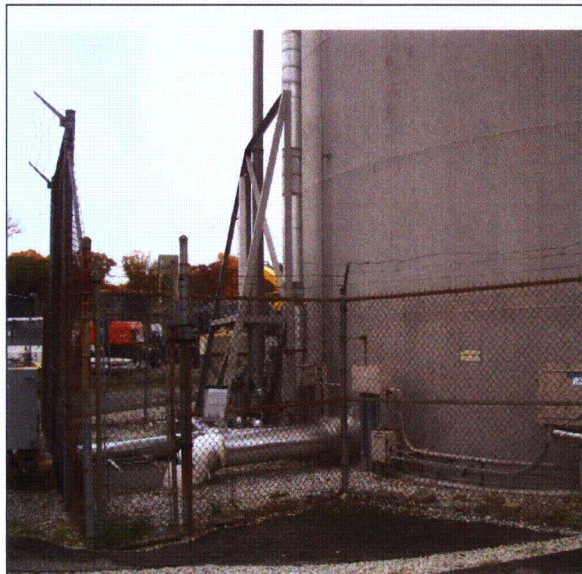
Note: General area west of CST.

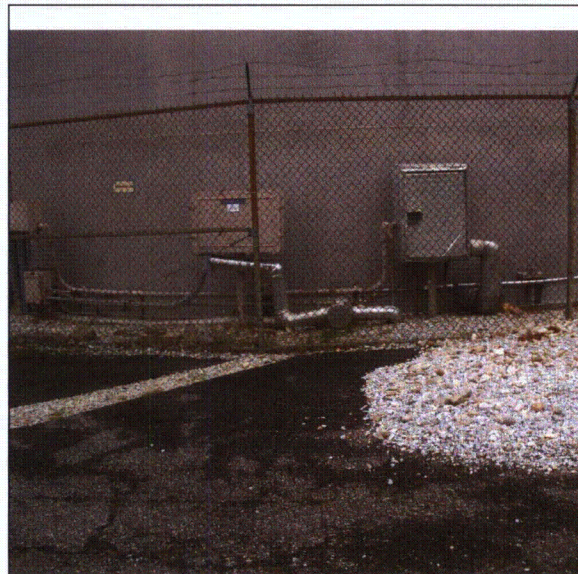
Note: Items around tank.

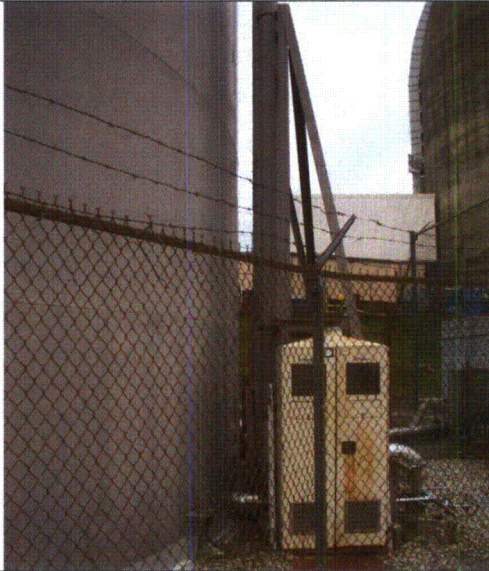
Note: Items around tank.

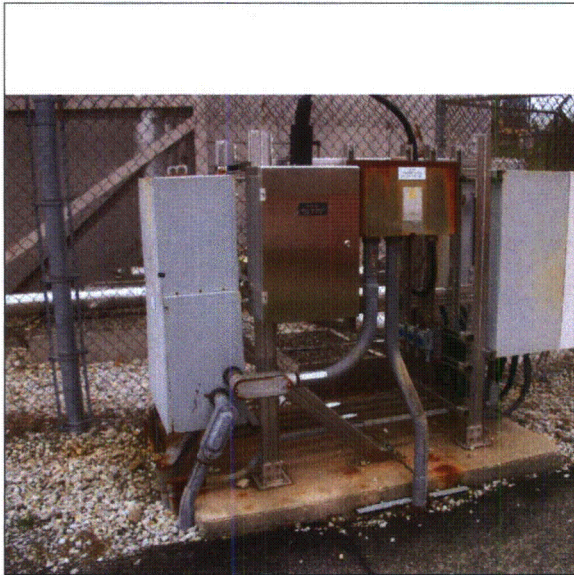
Note: Panel rack nearby.

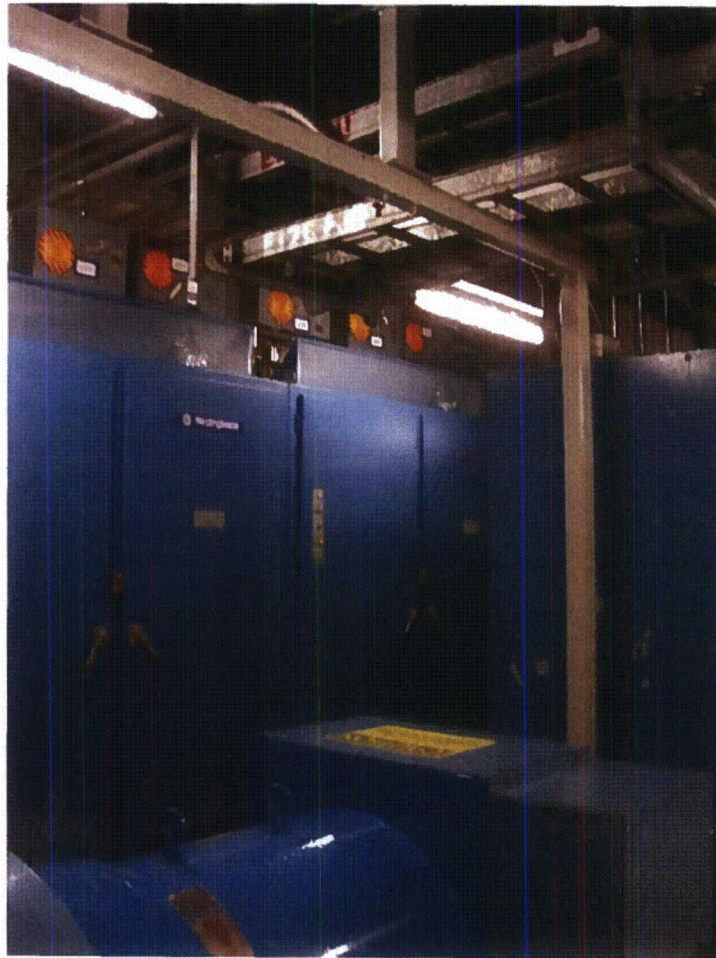
In the picture above, 22 MG Set is below the frame and the northern end of the MG Set Switchgear is shown on the right side.

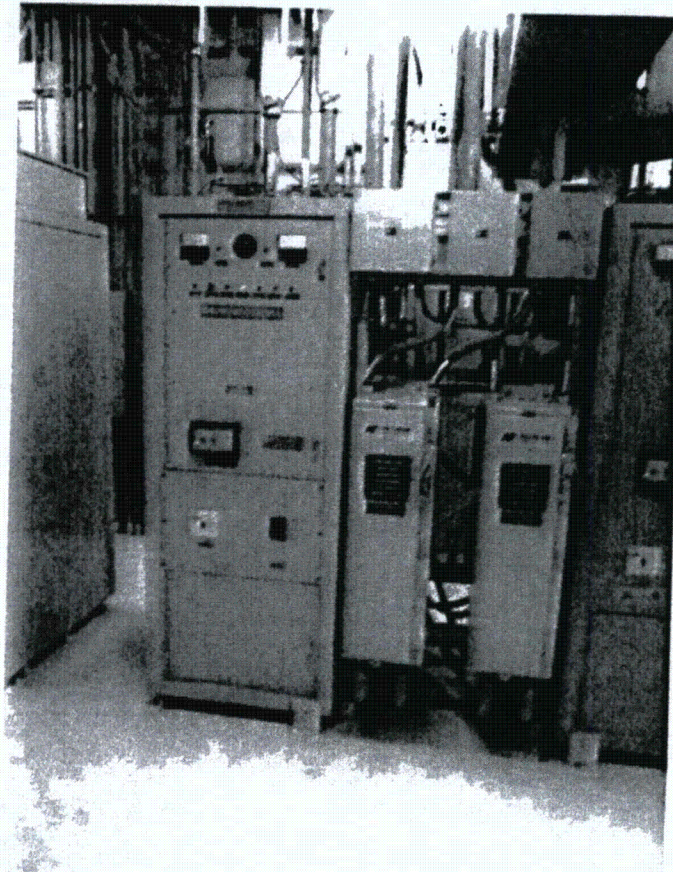
Battery Charger 21, shown below, was replaced in 1992 with a solid state model:

In Calculation GCC-00095-00, the frequency of the previous Westinghouse Battery Charger 21 was calculated to be 9.7 Hz.

In a letter dated April 15, 1992, attached, Nick Yarnell of SCI indicated that the new Battery Charger 21 has a frequency of 10 Hz and, based on the applicable floor response seismic spectrum, the applicable seismic acceleration is 0.71g.
