Seismic Walkdown Checklist (SWC) SWEL1-074

SEISMIC WALKDOWN CHECKLIST FORM

IP2

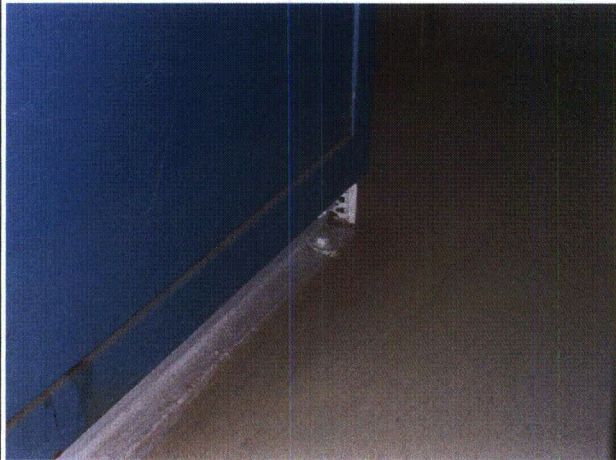
Note: *South-west anchor*

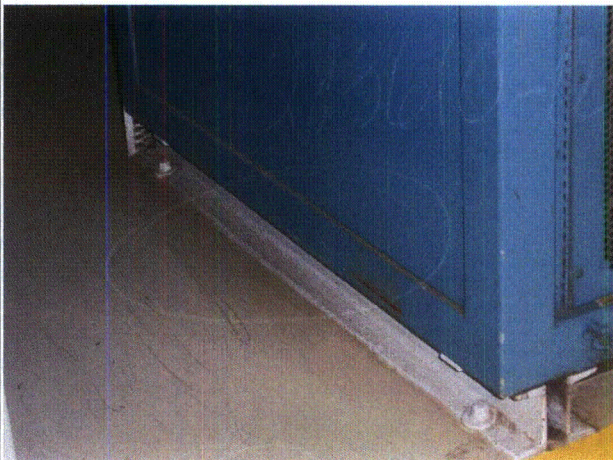
Note: *East anchors*

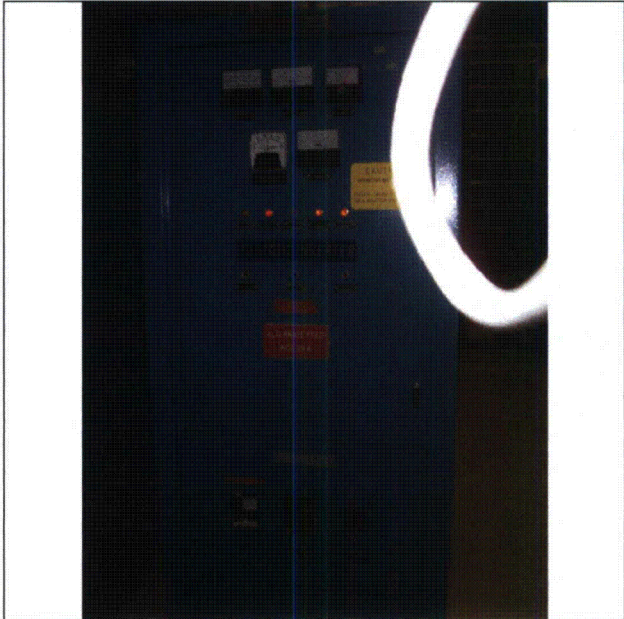
10 KVA Static inverter #23

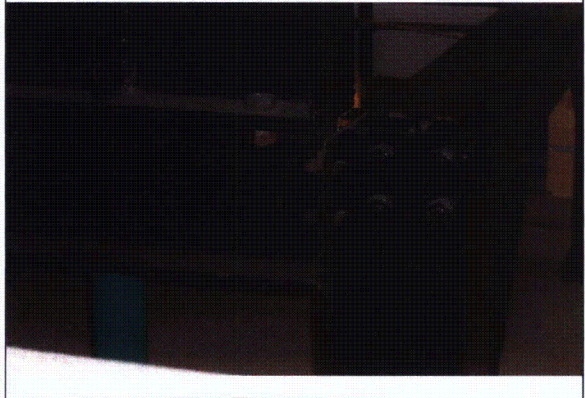
| <p>Note: <i>Typical anchorage to structural steel.</i></p> | <p>Note:</p> |

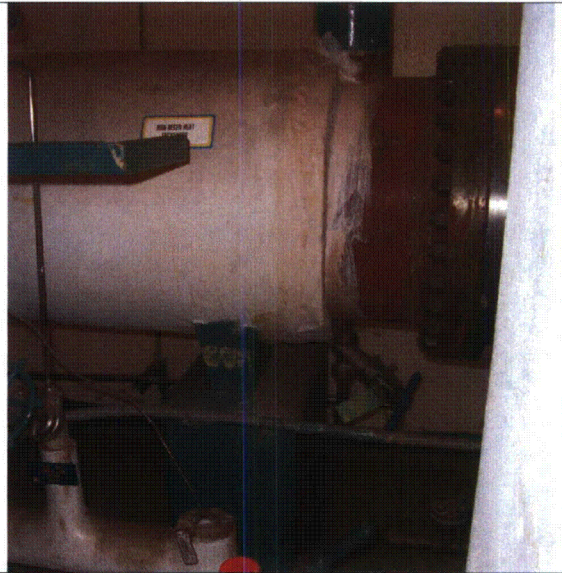
Note: South end of Non Regen Heat Exchanger

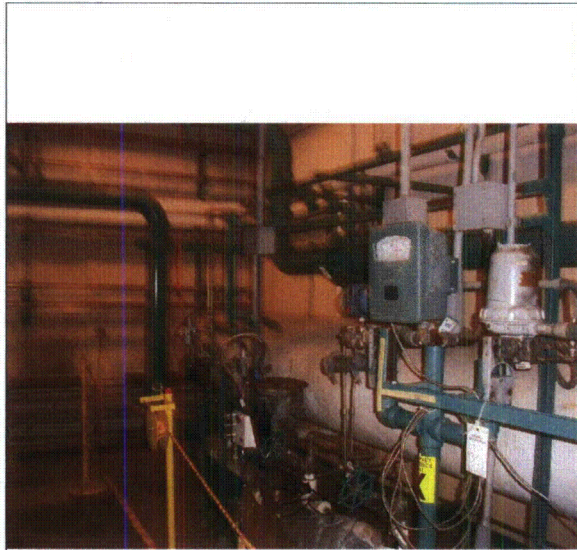
Note: View of HX from door way into cubical.

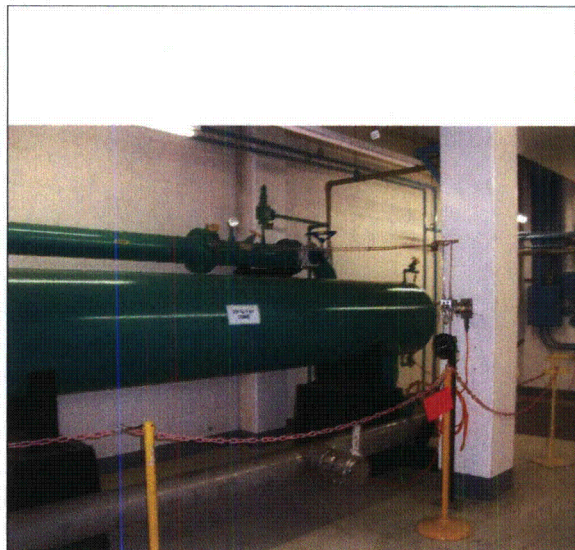
One light above is out..

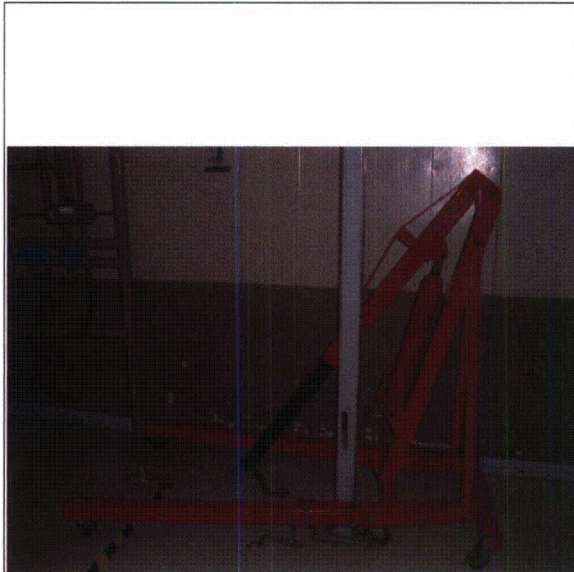
Note: Engine hoist needing to be secured to the cross bars to prevent movement from left to right in this photo.

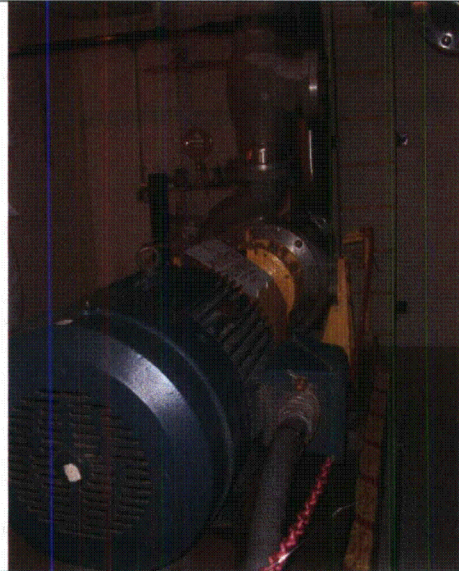
Note: General area of 21 SFP Pump

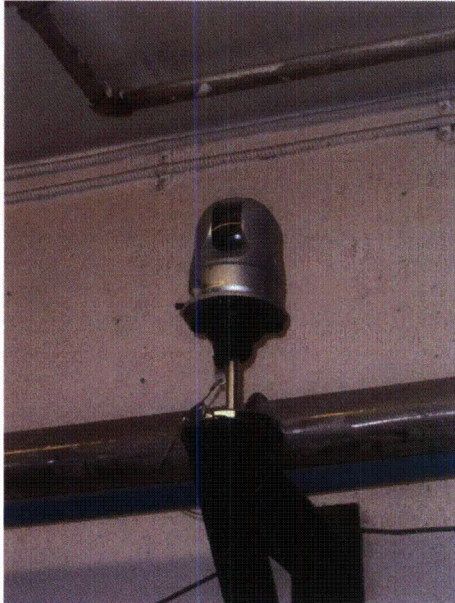
Note: Magnetic camera mount does not appear seismically adequate.

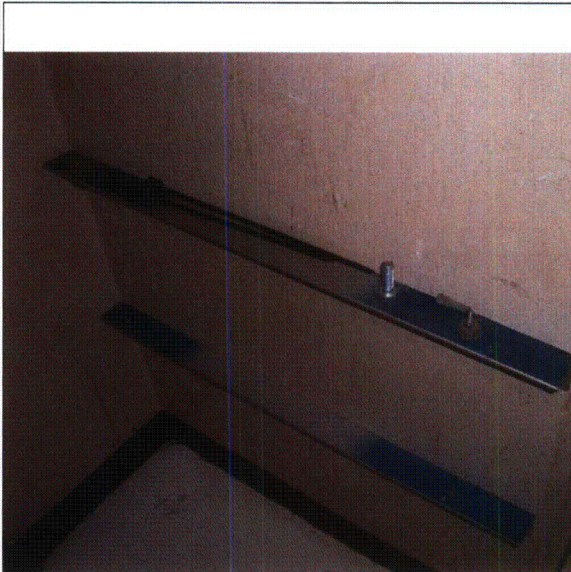
Note: Miscellaneous bolts nuts, and unistrut parts left near overhead trolley door.

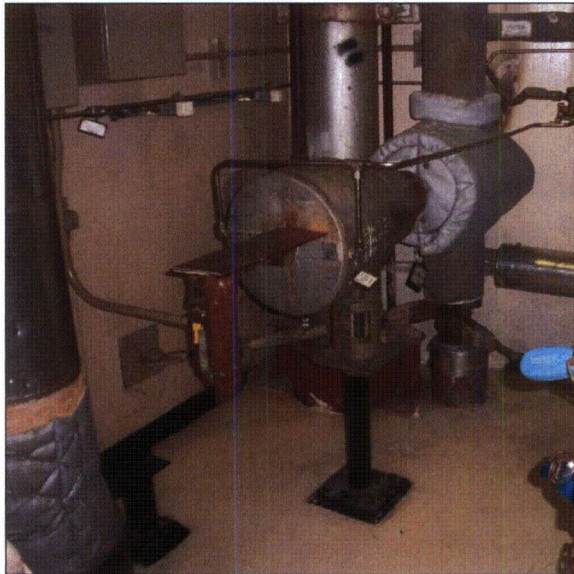
Note: General area of walk by

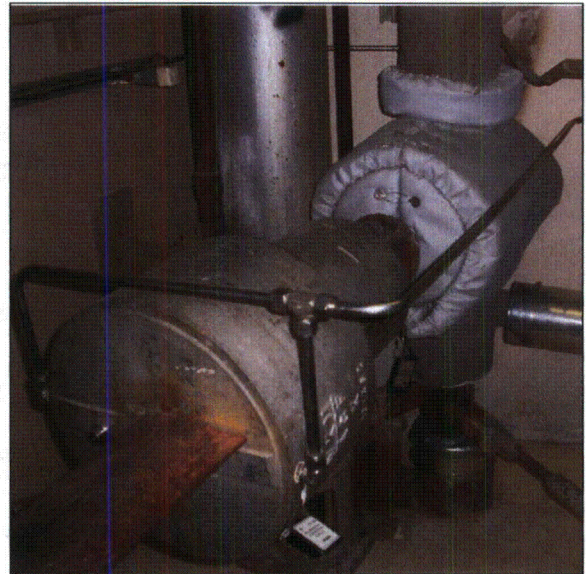
Note: General area of walk by

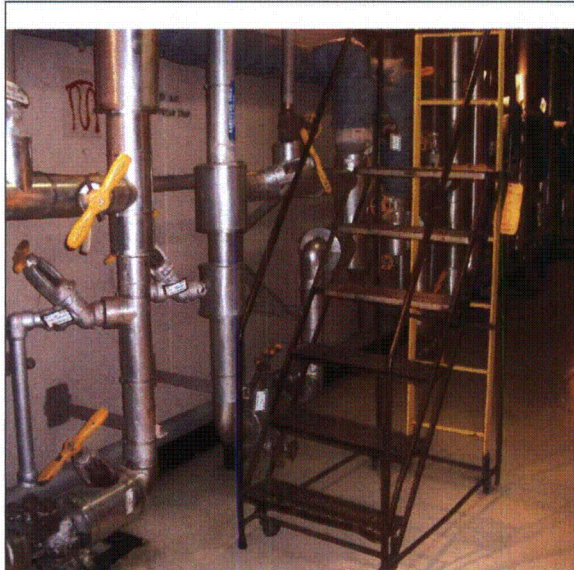
Note: Moveable stairs needing to be secured.

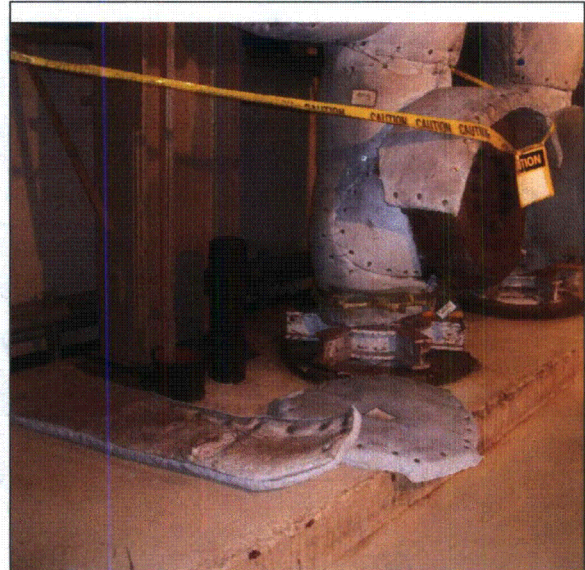
Note: Insulation in area has been removed from main steam lines for work. This is not a seismic issue. CR IP2-2012-06638 issued to track resolution.
