# **Attachment D**

## ***AREA WALK-BY CHECKLISTS (AWCs)***

Status: Y  N  U **Area Walk-By Checklist (AWC) AWC- 001**Location: Bldg. AB Floor El. 93 Room, Area<sup>1</sup> 1A102,07**SWEL Components: SWEL1- 024,030****Instructions for Completing Checklist**

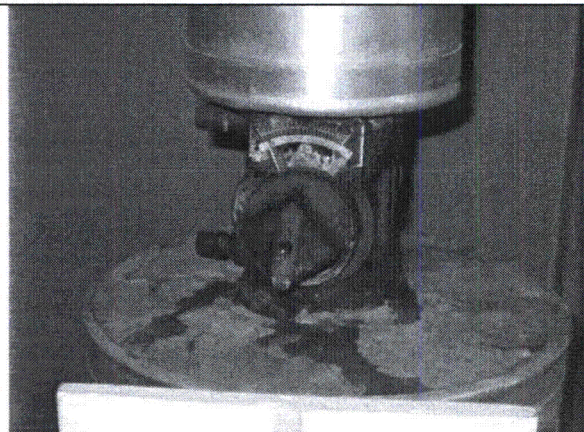
**Note:** Air supply line, 1P71-F546, water from condensation

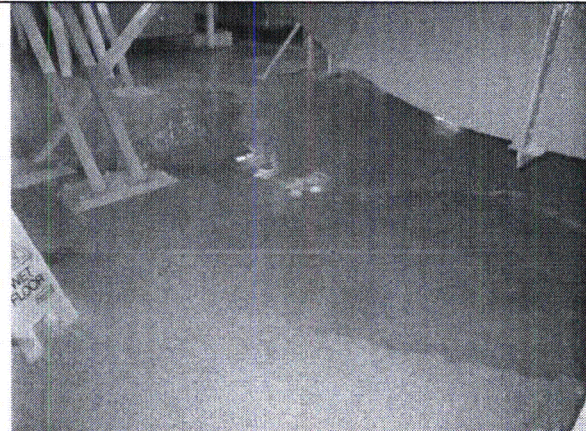
**Note:** *Water on the floor*

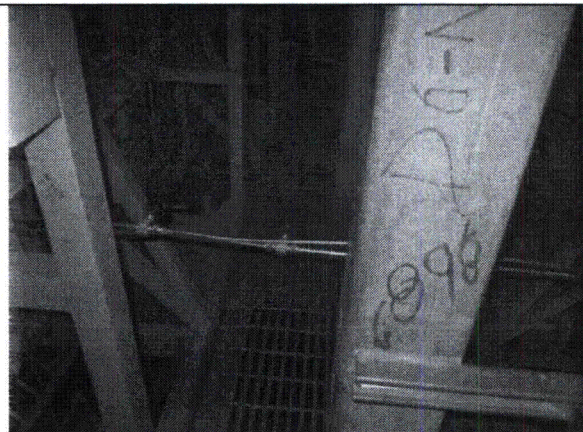
**Note:** *Tubing running between two instrument rack*

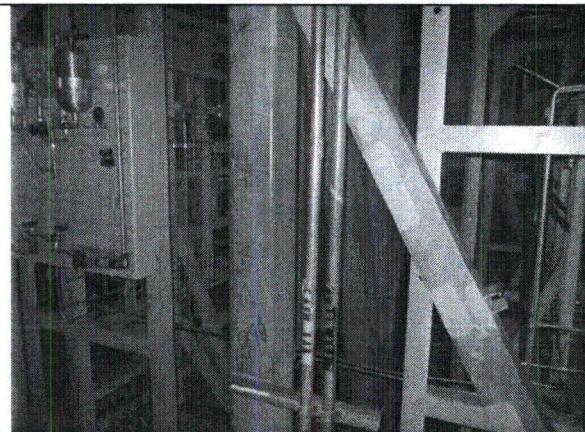
**Note:** *Tubing running between two instrument rack*

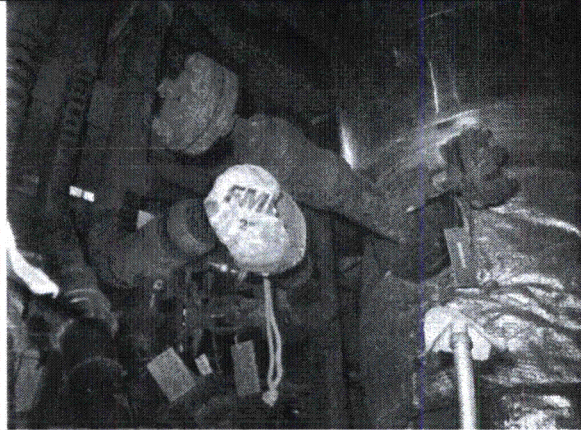
**Note:** *Liquid on FME bag, surface oxidation on pipe*

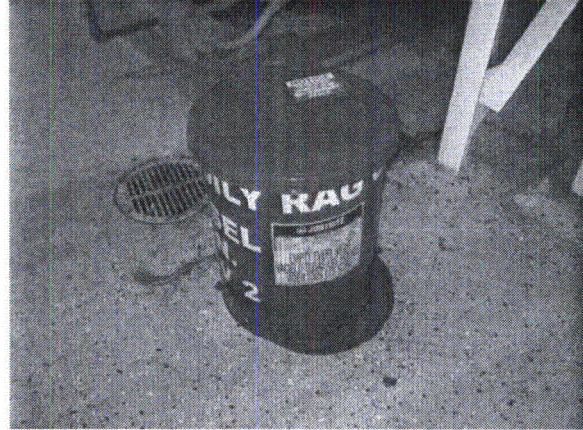
**Note:** *Rag Basket on floor*

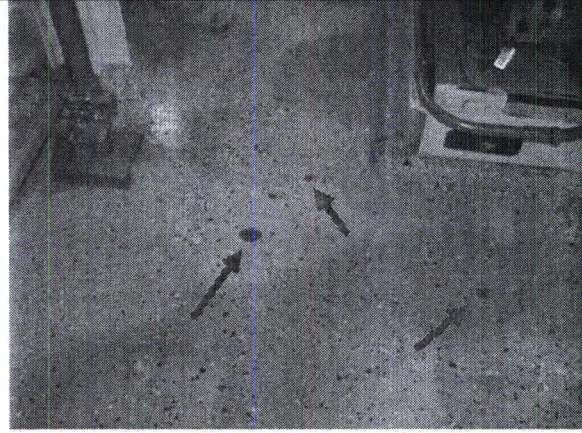
**Note:** *paint chips on the floor*

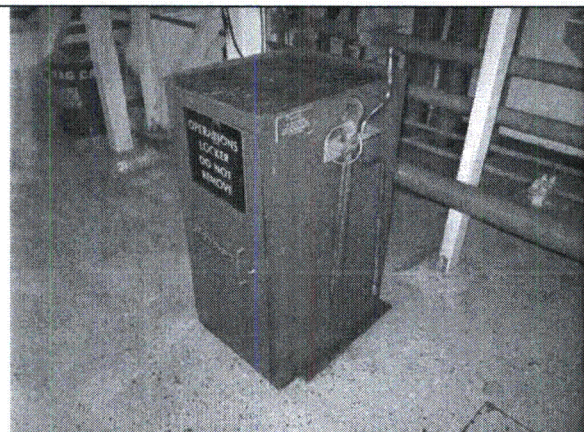
**Note:** *Operations Lockers and Rag Can*

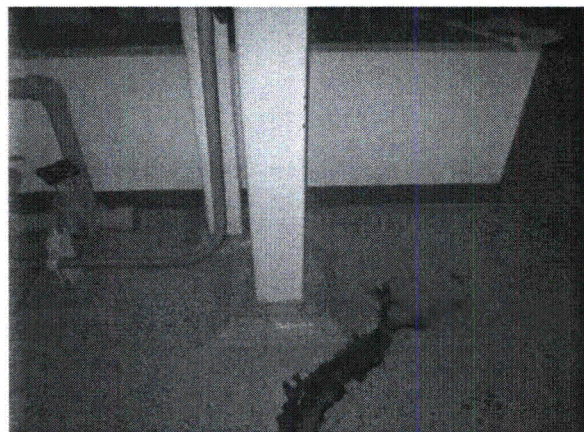
**Note:** *Oil spill on the floor*

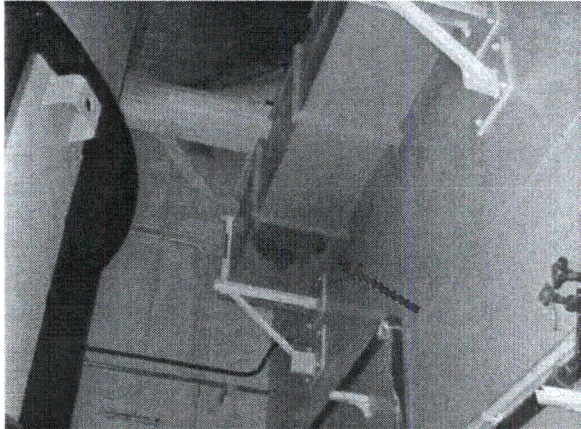
**Note:** *Paint peeling off from bottom of the duct*

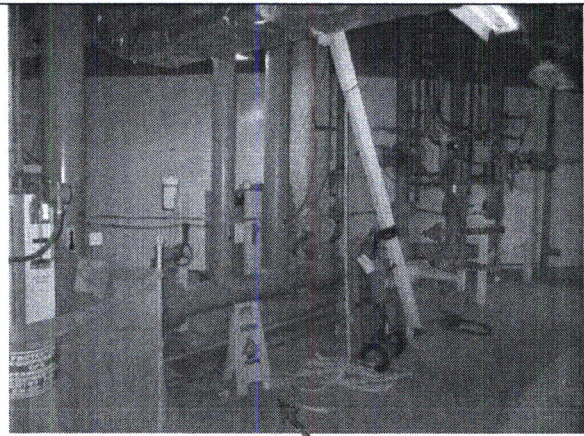
**Note:** *Temporary 280V/480V electrical panel on the cart which is tied-off from structural steel, and extension cord*
