**ATTACHMENT 9.6****SEISMIC WALKDOWN CHECKLIST FORM**

Status: Y  N  U **Seismic Walkdown Checklist (SWC) SWEL2- 004**Equipment ID No. PS-19-80A Equip. Class<sup>1</sup> 18 - INSTRUMENTS ON RACKSEquipment Description PRESSURE SWITCH (RK-10AA)Location: Bldg. RB Floor El. 303 Room, Area \_\_\_\_\_

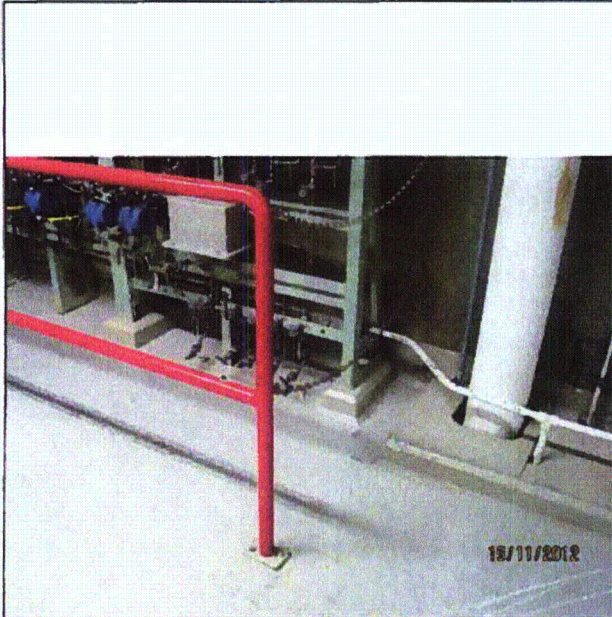
**Note:** Railing in front of RK25-6A/B

**Note:** Detail showing loose bolt on plate

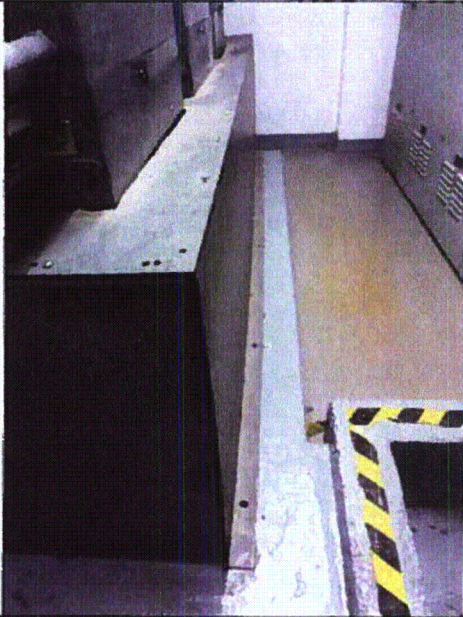
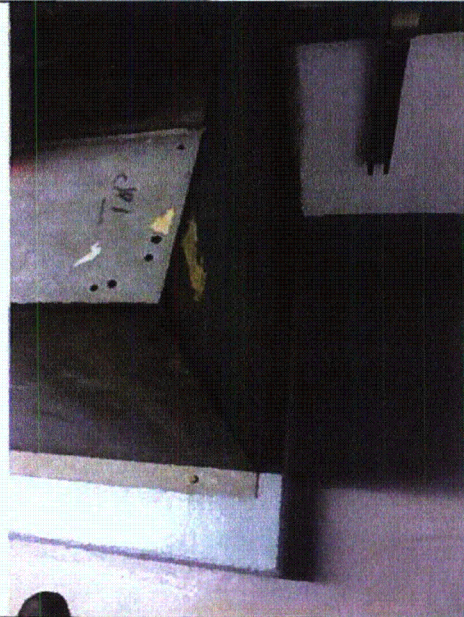
**Note:** *View of VR-1 S1*

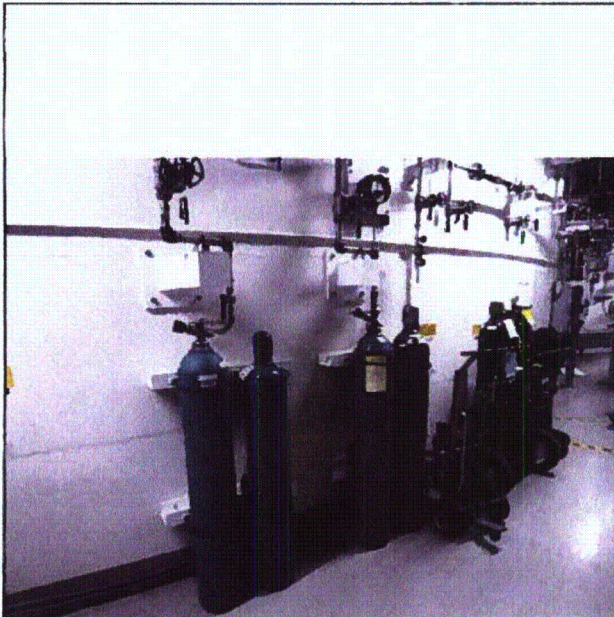
**Note: : CARTS ARE SECURED AND ARE LIGHT WEIGHT. NO SEISMIC IMPACT**

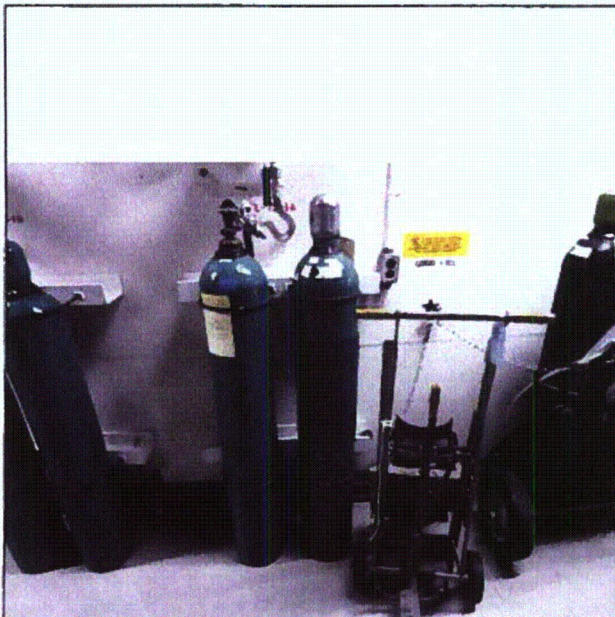
**Note:** CARTS ARE SECURED AND ARE LIGHT WEIGHT. NO SEISMIC IMPACT

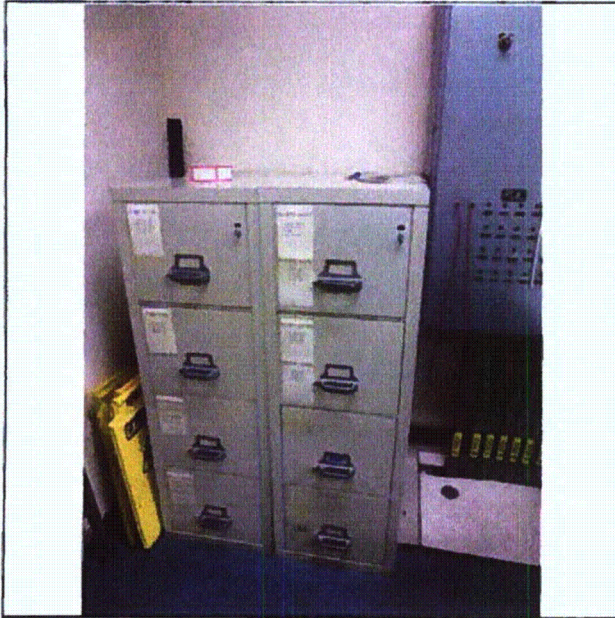
Note: Filing cabinets in SE corner.
