SUPPLEMENTAL SEISMIC WALKDOWN REPORT

SEISMIC WALKDOWN REPORT

This Supplemental Seismic Walkdown Report documents walkdowns performed at R.E. Ginna Nuclear Power Plant for components that were not accessible during the initial walkdowns and were not included in the Response to 10 CFR 50.54(f) Request for Information, Recommendation 2.3, Seismic [Ref. 3]. These seismic walkdowns did not identify any adverse seismic conditions that required licensing basis evaluations. Identified issues such as internal cabinet cleanliness and missing internal fasteners were entered into the station's corrective action program.

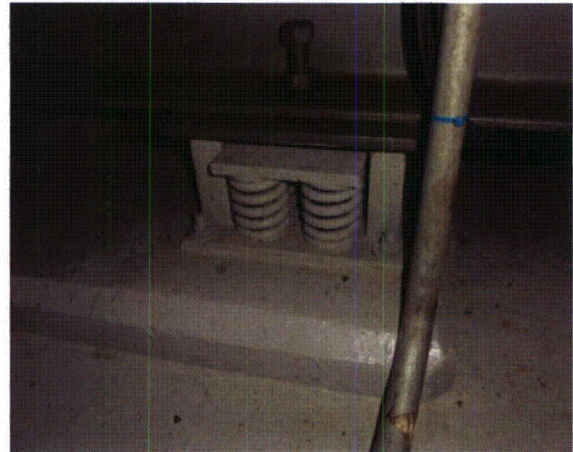
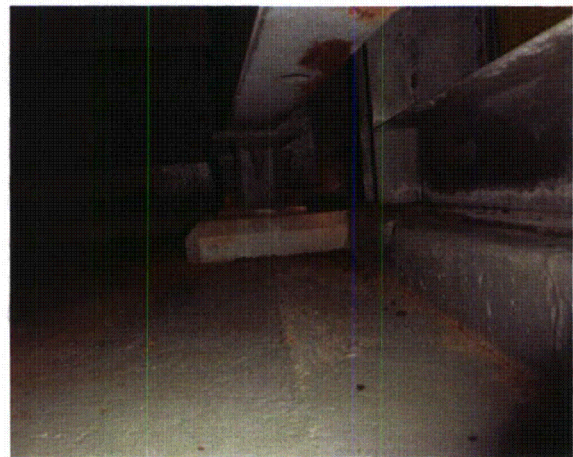
Supplemental Anchorage Installed per MDCN-1740

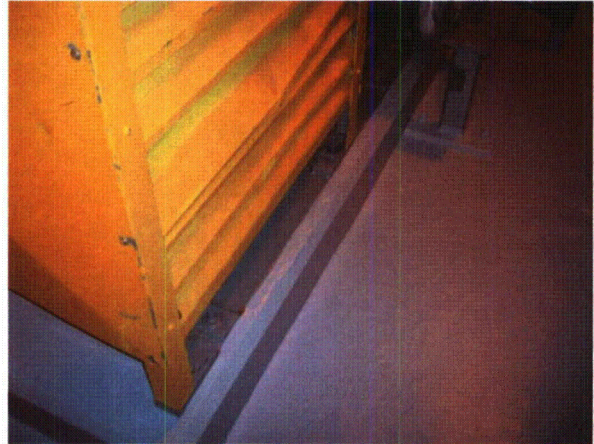
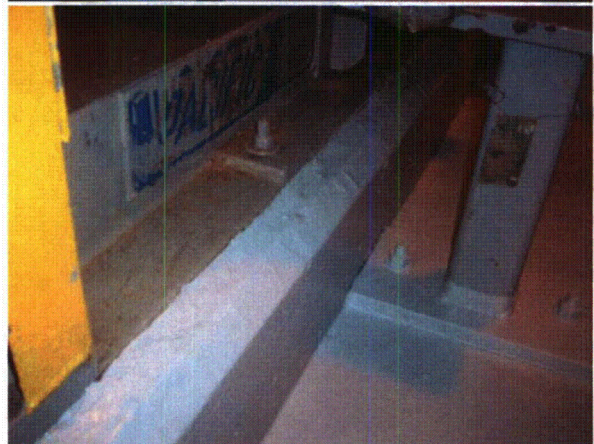
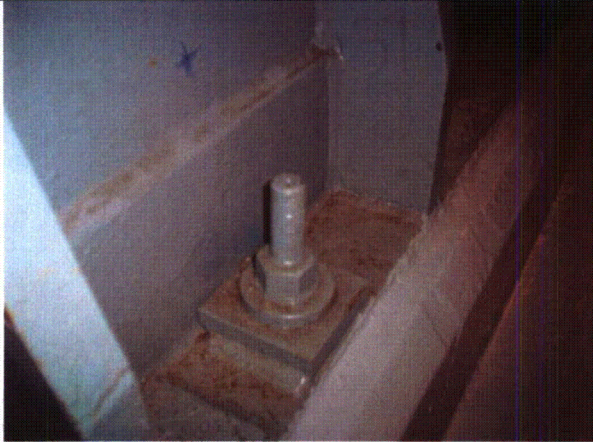
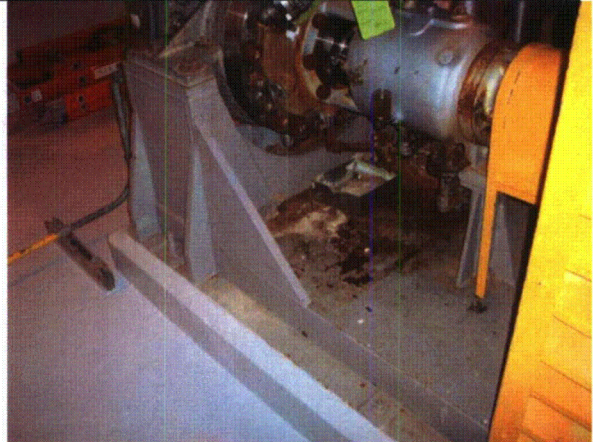
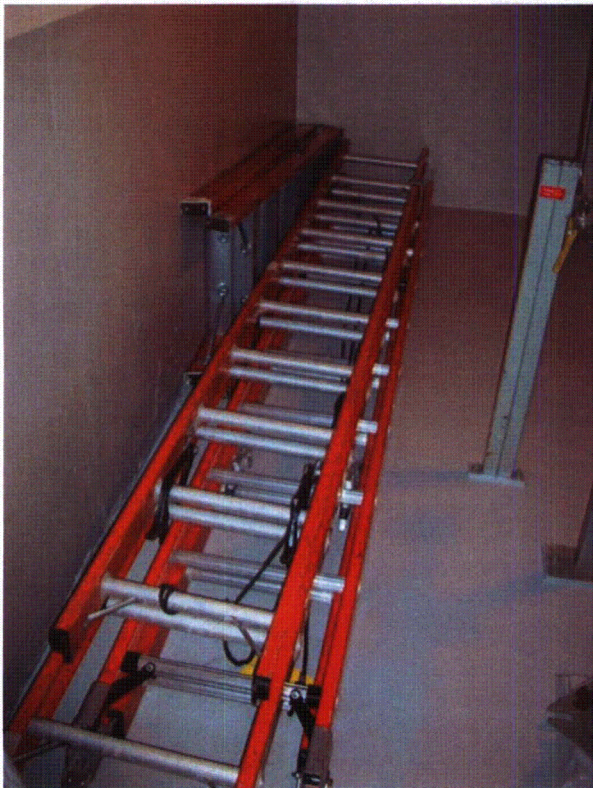
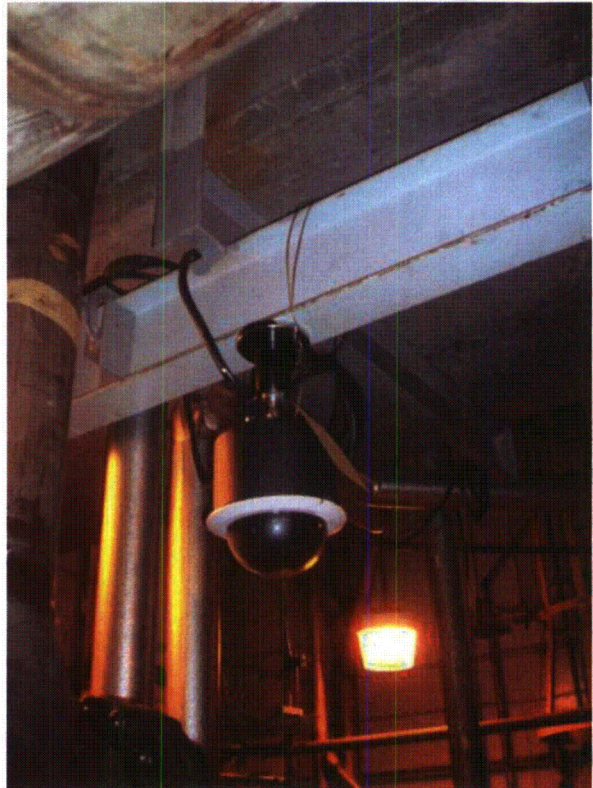
Equipment Description: RESIDUAL HEAT REMOVAL PUMP B

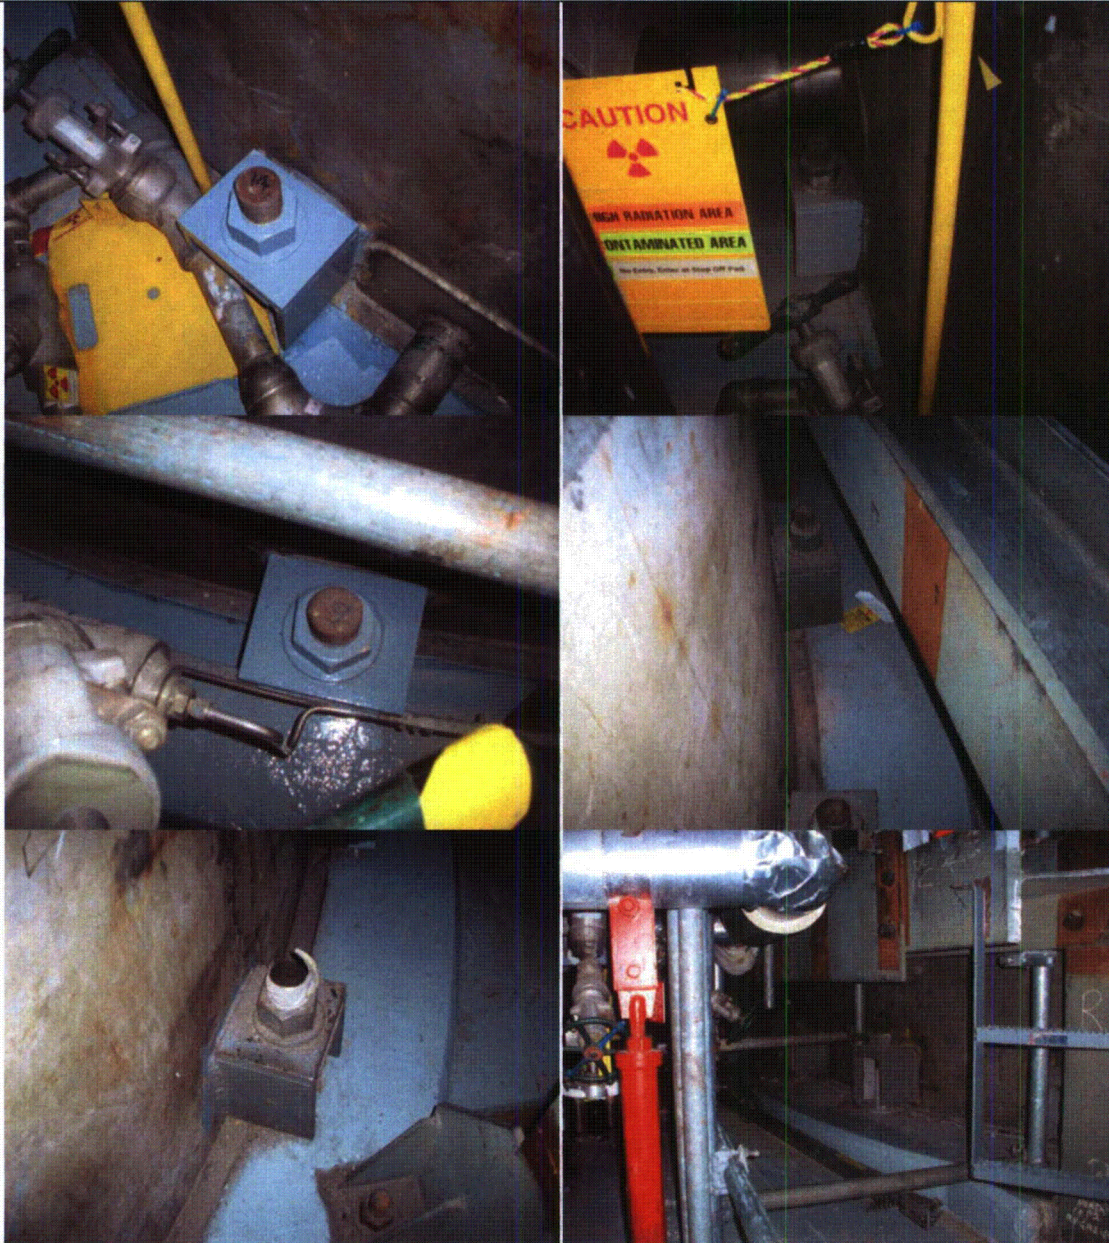
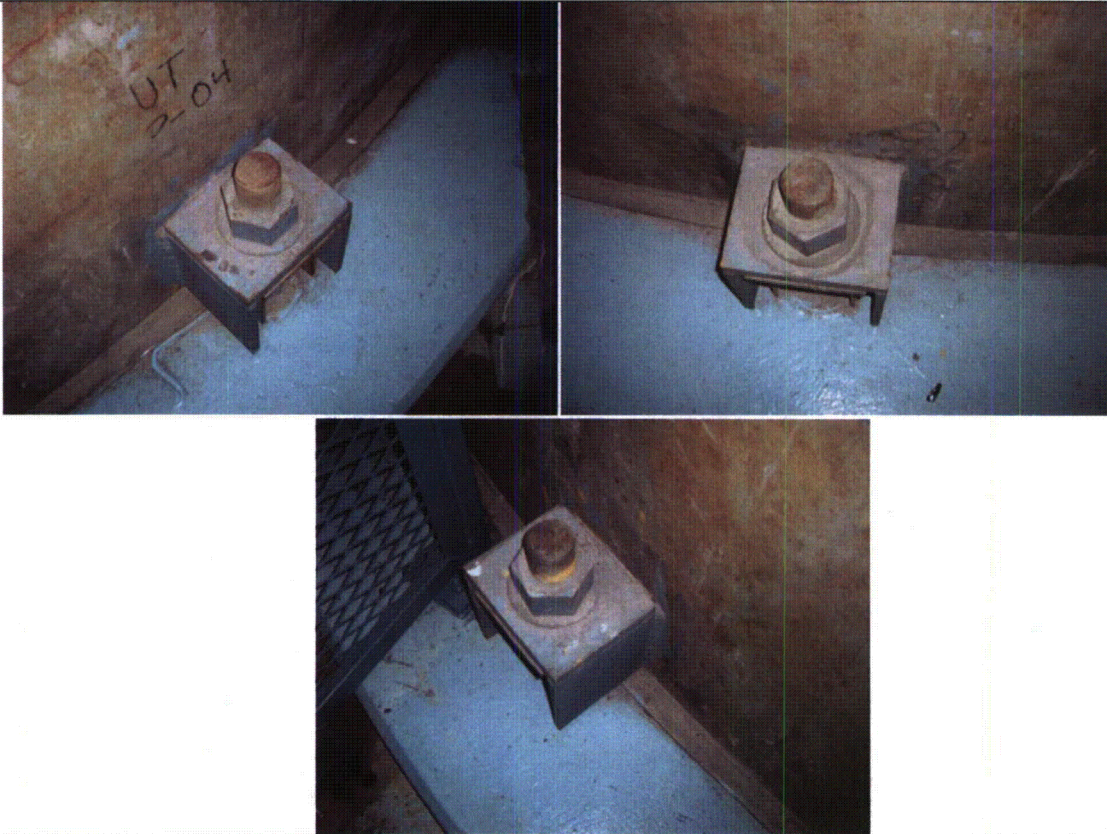
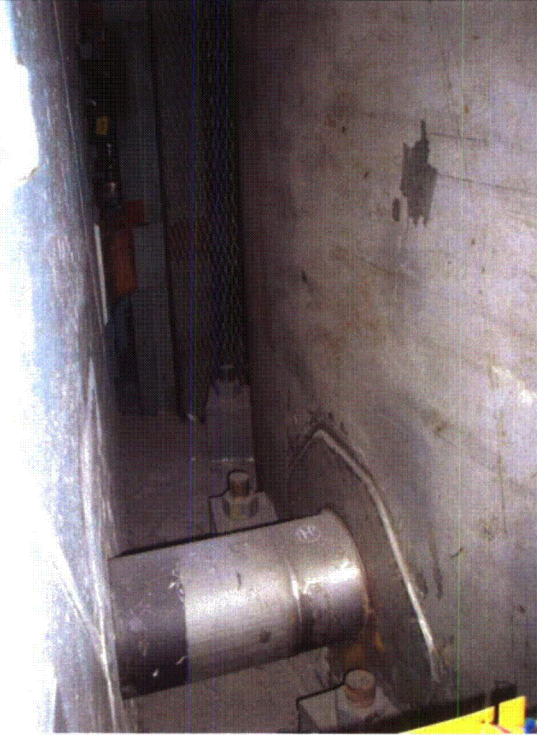
Equipment Description: REFUELING WATER STORAGE TANK

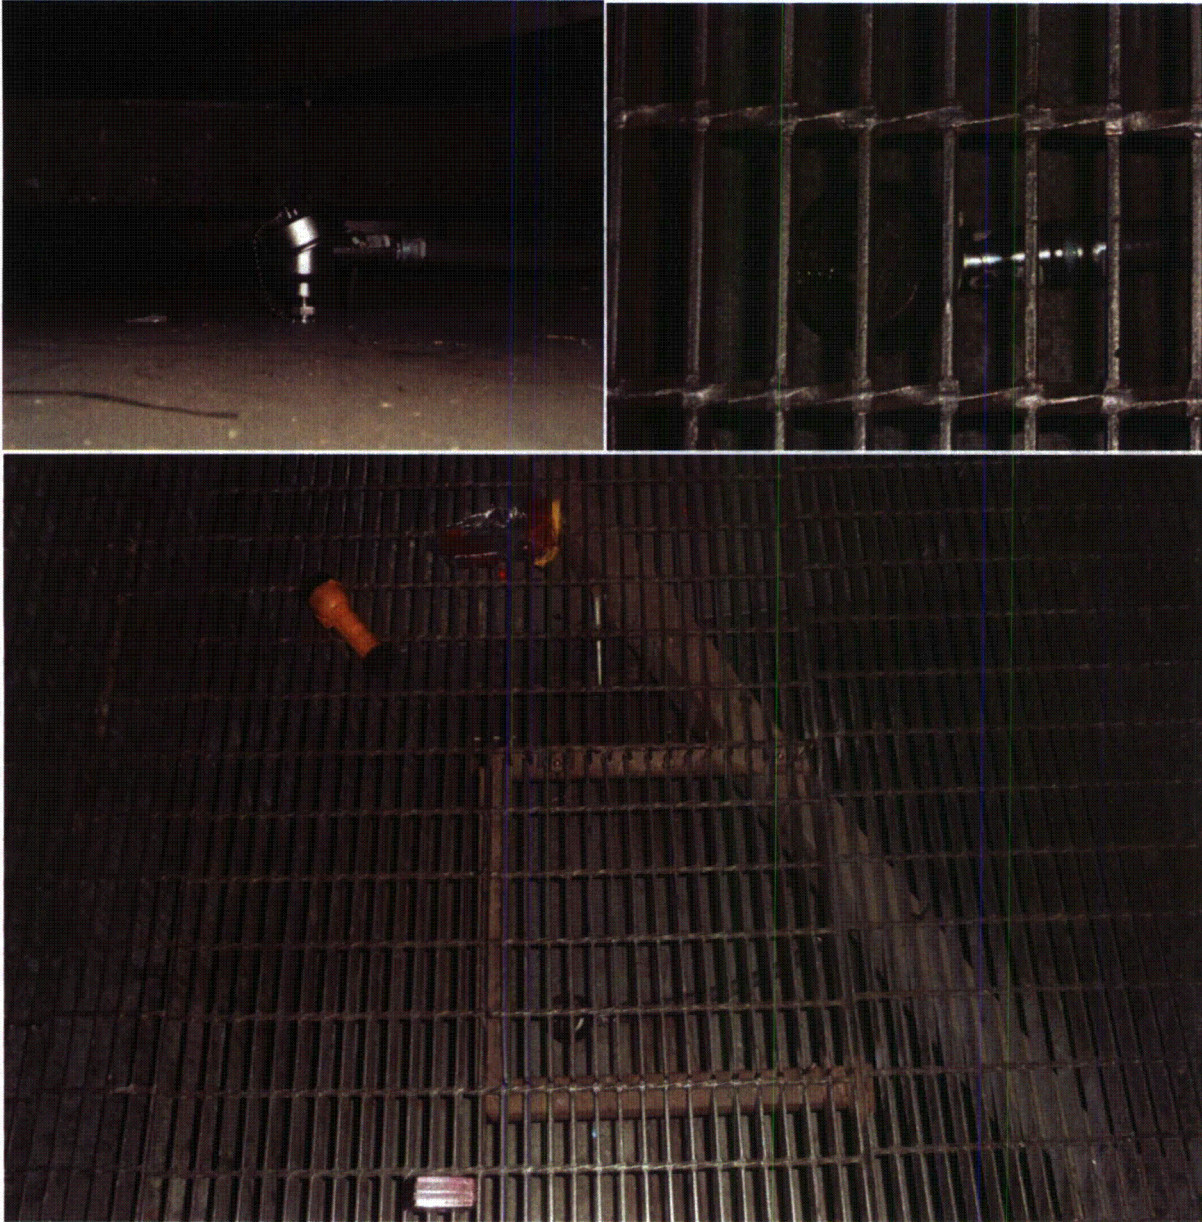
Equipment Description: CRFC A AIR OUTLET TEMPERATURE

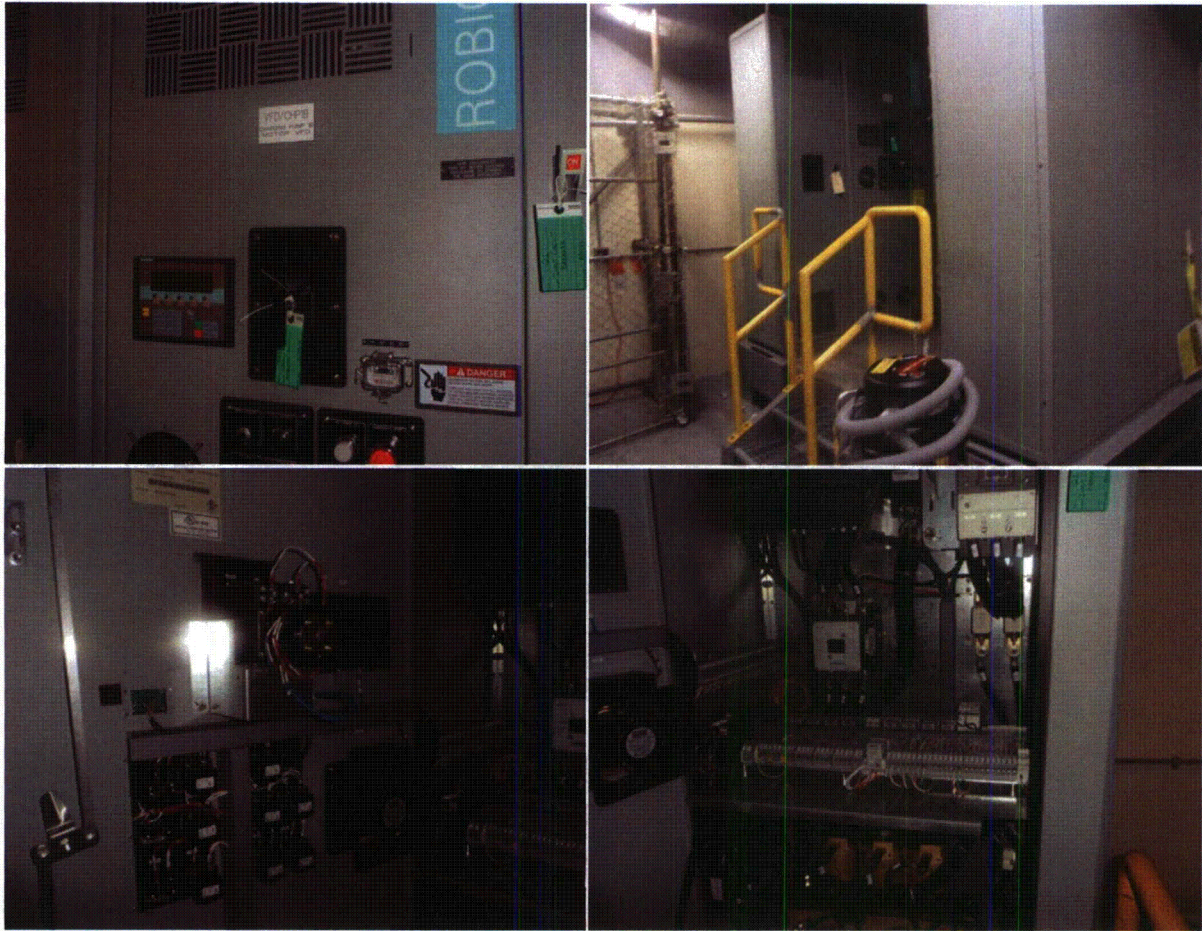
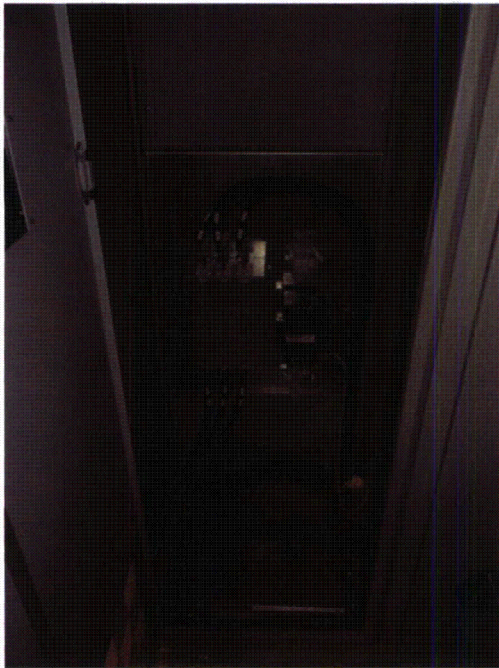
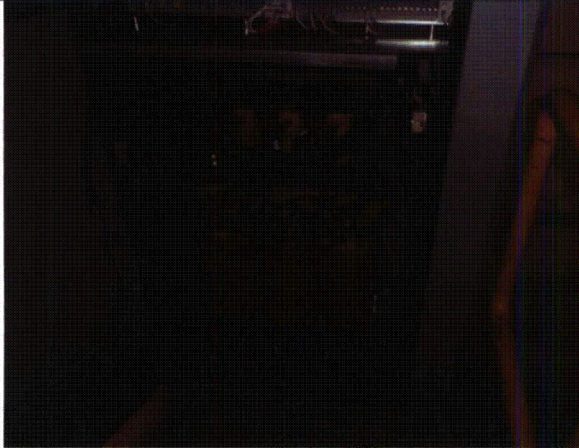
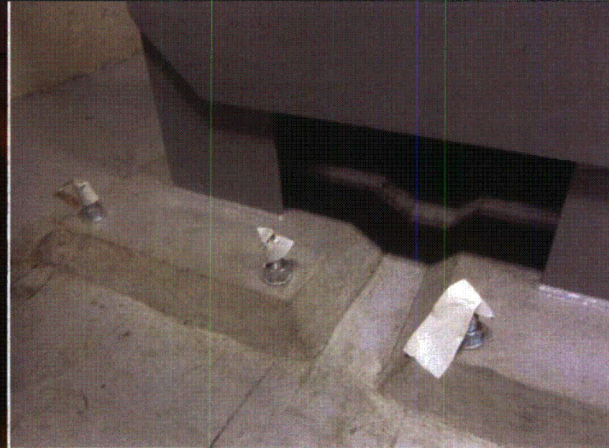
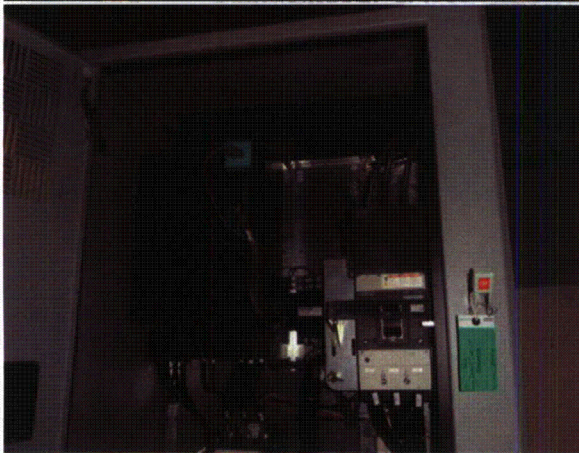
Equipment Description: CHARGING PUMP 1B MOTOR VFD
