APPENDIX C: AREA WALK-BY CHECKLISTS (AWCs)

PERRY NUCLEAR POWER PLANT

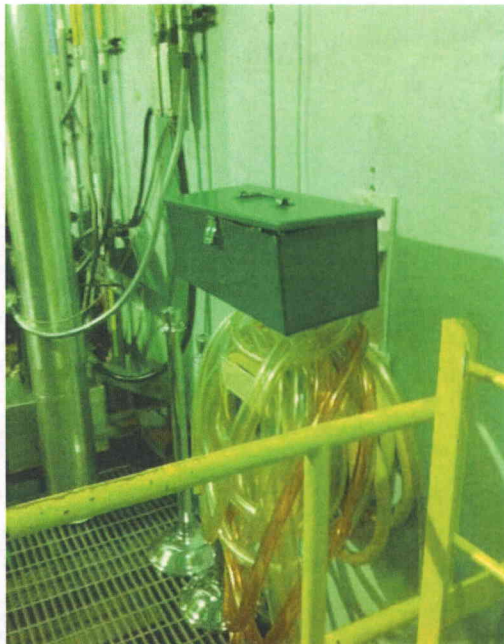
File Name: 1-60-2-1-18.jpeg
Description: View of toolbox in the area

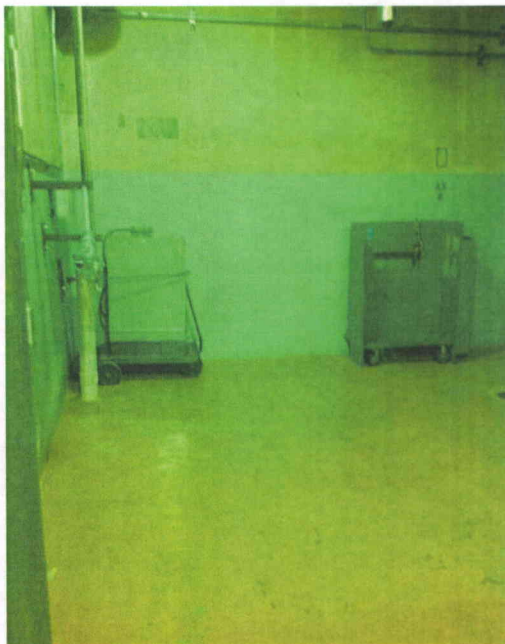
File Name: 1-65-3-1-18.jpeg
Description: View of temporary equipment restrained

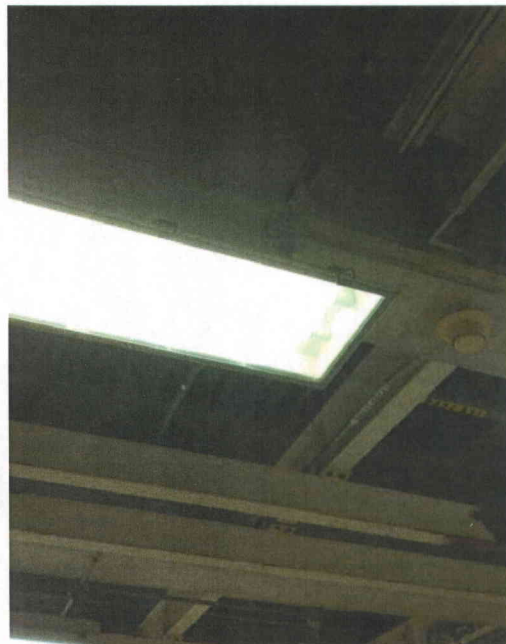
File Name: 1-60-4-1-02.jpeg
Description: Protective light cover

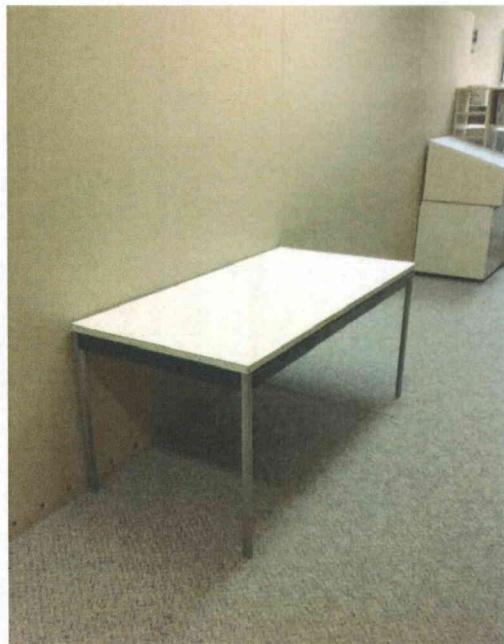
File Name: 1-68-1-1-03.jpeg
Description: Table not restrained

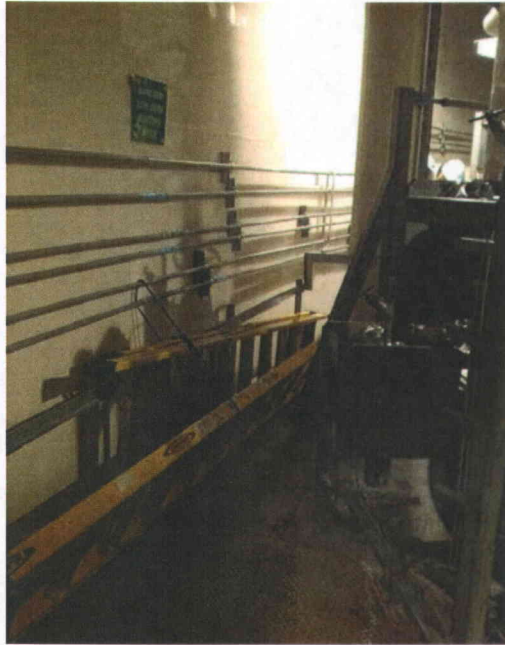
File Name: 1-70-1-1-12.jpeg
Description: Ladders tied

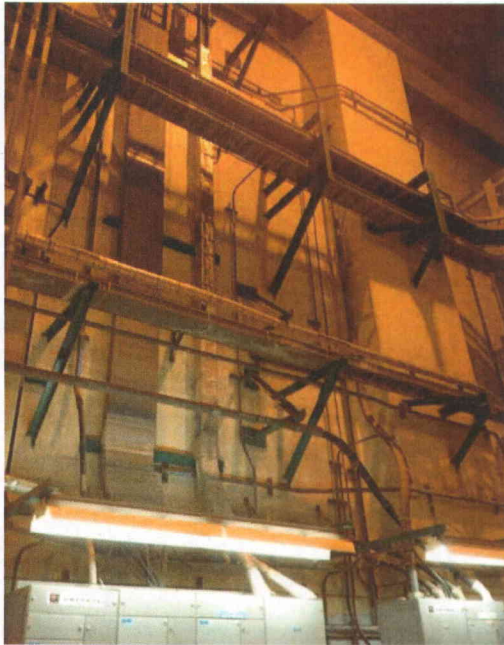
File Name: 1-59-1-1-05.jpeg
Description: Raceways rigidly supported

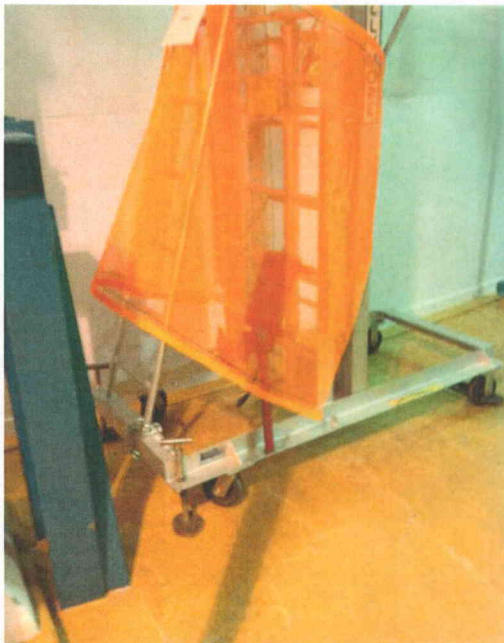
File Name: 1-60-2-1-14.jpeg
Description: Maintenance equipment identified in the area

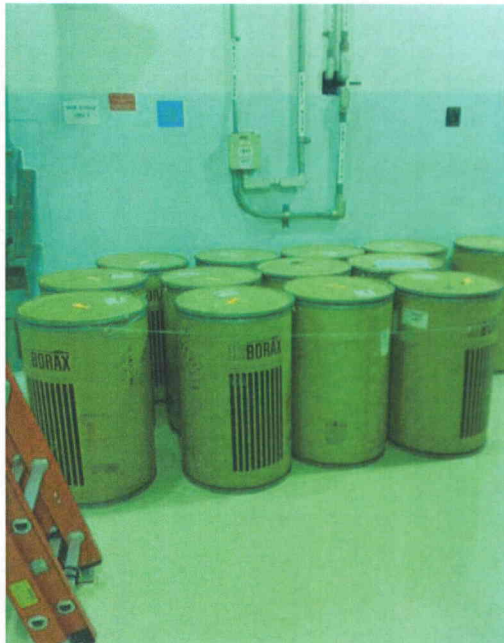
File Name: 1-60-1-1-09.jpeg
Description: View of containers in the area
