Seismic Walkdown Checklist (SWC)

Equipment ID No. MCC-1-E7 Equip. Class 1. Motor Control Center

Equipment Description 480V Motor Control Center FED From 480V Substation 1-8Bus 1N(8N14)

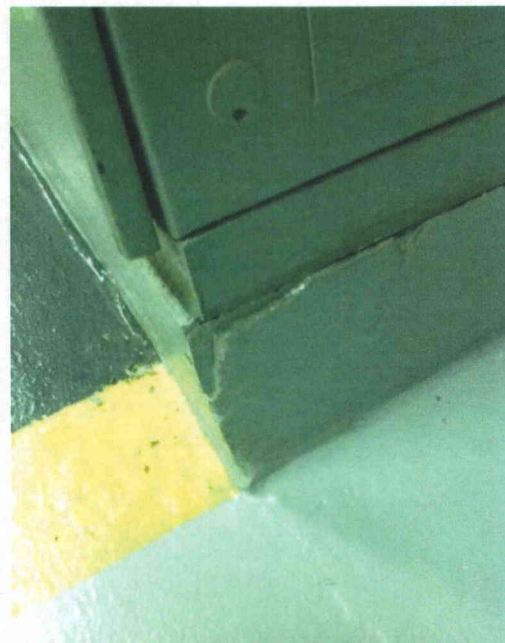
File Name: 2-64-1-1-22.jpeg
Description: Close up view of embedment detail

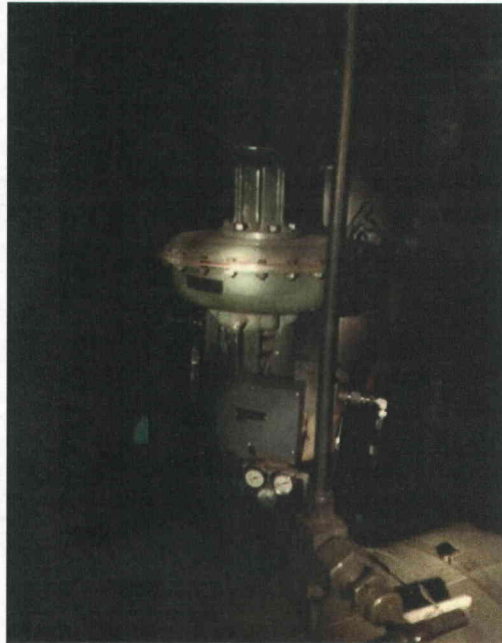
File Name: 2-61-3-1-32.jpeg
Description: General view of component

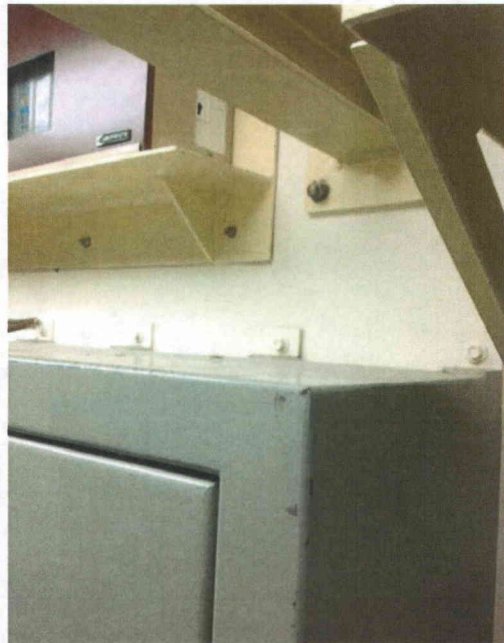
File Name: 2-64-3-1-18.jpeg
Description: View of typical wall anchorage configuration

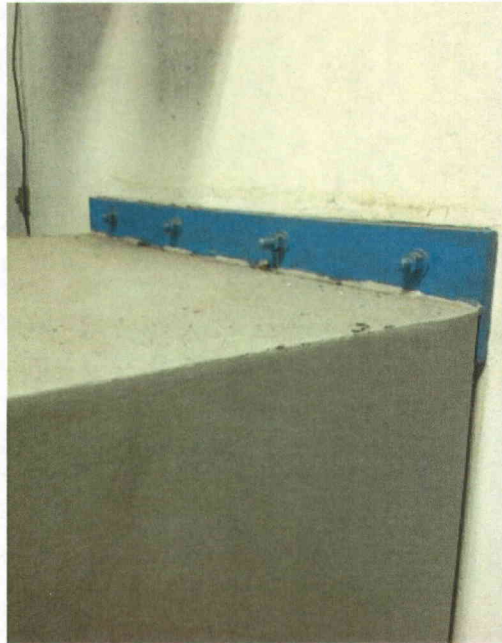
File Name: 2-63-4-1-20.jpeg

Description: View of typical wall anchorage configuration

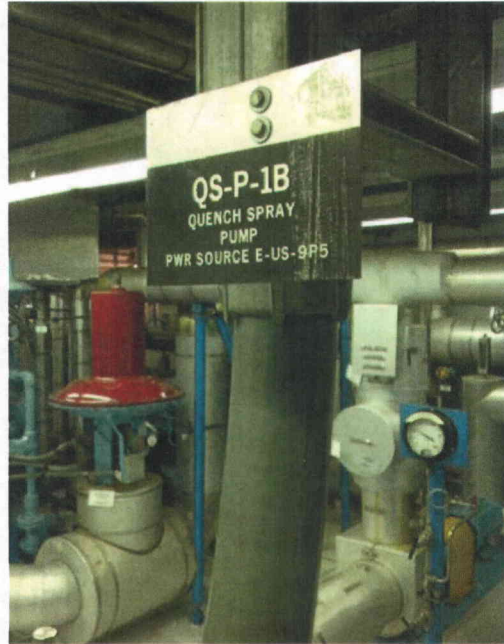
File Name: 2-61-7-1-50.jpeg
Description: Component Plate ID

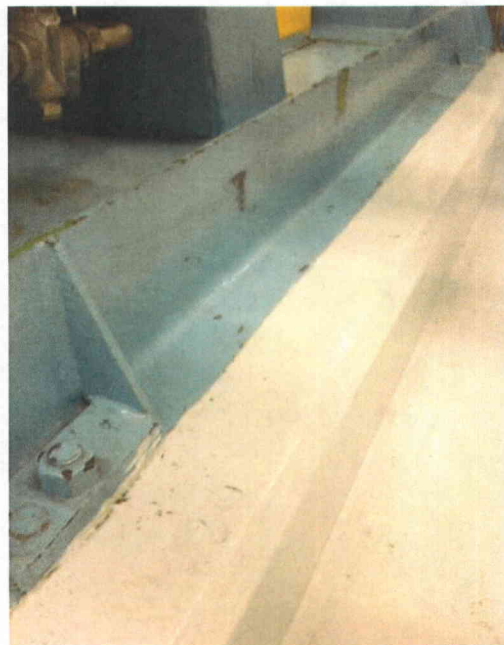
File Name: 2-64-7-1-50.jpeg
Description: Typical frame anchorage configuration

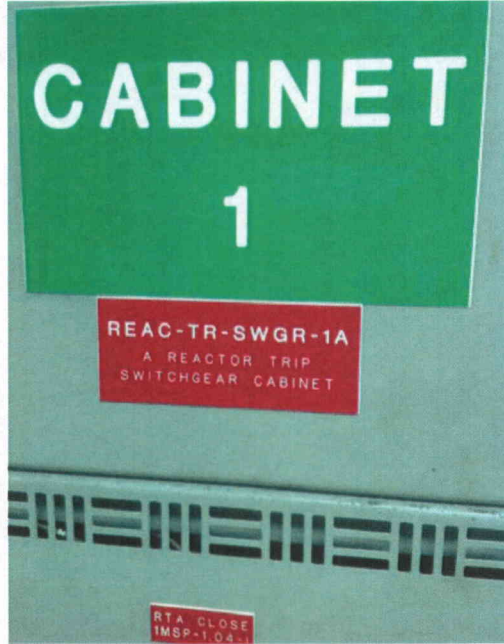
File Name: 2-61-1-1-33.jpeg
Description: Component Plate ID

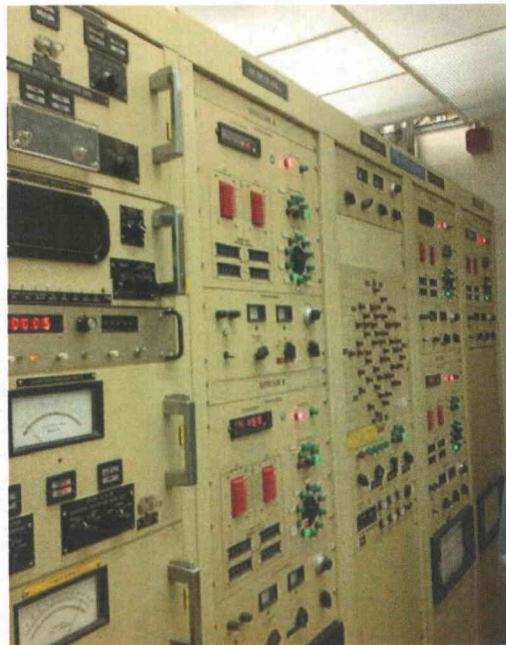
File Name: 2-62-4-1-18.jpeg
Description: General view of component

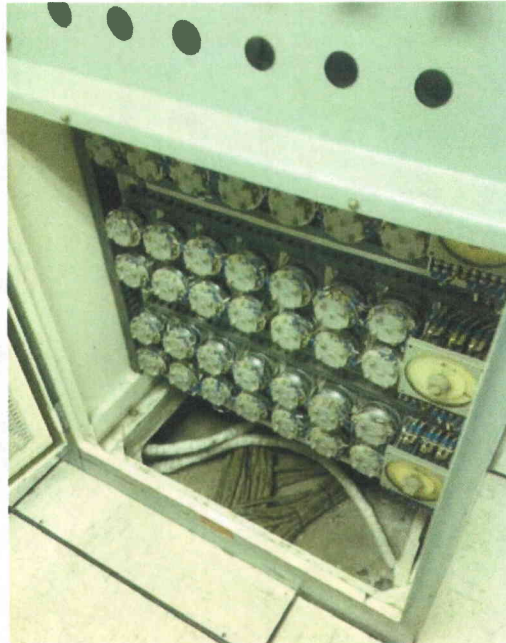
File Name: 2-63-3-1-49.jpeg
Description: General view inside of component

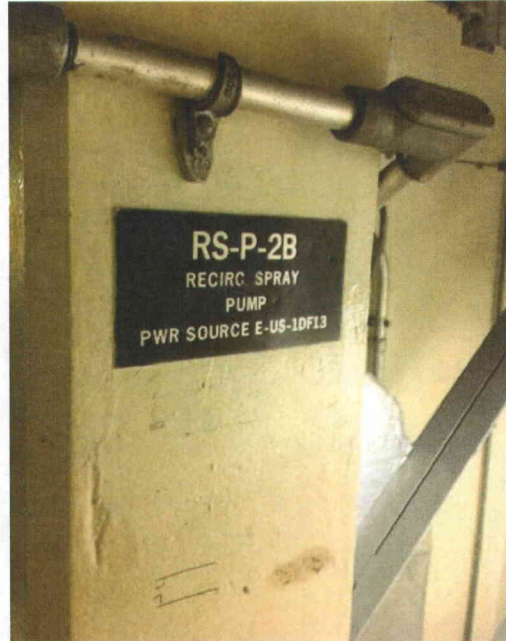
File Name: 2-64-1-1-10.jpeg
Description: Component Plate ID

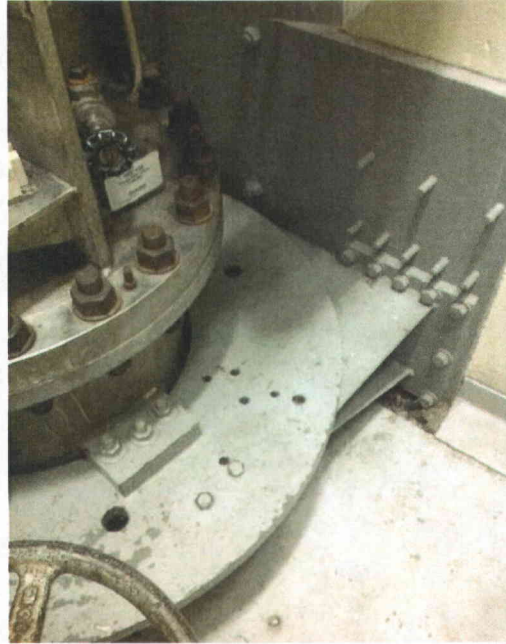
File Name: 2-62-1-1-10.jpeg
Description: Anchorage configuration for pump's bottom section

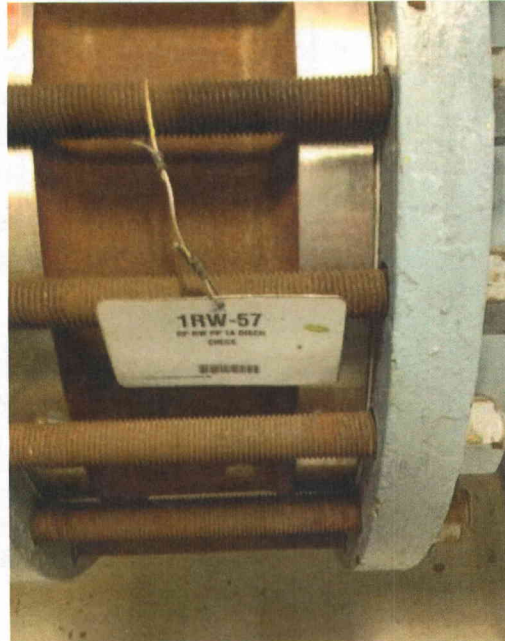
File Name: 2-61-4-1-27.jpeg
Description: Component Plate ID

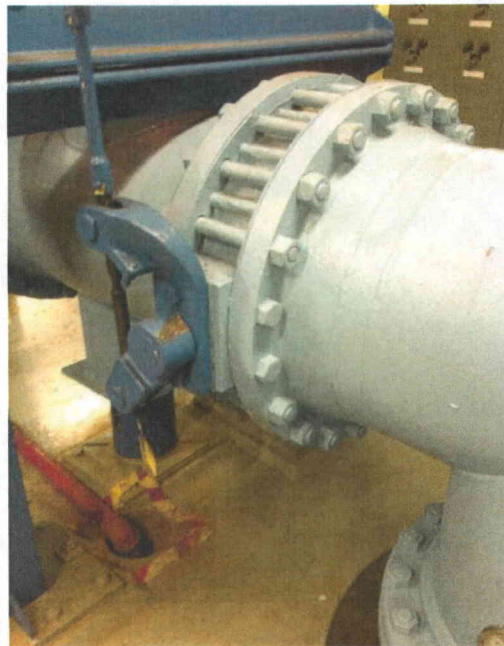
File Name: 2-62-1-1-46.jpeg
Description: General view of component

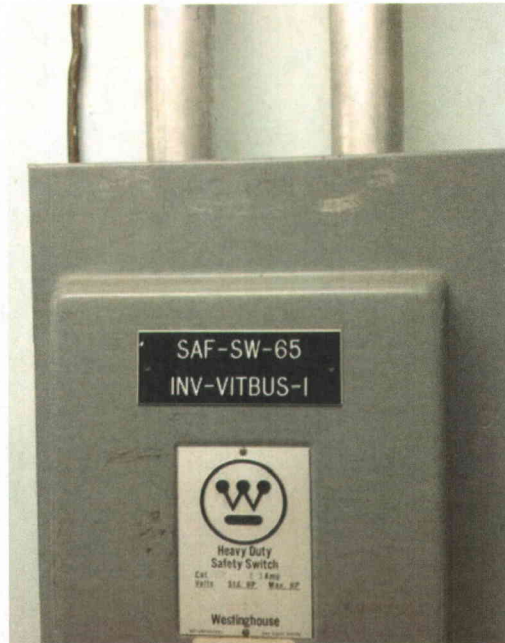
File Name: 2-61-5-1-25.jpeg
Description: Component Plate ID

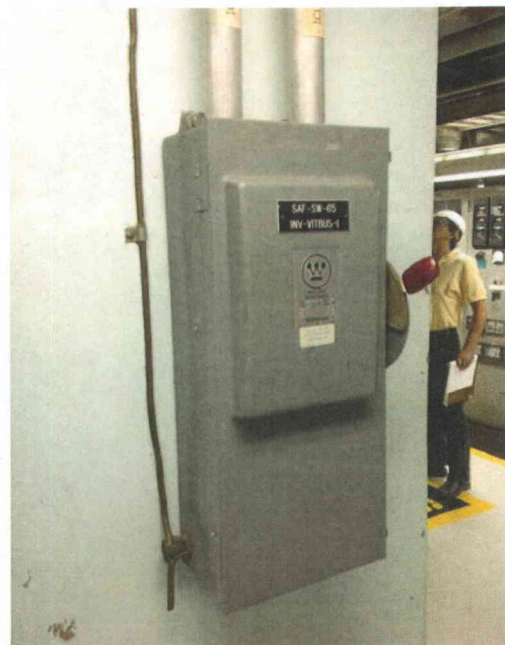
File Name: 2-62-5-1-25.jpeg
Description: General view of component

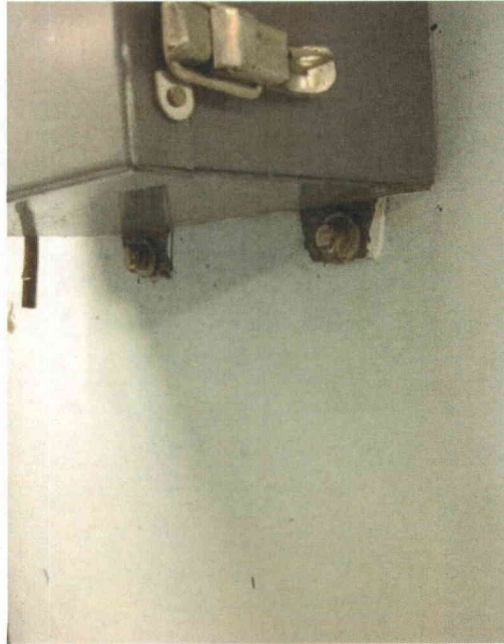
File Name: 2-63-5-1-25.jpeg
Description: Bottom wall mounting configuration

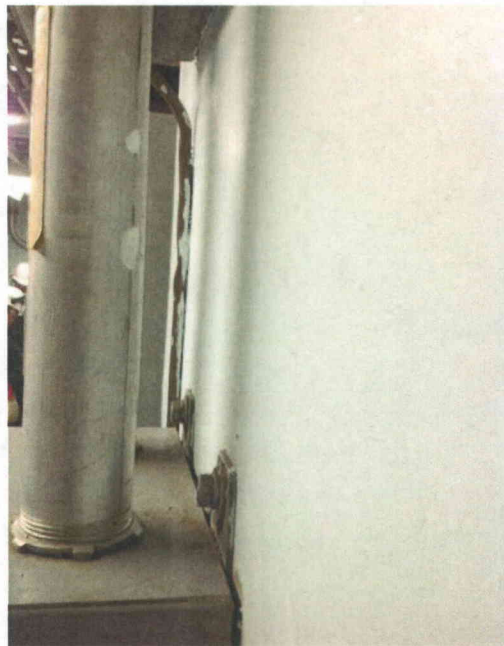
File Name: 2-64-5-1-25.jpeg
Description: Top wall mounting configuration

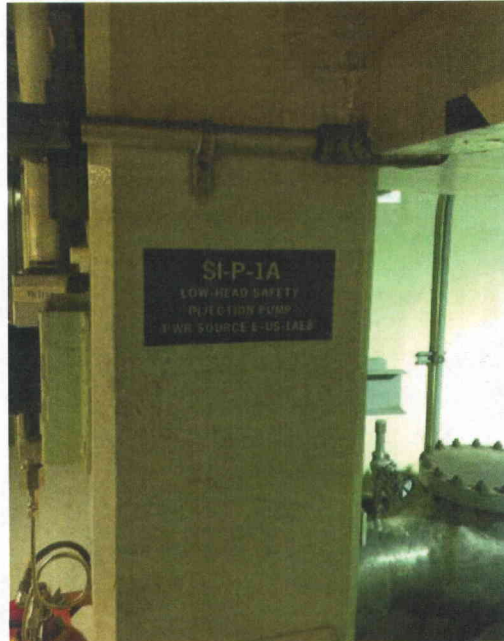
File Name: 2-95-1-1-31.jpeg
Description: Component Plate ID

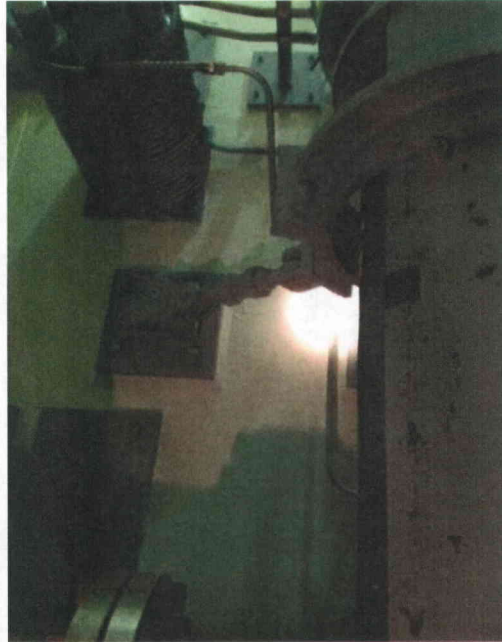
File Name: 2-62-1-1-31.jpeg
Description: Wall mounted brace detail

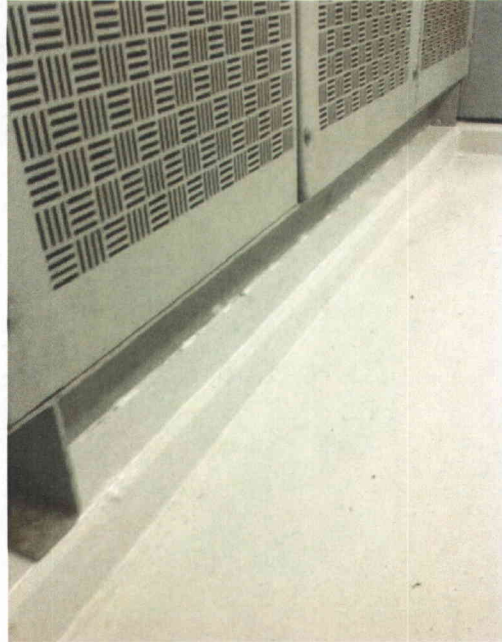
File Name: 2-63-12-1-25.jpeg
Description: View of base mounting frame configuration

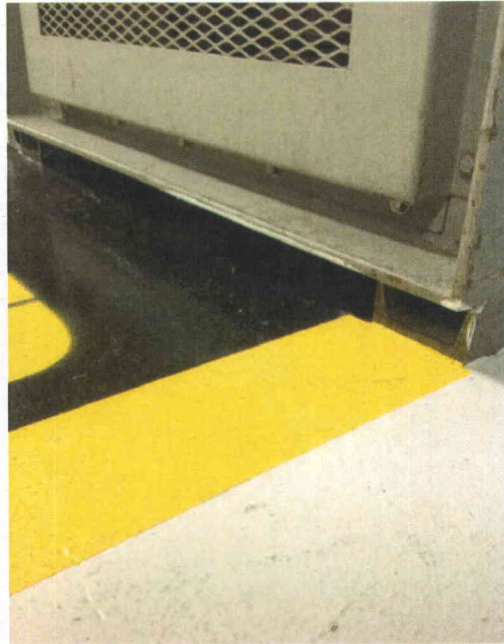
File Name: 2-63-7-1-25.jpeg
Description: View of channel mounting base

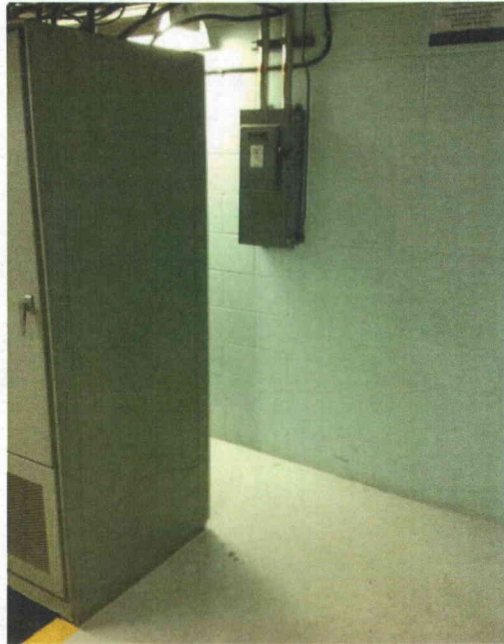
File Name: 2-73-7-1-25.jpeg

Description: Block wall identified in the vicinity of the component

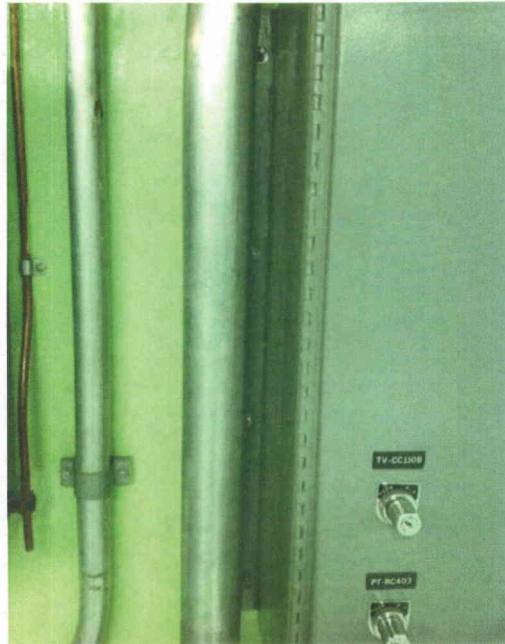
File Name: 2-63-1-1-23.jpeg
Description: View of wall mounting configuration

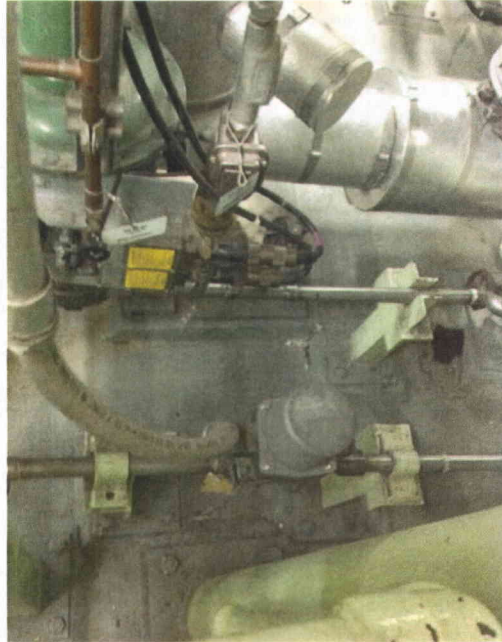
File Name: 2-63-2-1-38.jpeg

Description: View of line supports location relative to valve

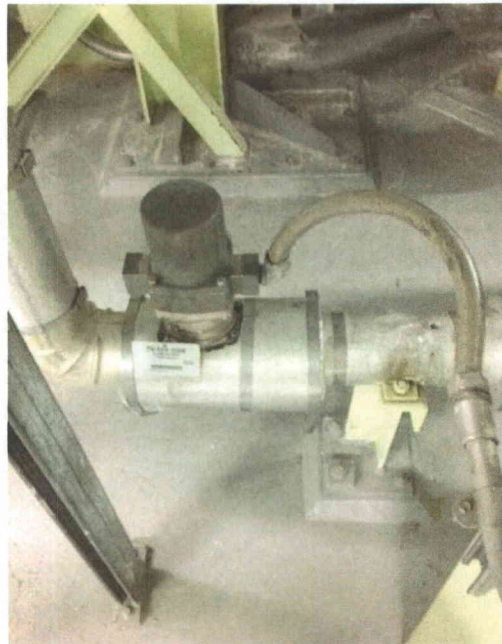
File Name: 2-62-2-1-37.jpeg
Description: General view of component

1. Is the anchorage configuration verification required (i.e., is the item one of the 50% of SWEL items requiring such verification)?
Side mounted on large pipe found in good condition. (This valve is a power assisted check valve)

3. Is the anchorage free of corrosion that is more than mild surface oxidation?
Slight surface corrosion identified.
- | | | | |

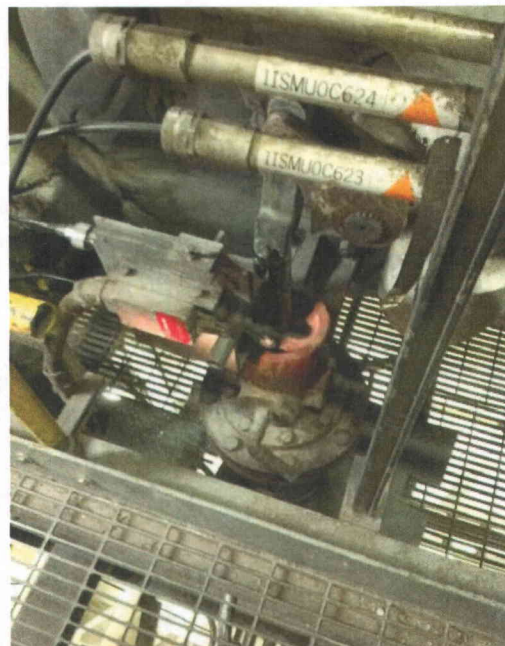
File Name: 2-62-5-1-32.jpeg
Description: General view of component

| 3. Is the anchorage free of corrosion that is more than mild surface oxidation? <i>Valve found in good condition.</i> | <input type="checkbox"/> | <input type="checkbox"/> | <input type="checkbox"/> | <input checked="" type="checkbox"/> |

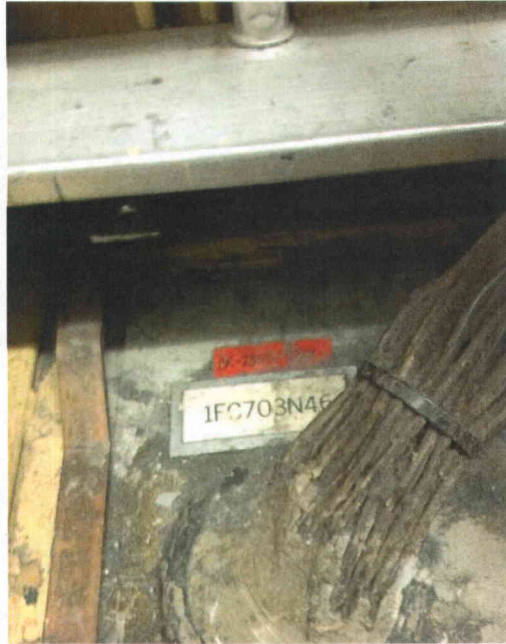
File Name: 2-63-6-1-18.jpeg
Description: Welded detail between panel housing and embedment

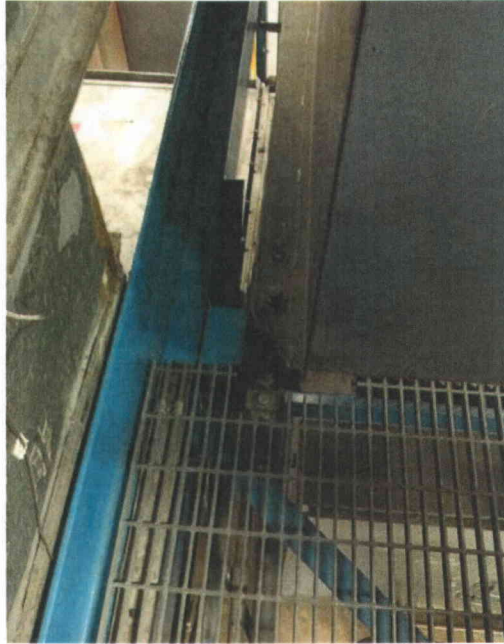
File Name: 2-63-1-1-06.jpeg

Description: View of beam mounting detail

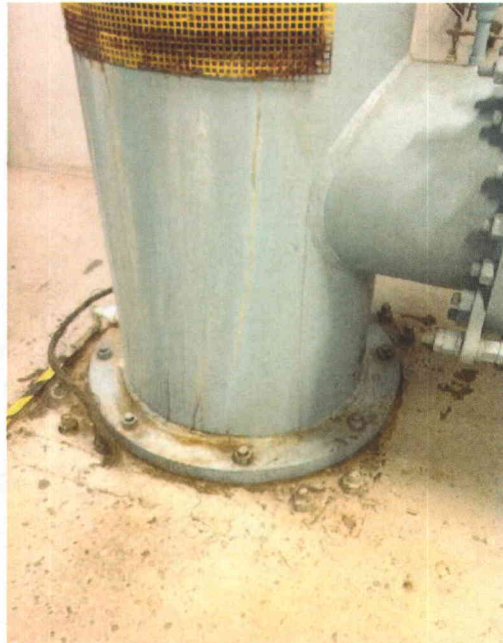
File Name: 2-63-3-1-27.jpeg
Description: View of anchorage configuration
