## APPENDIX C AREA WALK-BY CHECKLISTS (AWCs)

**Area Walk-By Checklist (AWC)**

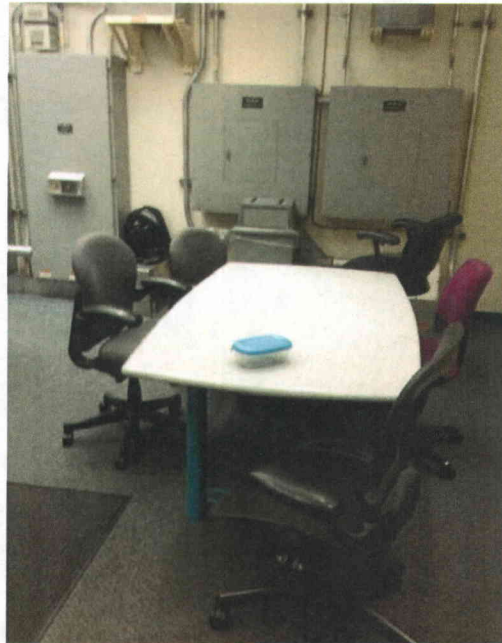
File Name: 1-69-1-4-18.jpeg

Description: Several unrestrained tables, chairs, and trash cans in vicinity

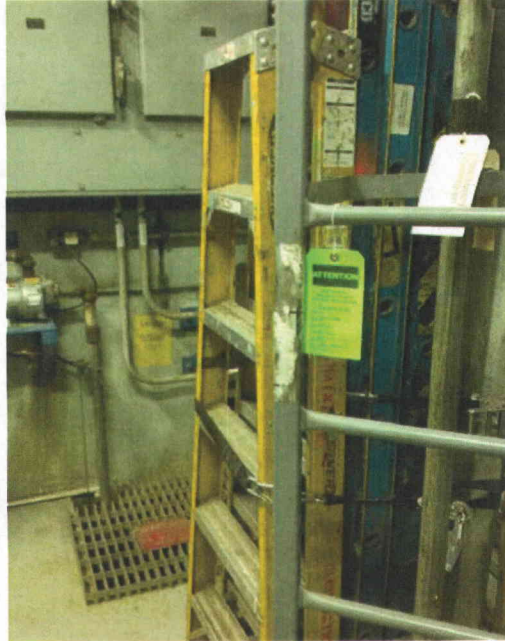
File Name: 1-67-1-4-28.jpeg  
Description: Ladders are secure

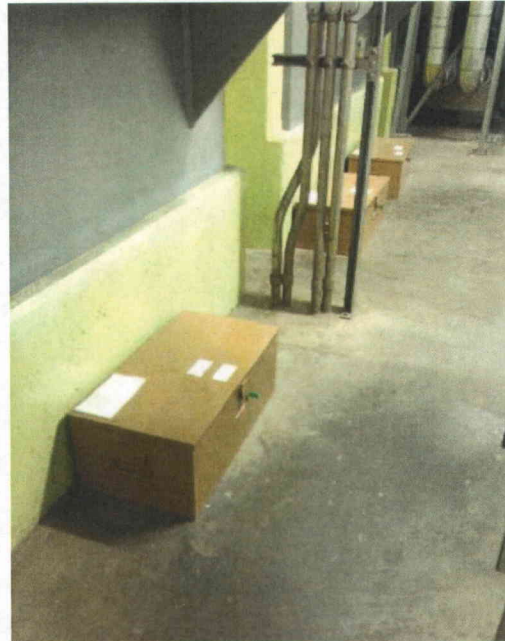
File Name: 1-71-1-4-32.jpeg  
Description: Boxes, secure.

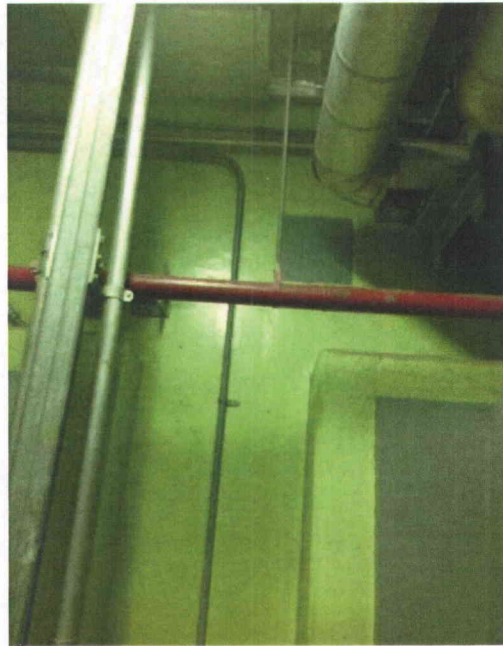
File Name: 1-74-1-4-32.jpeg  
Description: Fire line is secure.

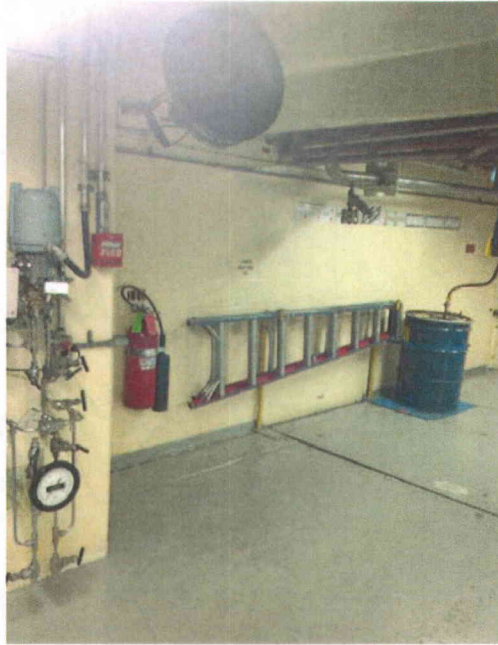
File Name: 1-66-1-4-43.jpeg  
Description: Block wall East

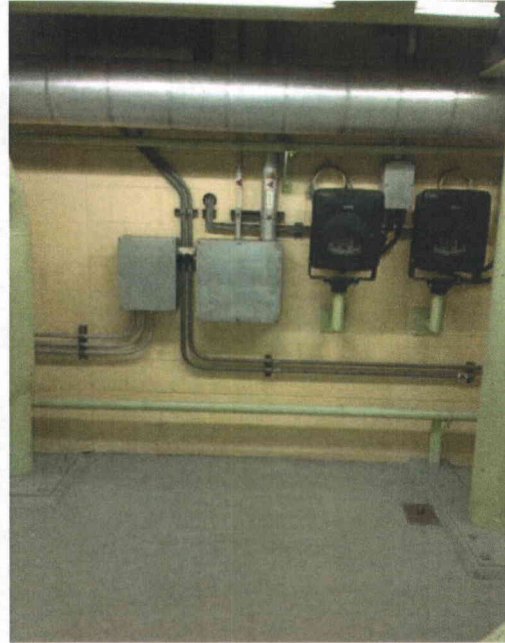
File Name: 1-67-1-4-43.jpeg  
Description: Blocks wall North

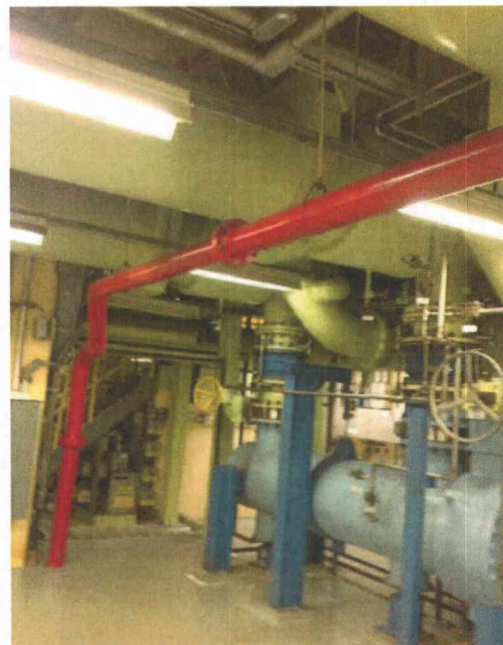
File Name: 1-60-1-4-44.jpeg  
Description: Rod hung fire pipe is sufficiently rugged

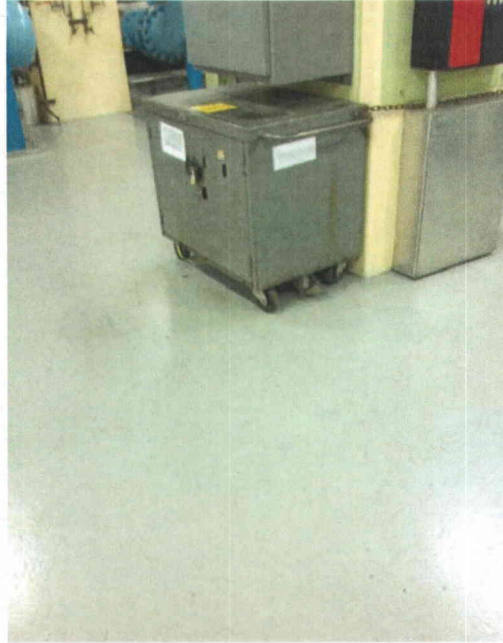
**File Name:** 1-65-1-4-44.jpeg  
**Description:** Cart properly restrained

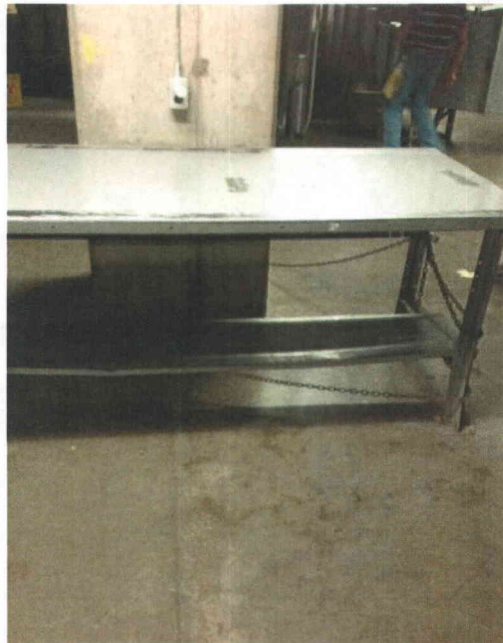
File Name: 1-60-1-4-56.jpeg  
Description: Table, secured
