APPENDIX B: SEISMIC WALKDOWN CHECKLISTS (SWCs)

Seismic Walkdown Checklist (SWC)

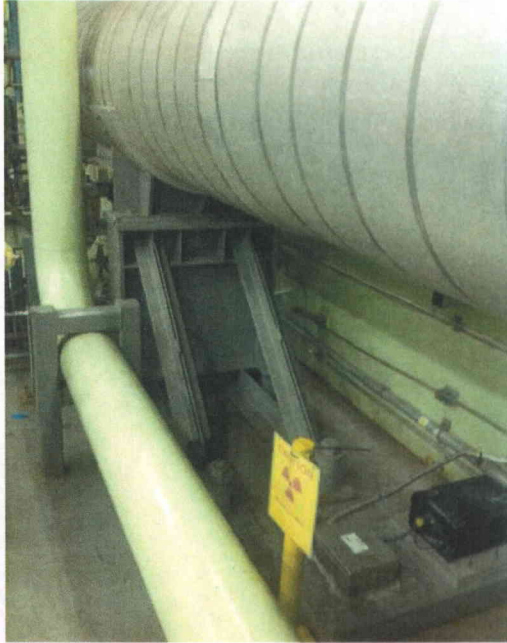
File Name: 2-62-4-2-01.jpeg
Description: View of Fixed Support

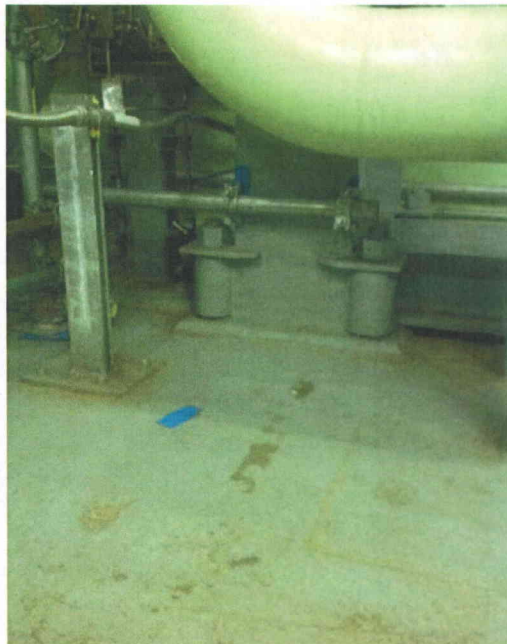
File Name: 2-63-4-2-01.jpeg
Description: View of Fixed Support

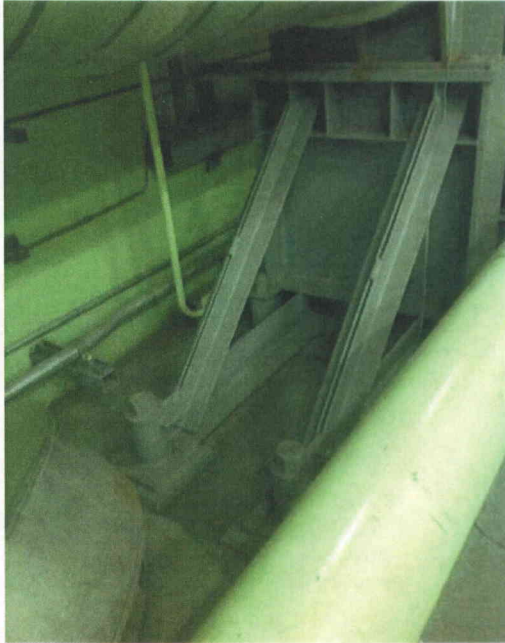
File Name: 2-64-4-2-01.jpeg
Description: View of Sliding Support

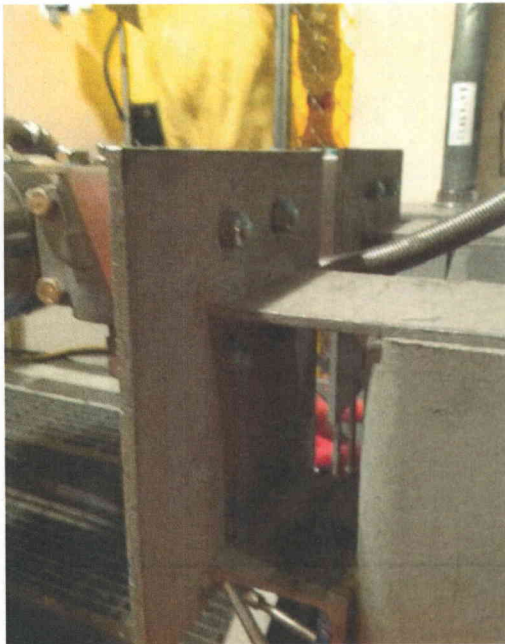
File Name: 2-63-8-2-19.jpeg
Description: View of Mounting Bolts

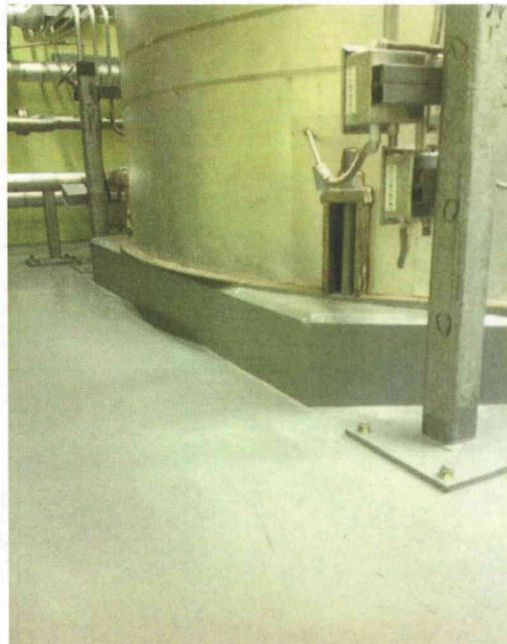
File Name: 2-64-4-2-04.jpeg
Description: General View of Pedestal and Anchorage

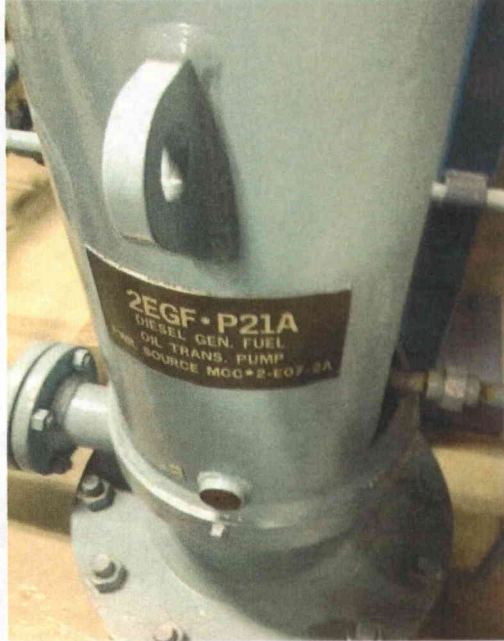
File Name: 2EGF-P21A(1).jpg
Description: Component Plate ID

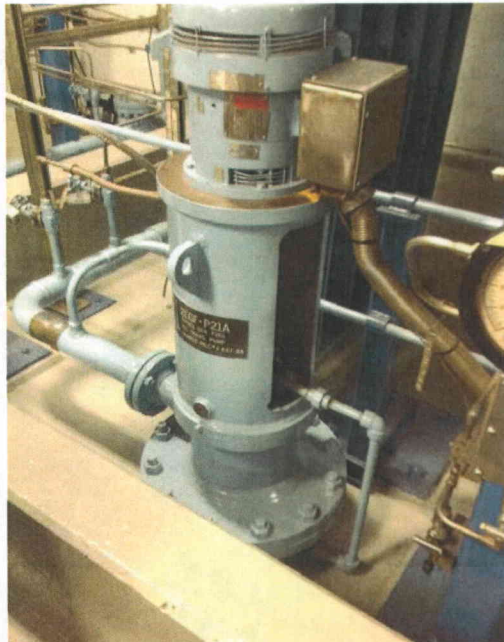
File Name: 2EGF-P21A(2).jpg
Description: General View of Component and Anchorage

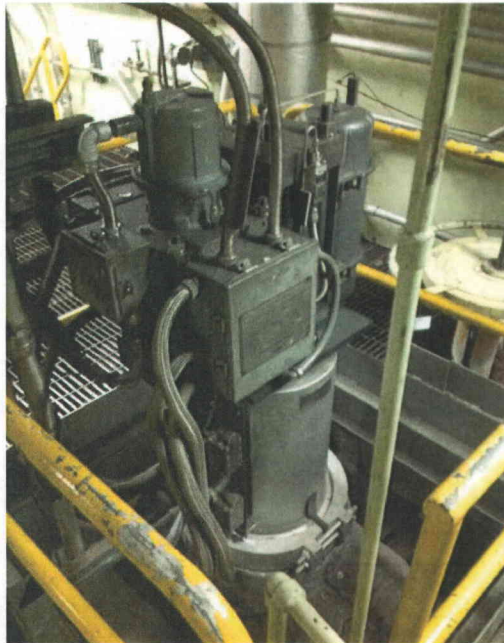
File Name: 2-64-2-2-16.jpeg
Description: View of Attached Lines

9. Do attached lines have adequate flexibility to avoid damage?
Attached lines identified with adequate flexibility.

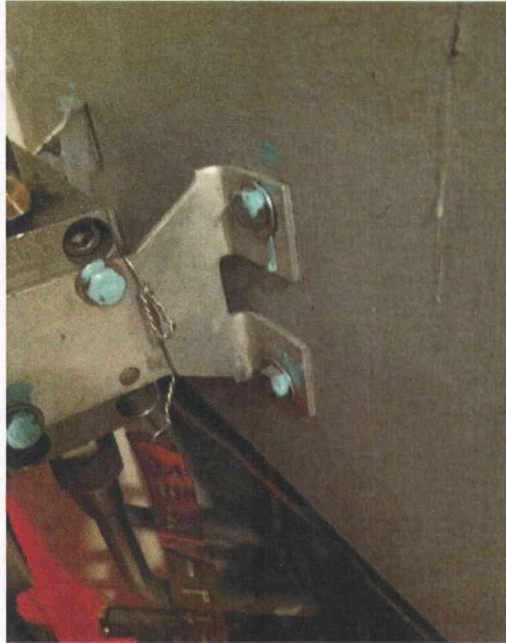
File Name: 2-63-1-2-19.jpeg
Description: View of Mounting Bolts

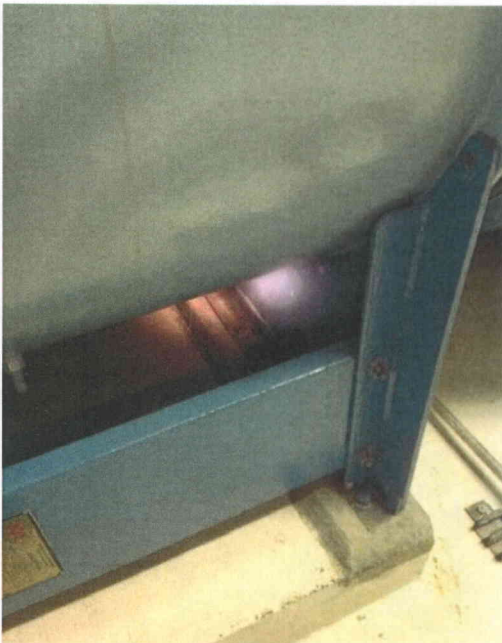
File Name: 2HVD-FN270A(4).jpg
Description: View of Support Saddle

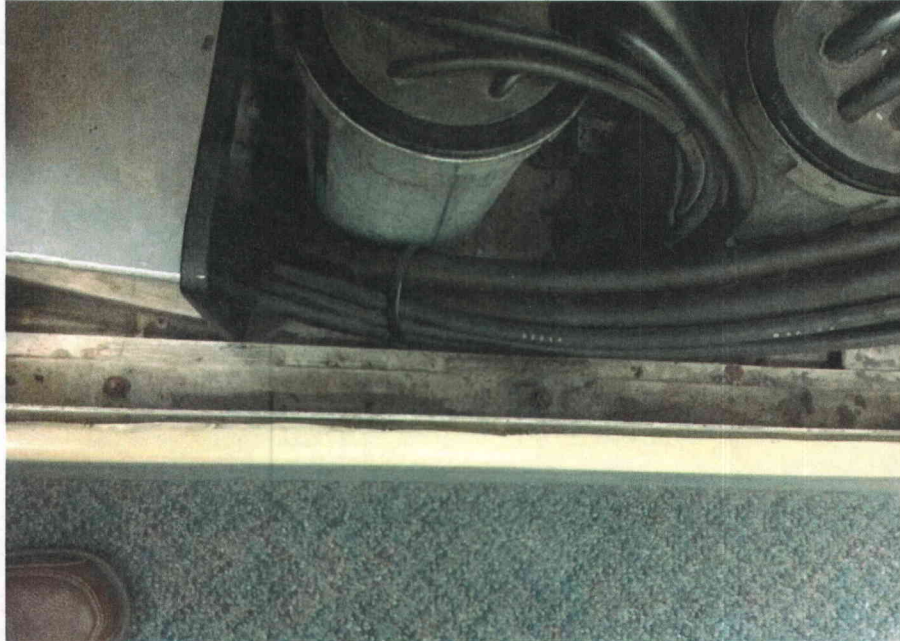
File Name: 2HVR-TI228(1).jpg
Description: View of Cabinet Anchorage

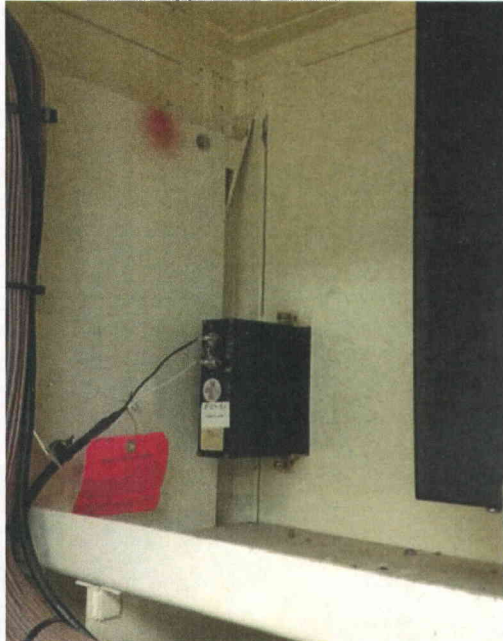
File Name: 2HVR-TI228-1(1).jpg
Description: View of Component Anchorage

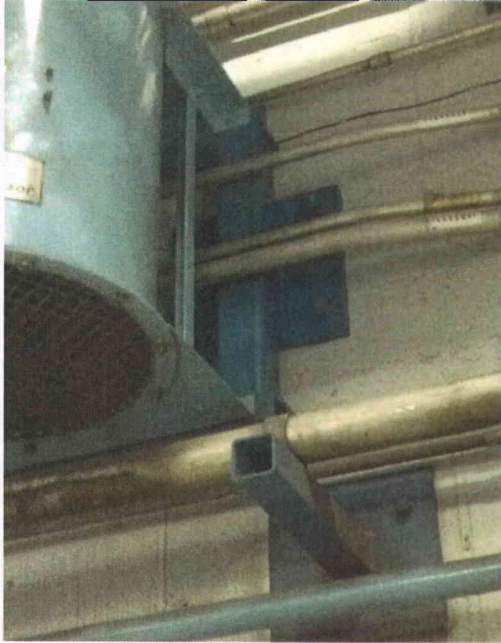
File Name: 2HVW-FN257A(1).jpg
Description: View of Anchorage

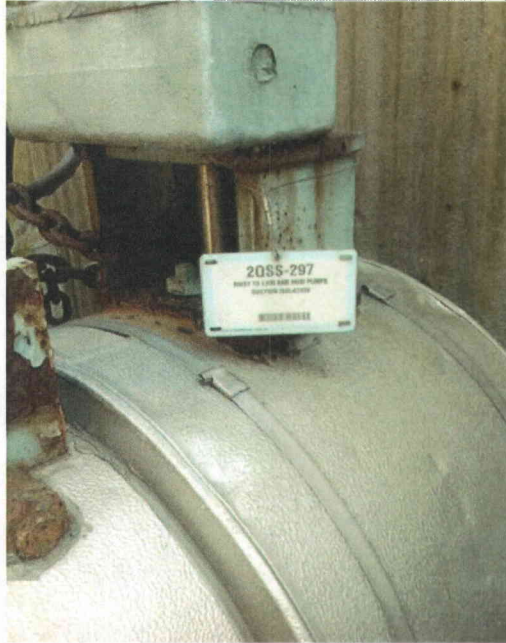
Corrosion is identified in anchor bolts. CR-2012-14744 generated to document this condition.
