Seismic Walkdown Checklist (SWC)

Equipment ID No. 2SIS-MOV867A Equip. Class 8A. Motor Operated Valve

Equipment Description HHSI Isol to Cold Leg Injection

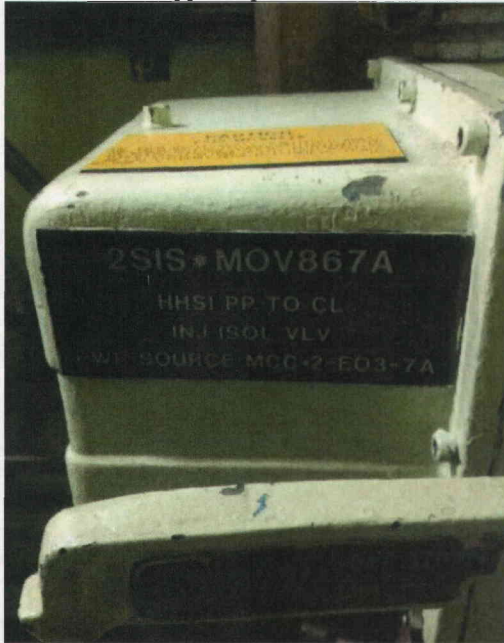
File Name: 2-61-1-2-01.jpeg
Description: Component Plate ID

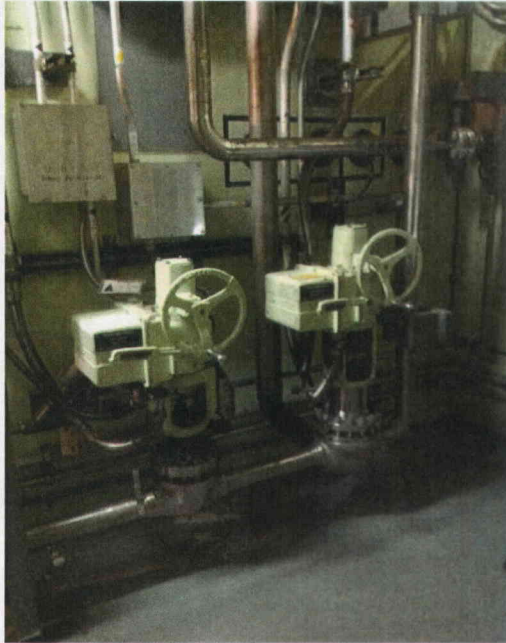
File Name: 2-63-1-2-01.jpeg

Description: General View of Component Area

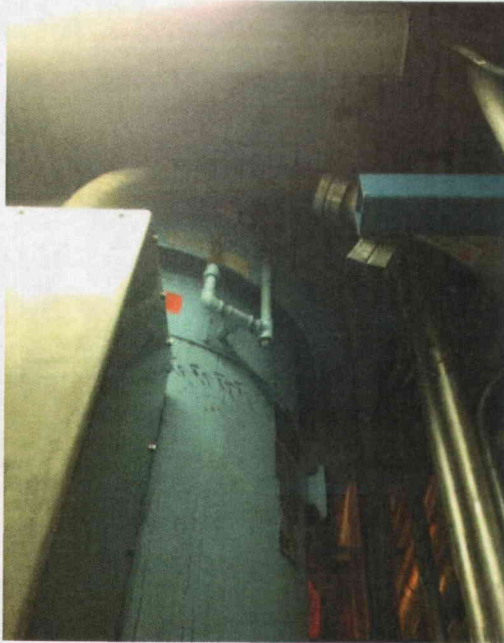
File Name: 2SWS-P21A(5).jpg
Description: View of Attached Line

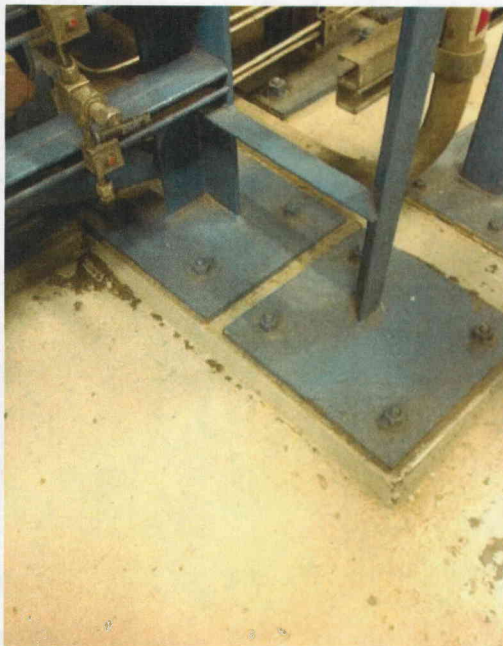
File Name: 2SWS-PT-117A(4).jpg
Description: View of Rack Anchorage

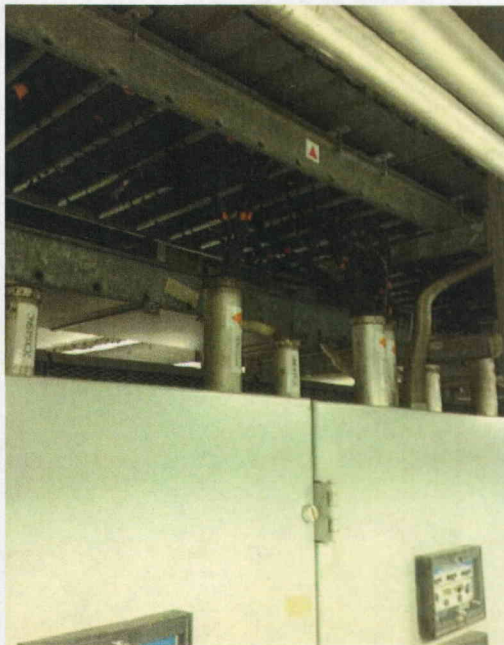
File Name: 4KVS-2AE(3).jpg
Description: View of Flexible Top Conduit

9. Do attached lines have adequate flexibility to avoid damage?
Attached top conduit is adequately flexible.

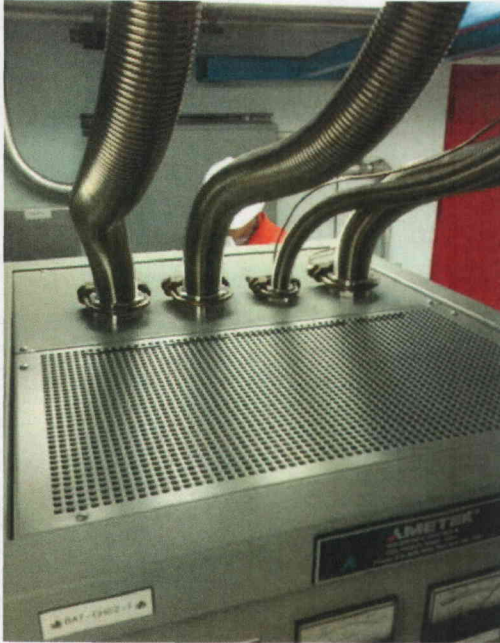
File Name: BAT-CHG2-1(5).jpg
Description: View of Flexible Top Lines

9. Do attached lines have adequate flexibility to avoid damage?
Attached top entry conduit found with adequate flexibility.

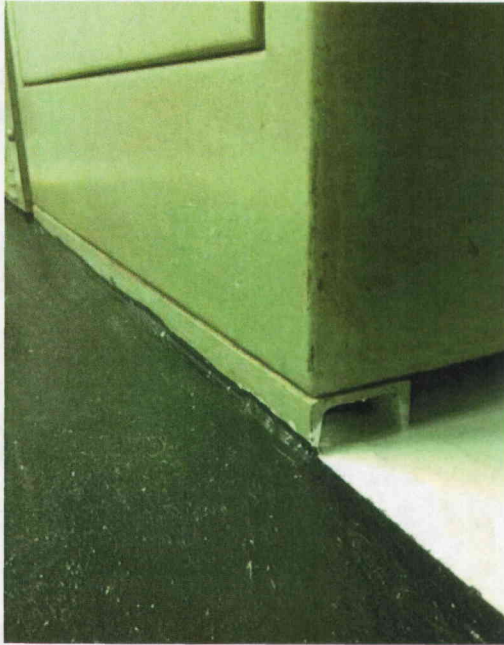
File Name: DC-SWBD2-1(3).jpg
Description: View of Anchorage

Calculation NM(B)-468-CZC confirms anchorage configuration as 12-3" long welds at corners of MCC sections for a total of 18" of fillet welds at front and 18" of welds at the back of the MCC. The welds are specified to be placed at each corner of MCC section. The required welds per the referenced calc is 36" vs. 50" observed during walkdown. The configuration is adequate.

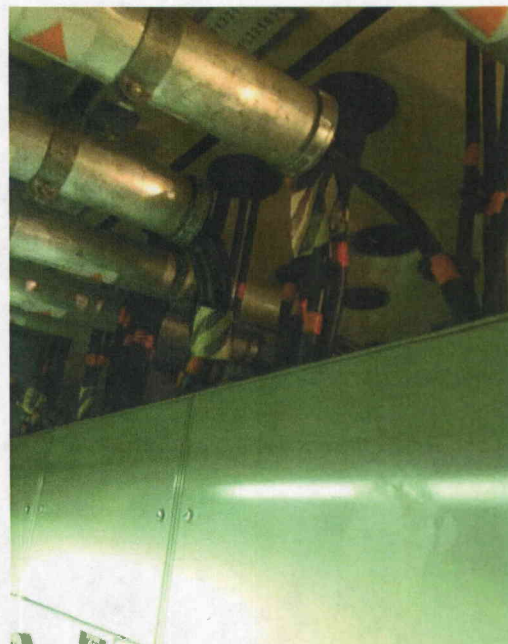
File Name: 2-96-3-2-04.jpeg
Description: Flexible top lines

Attached top entry conduit found with adequate flexibility.

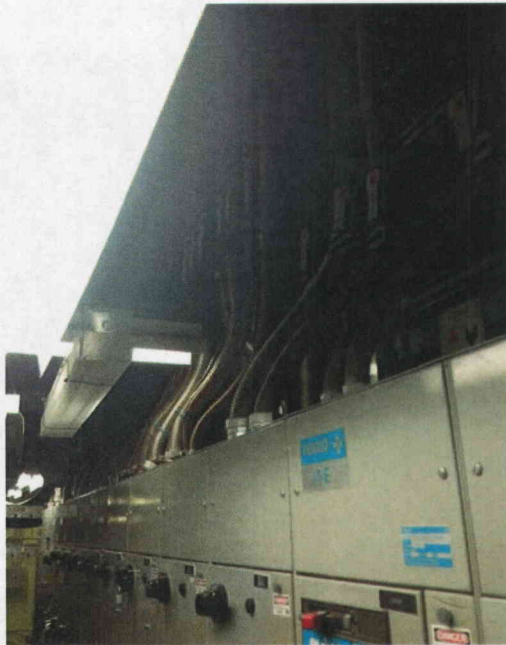
File Name: 2-73-1-2-13.jpeg
Description: View of Flexible Top Conduit

9. Do attached lines have adequate flexibility to avoid damage?
Attached top conduit found with adequate flexibility.

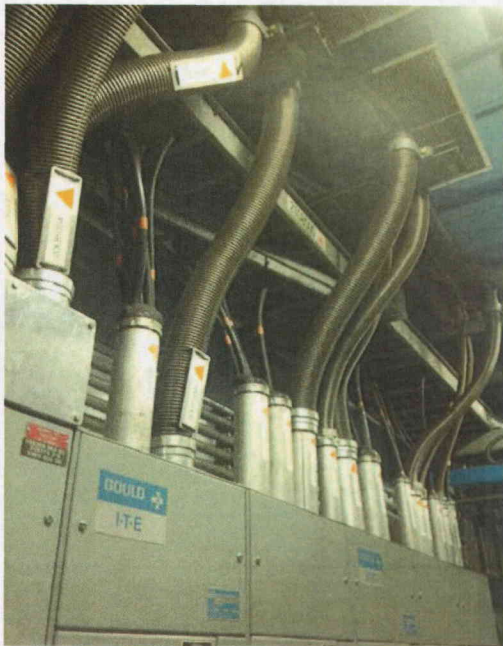
File Name: MCC-2-E07(4).jpg
Description: View of Flexible Top Lines

9. Do attached lines have adequate flexibility to avoid damage?
Attached top conduit found with adequate flexibility.

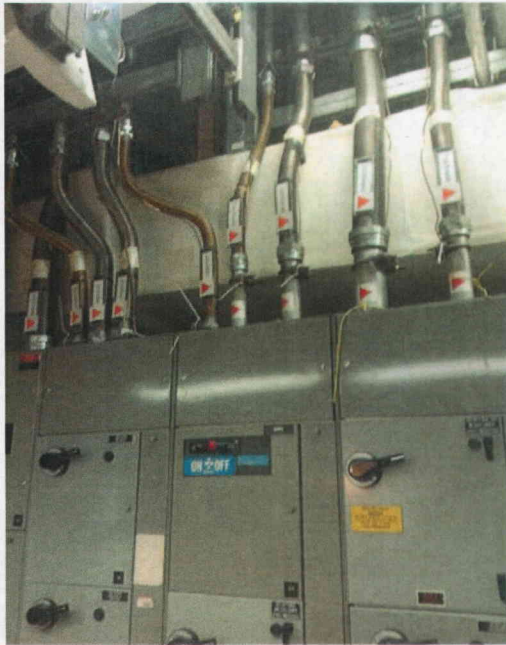
File Name: 2-64-1-2-06.jpeg
Description: View of Flexible Top Conduit

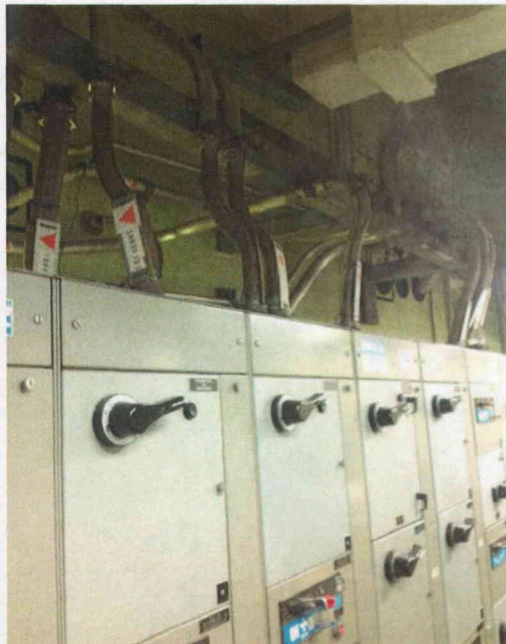
File Name: 2-64-1-2-24.jpeg
Description: View of Flexible Top Conduit

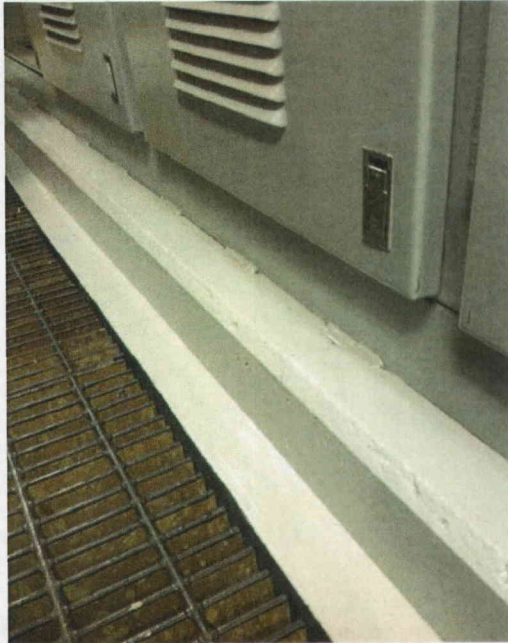
File Name: 2-64-8-2-08.jpeg
Description: Typical Anchor Weld

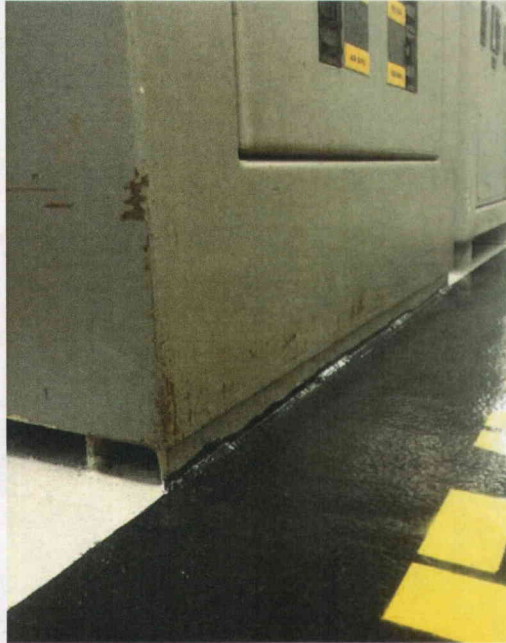
File Name: 2-63-18-2-26.jpeg
Description: View of Anchor Weld

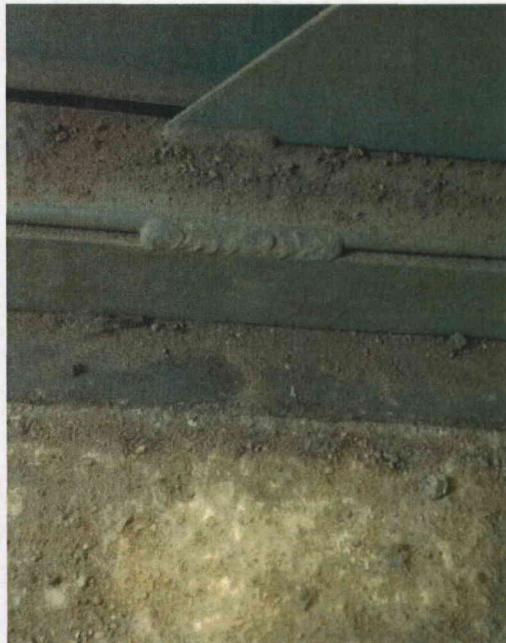
File Name: 2-95-17-2-26.jpeg
Description: View of Internal Welding

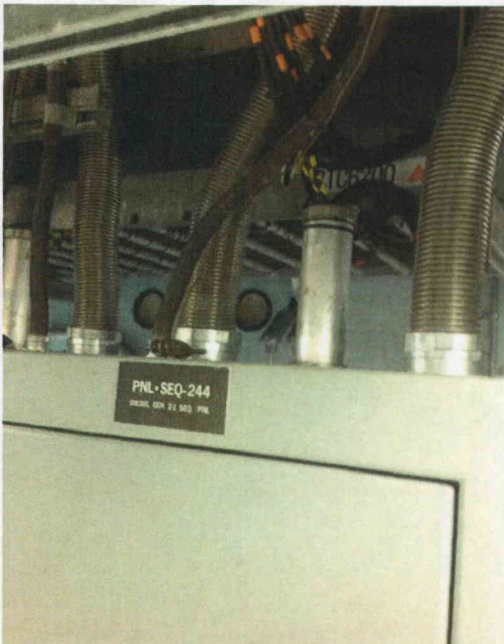
File Name: PNL-SEQ-244(4).jpg
Description: View of Flexible Top Lines

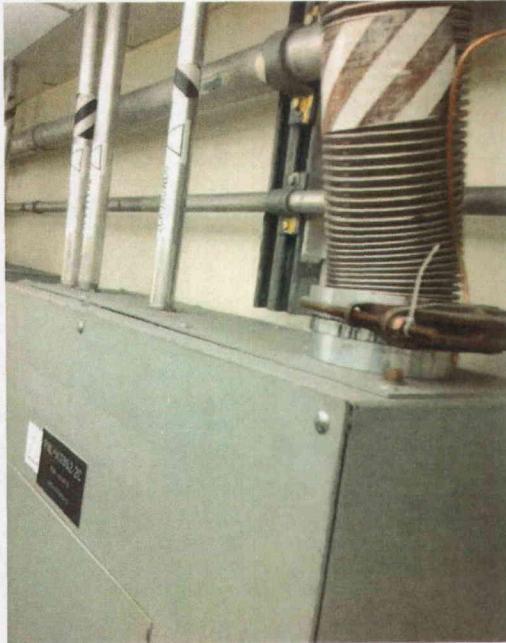
File Name: PNL-VITBS2-2C(3).jpg
Description: View of Attached Lines

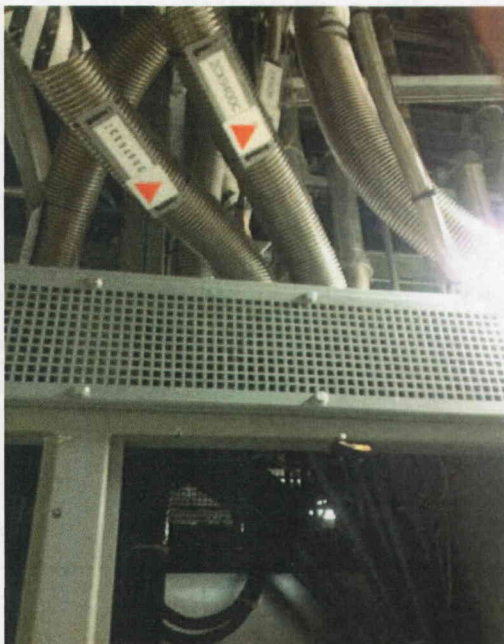
File Name: 2-73-5-2-06.jpeg
Description: View of Flexible Top Conduit

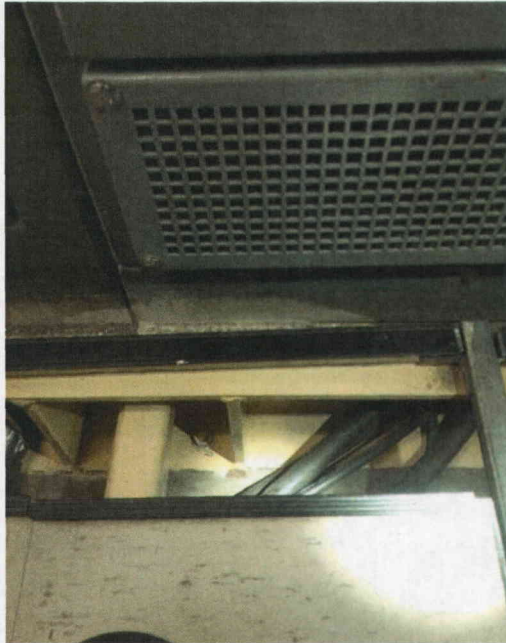
File Name: 2-97-5-2-06.jpeg

Description: View of Base Weld and Wide Flange Anchor Bolt

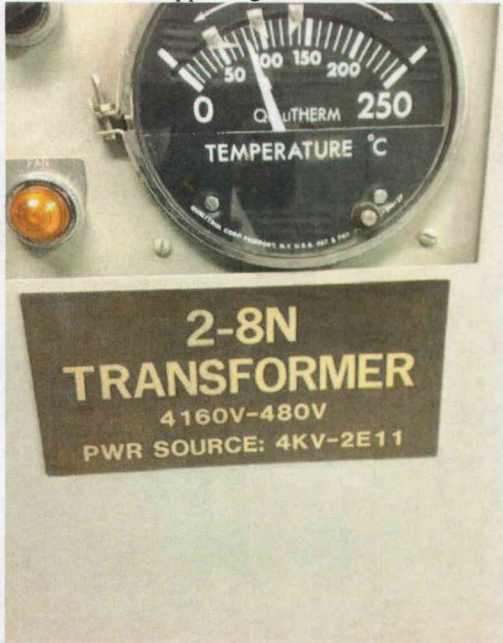
File Name: TRF2-8N(2).jpg
Description: Component Plate ID

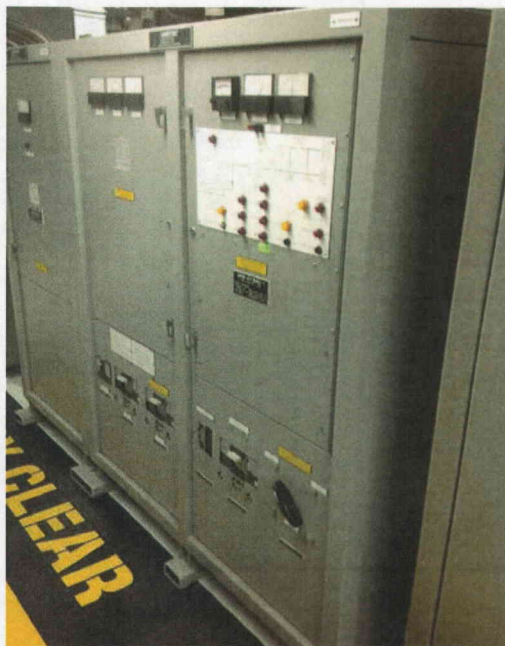
File Name: UPS-VITBS2-1(2).jpg
Description: General View of Component

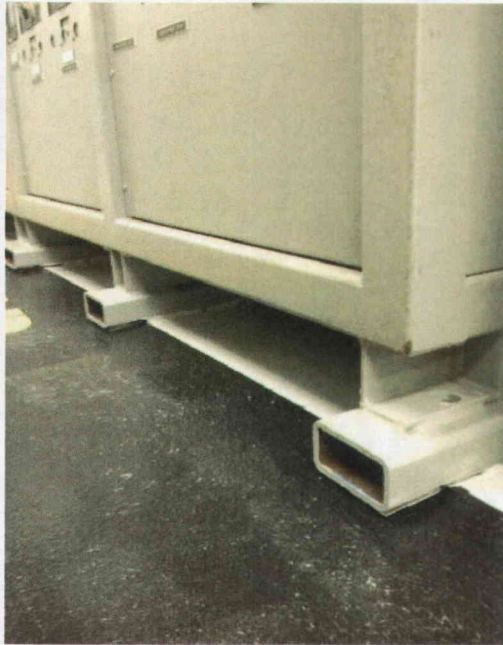
File Name: UPS-VITBS2-1(3).jpg
Description: View of Anchorage

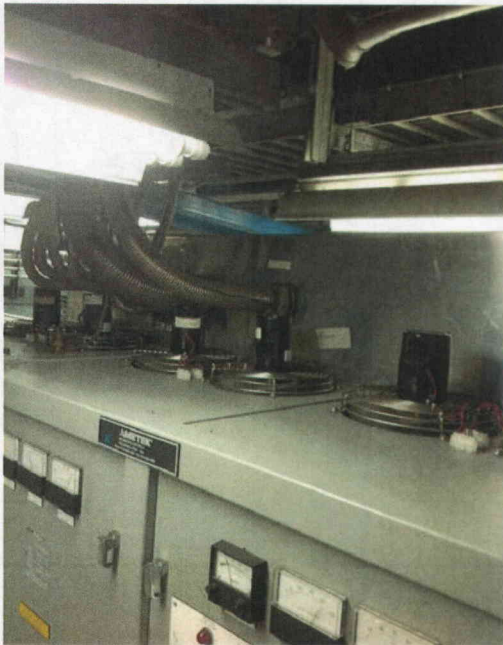
File Name: UPS-VITBS2-1(4).jpg
Description: View of Flexible Top Lines

9. Do attached lines have adequate flexibility to avoid damage?
Attached lines have adequate flexibility.

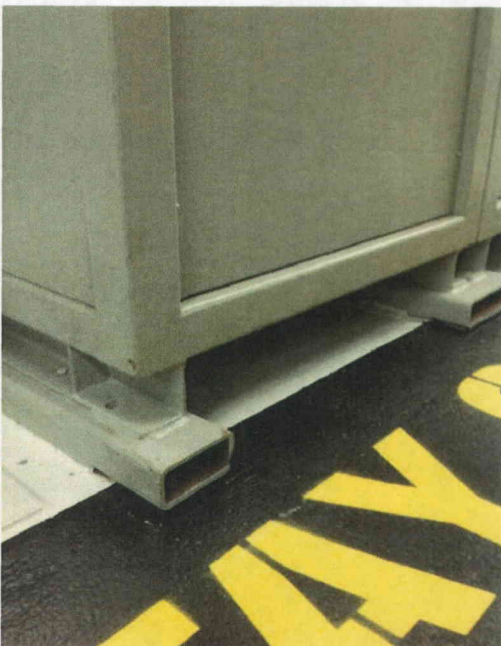
File Name: UPS-VITBS2-1-REG(4).jpg
Description: View of Anchorage
