APPENDIX C: AREA WALK-BY CHECKLISTS (AWCs)

Area Walk-By Checklist (AWC)

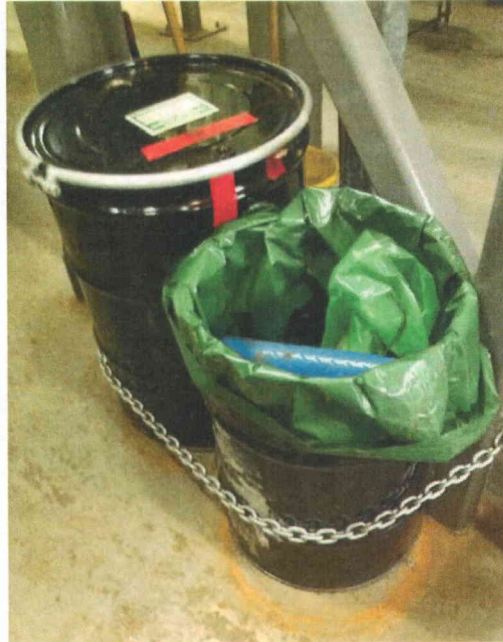
File Name: 1-59-4-3-01.jpeg

Description: Drums in the area identified to be properly restrained

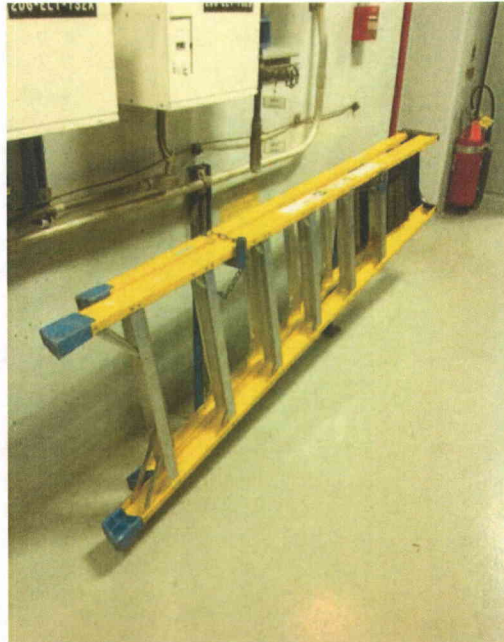
File Name: EDG2-1(5).jpg
Description: Properly restrained ladder identified in the area

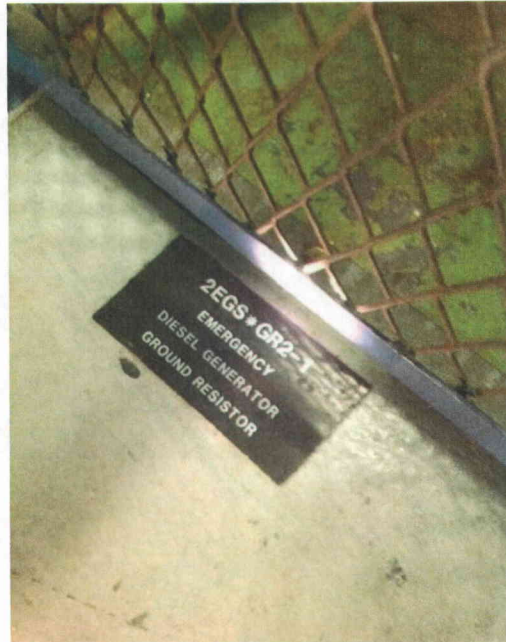
File Name: EDG2-1_Up(7).jpg
Description: DG resistor tag ID

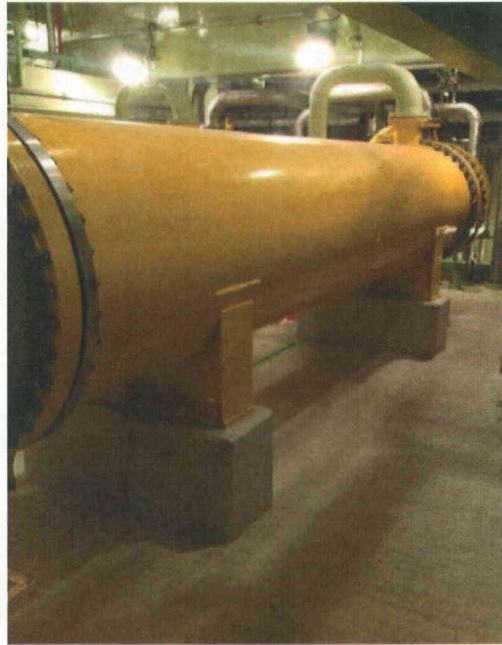
File Name: 1-65-2-3-29.jpeg

Description: View of Heat Exchanger mounted on saddle supports

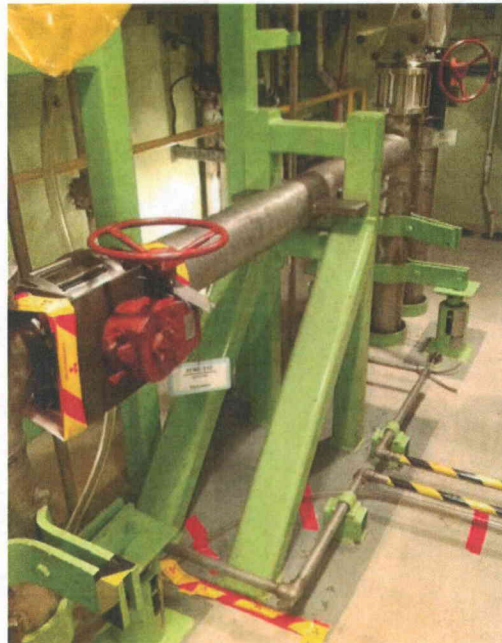
File Name: 1-66-2-3-29.jpeg

Description: Nearby floor mounted pipe supports.

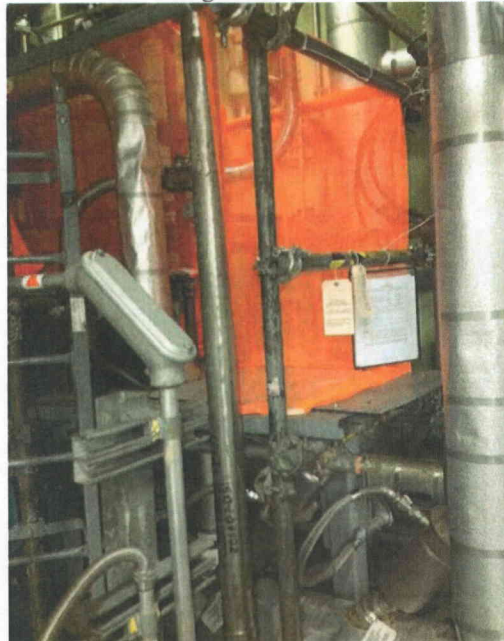
File Name: 1-75-2-3-12.jpeg

Description: Scaffold located in the area

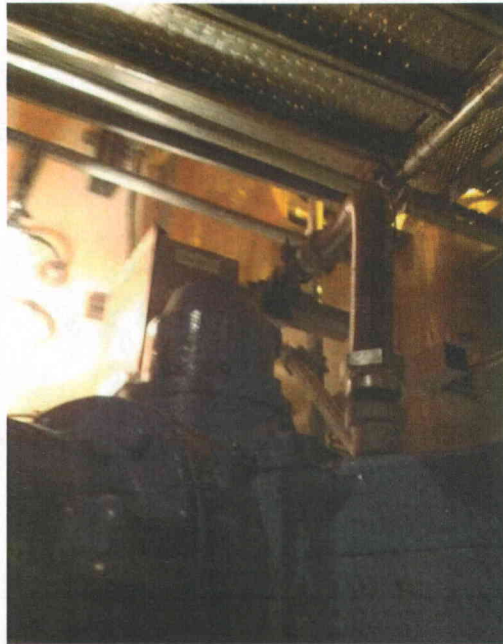
File Name: 2-62-5-2-19.jpeg
Description: View of scaffolding above 2RHS-MOV720A
