APPENDIX B: SEISMIC WALK-DOWN CHECKLISTS (SWCs)

Seismic Walkdown Checklist (SWC)

Equipment ID No. 0G41A0002A Equip. Class 21. Tanks and Heat Exchangers

Equipment Description FPCC Surge Tank

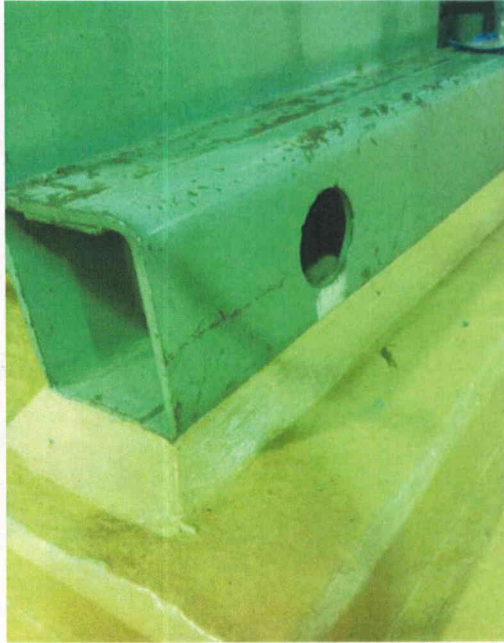
Anchorage configuration confirmed by Drawing 414-046, Foundation Plan "G"

8. Are overhead equipment, distribution systems, ceiling tiles and lighting, and masonry block walls not likely to collapse onto the equipment?
Hanging lights identified above component. Judged not to be an adverse condition.

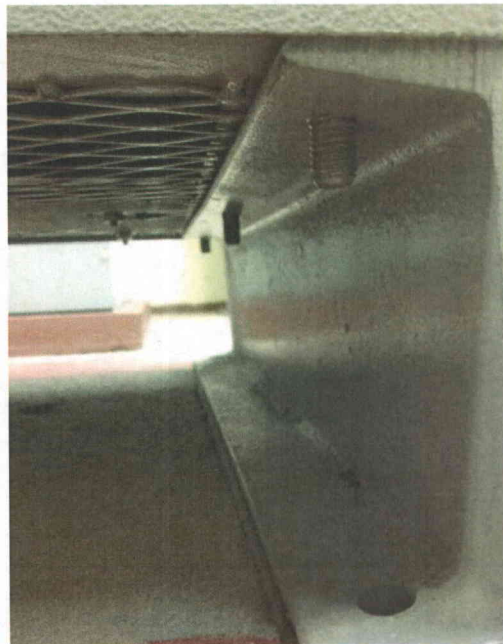
Slight surface corrosion identified but judged not a concern.

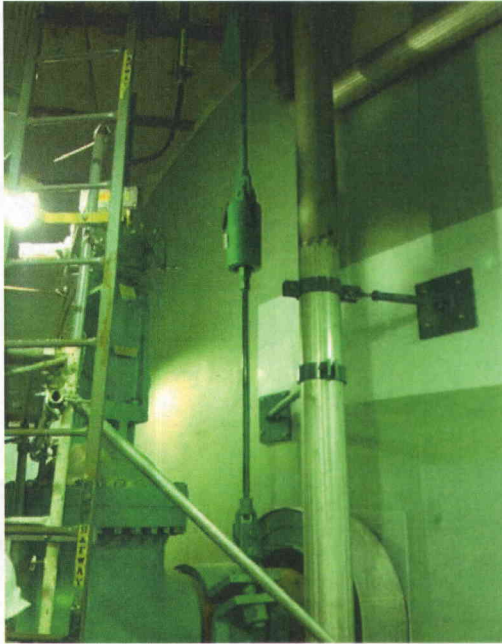
File Name: 2-73-8-4-18.jpeg
Description: View vertical support for main line

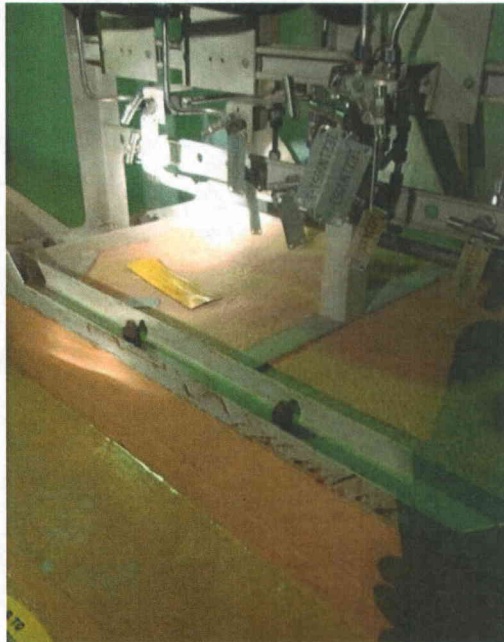
File Name: 2-64-7-4-18.jpeg
Description: Anchorage configuration for instrument rack

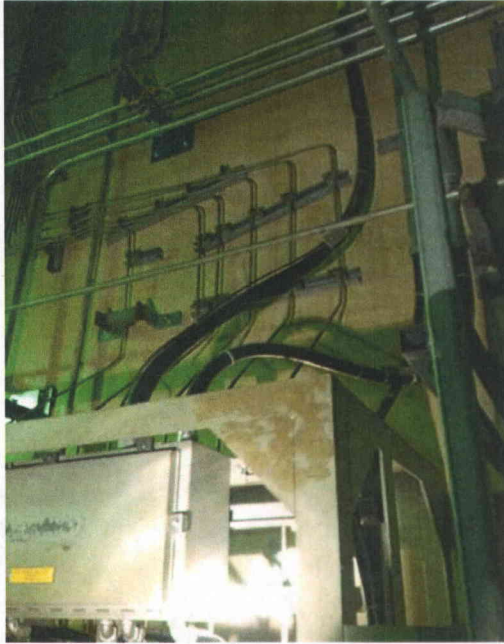
File Name: 2-73-7-4-18.jpeg
Description: View of top attached lines

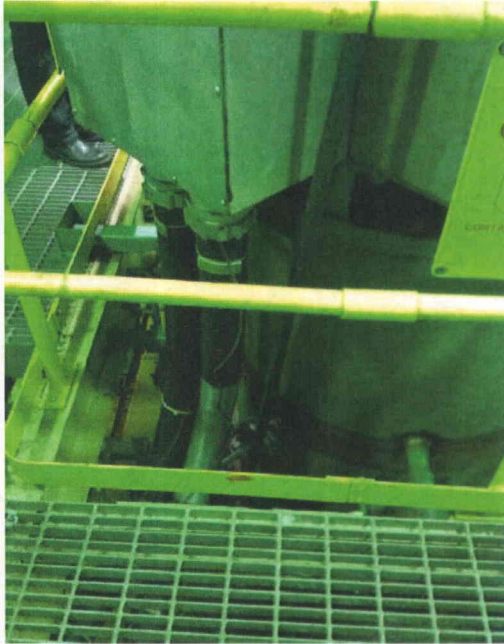
File Name: 2-63-14-4-18.jpeg
Description: View of attached lines

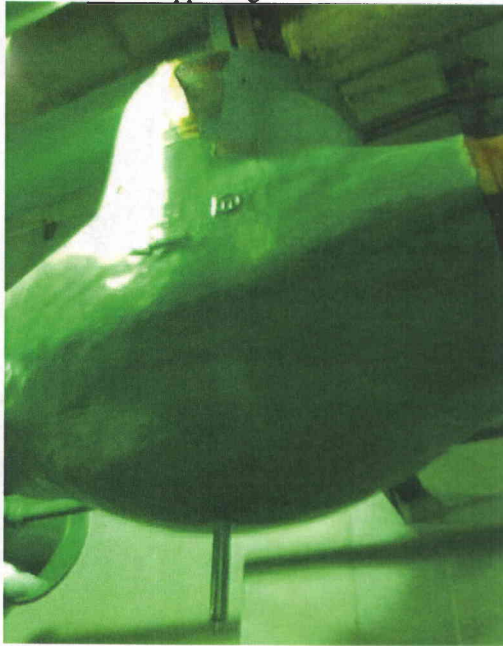
File Name: 2-61-13-4-18.jpeg
Description: Close up view of component

No significant corrosion identified.

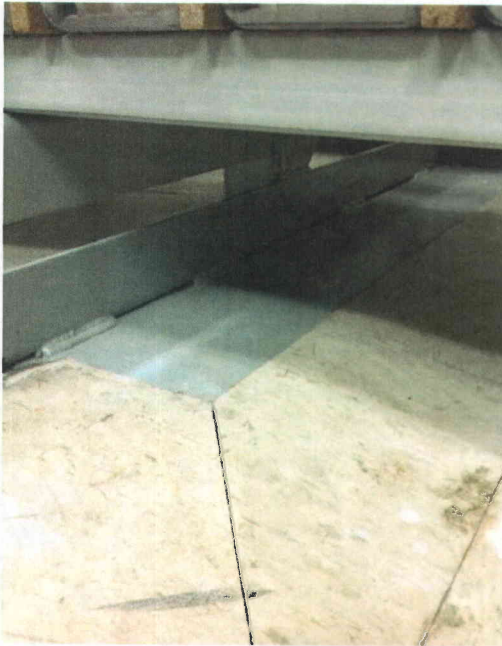
File Name: 2-63-5-4-06.jpeg
Description: View of component base detail
